# Shoreline Stability Assessment Study Report

Byllesby-Buck Hydroelectric Project  
(FERC No. 2514)

November 17, 2021

Appalachian Power Company

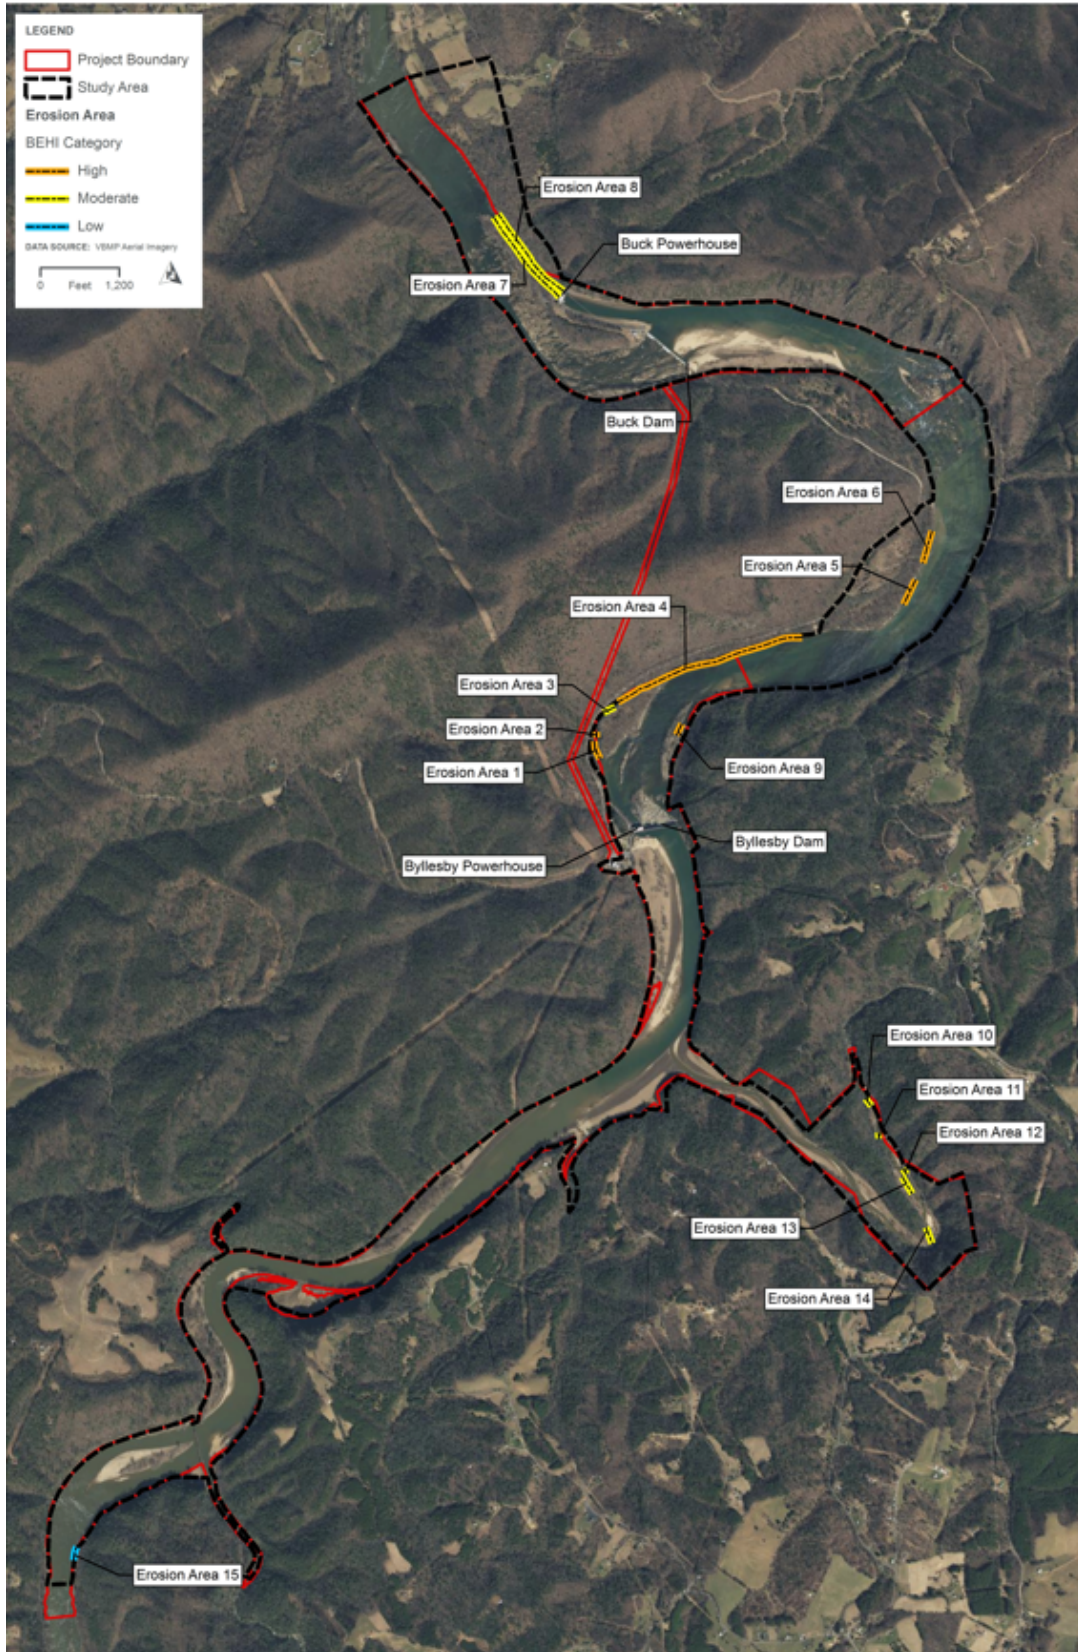
Figure 3. Erosion Areas in the Study Area Categorized by BEHI

Of the approximately 7.25 miles of New River shoreline assessed, results of the field investigation indicated that approximately 80 percent of the shoreline within the study area exhibited no signs of erosion. The areas identified as having some degree of shoreline erosion had average BEHI scores ranging from 11.75 (low) to 33.85 (high). There were no areas categorized as having very high or extreme erosion potential. Where erosion was noted, coordinates were recorded on the upstream and downstream extent of the erosion area, and in between, if necessary. Individual points within each area of erosion fell into the same total category (i.e., extreme, very high, high, moderate, low, very low). The average scores for each area of erosion are provided in Table 3. Figure 3 shows the locations of the erosion areas assessed within the study area.

The majority of the banks with some level of visible erosion had moderate root depth, low to moderate surface protection, and moderate to high bank angle. Generally, banks adjacent to the Jefferson National Forest exhibiting significant incision were least stable. High erosion potential was observed in Erosion Areas 1 and 2 on the west bank just north of Bylesby Powerhouse (Figure 3). High erosion potential was also observed in Erosion Areas 4, 5, and 6 along the west bank north of Areas 1 and 2. Erosion Area 3 immediately to the north of Erosion Areas 1 and 2 had moderate erosion potential. Erosion Area 9 on the east bank across from Area 2 also exhibited high erosion potential. Streambanks to the north near Buck Powerhouse and to the southeast near Crooked Creek were categorized as having moderate erosion potential and Erosion Area 15 exhibited low erosion potential.

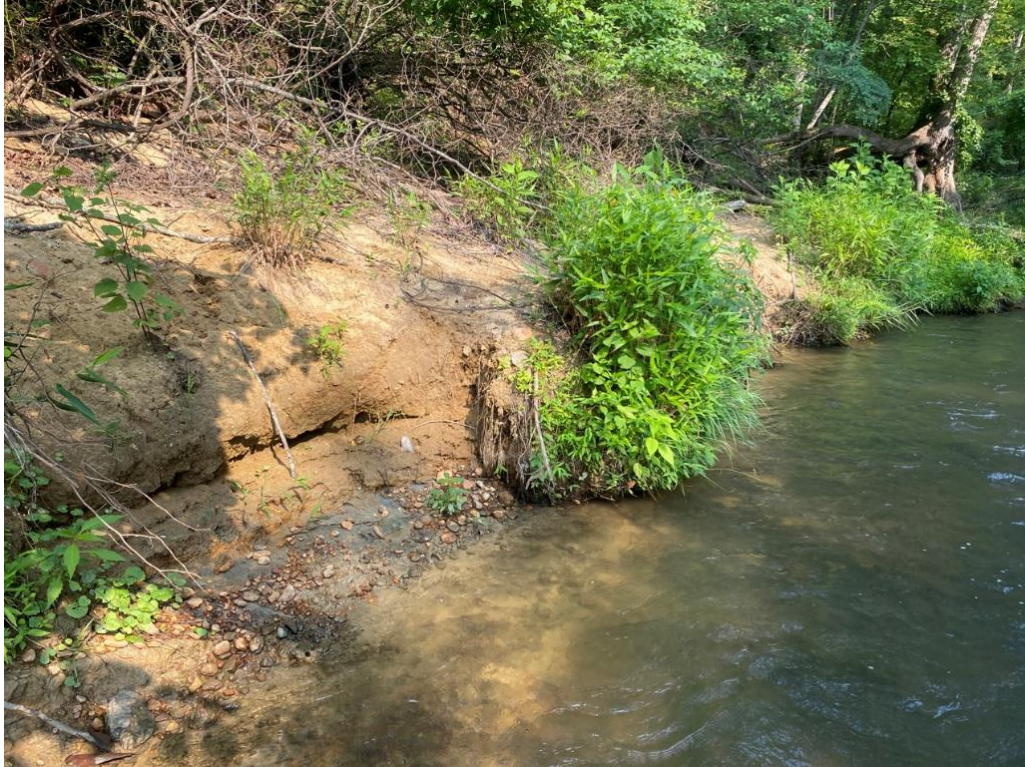
**Erosion Area 1; Category “High”**

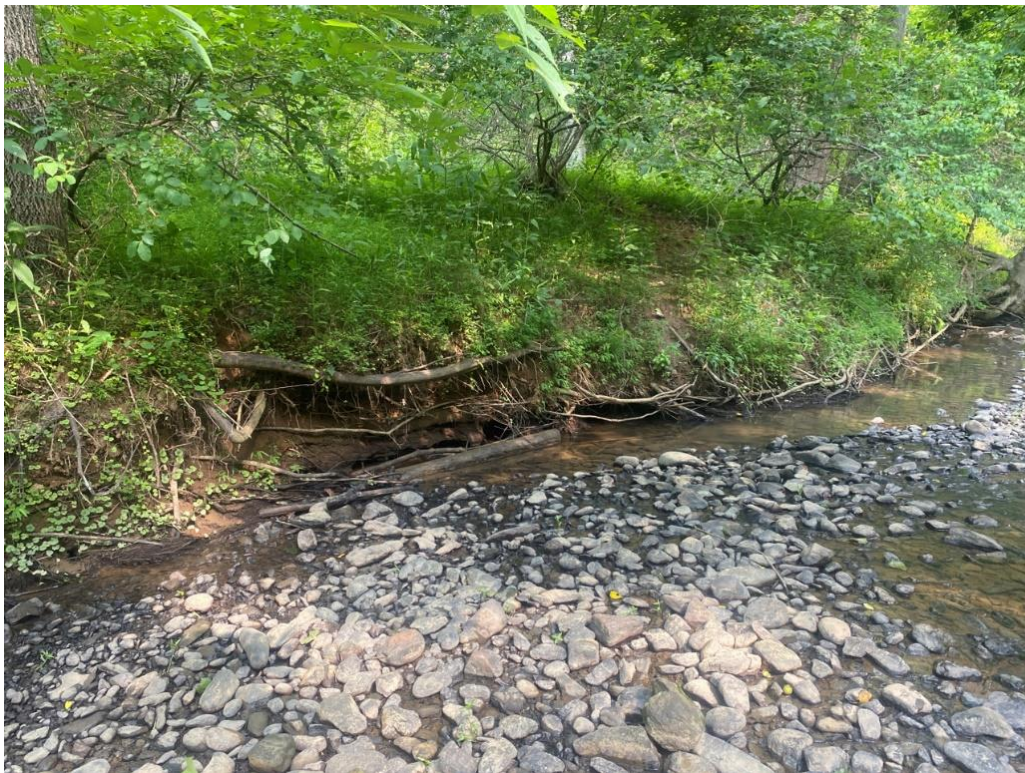
**Erosion Area 2; Category “High”**

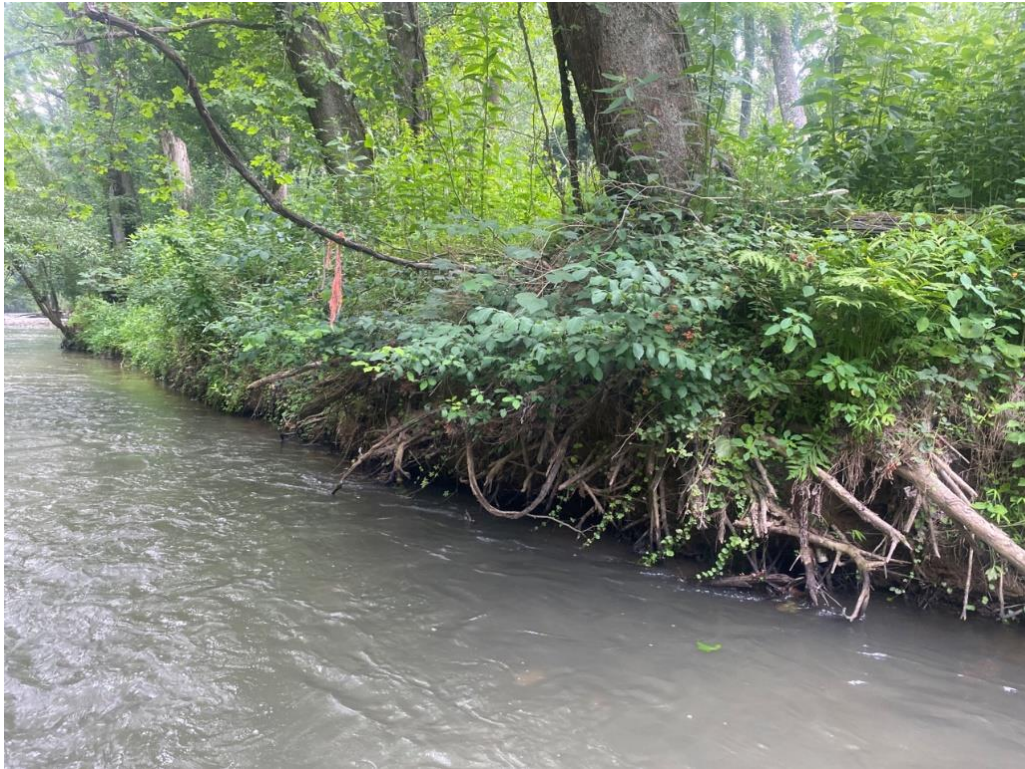
**Erosion Area 3; Category “Moderate”**

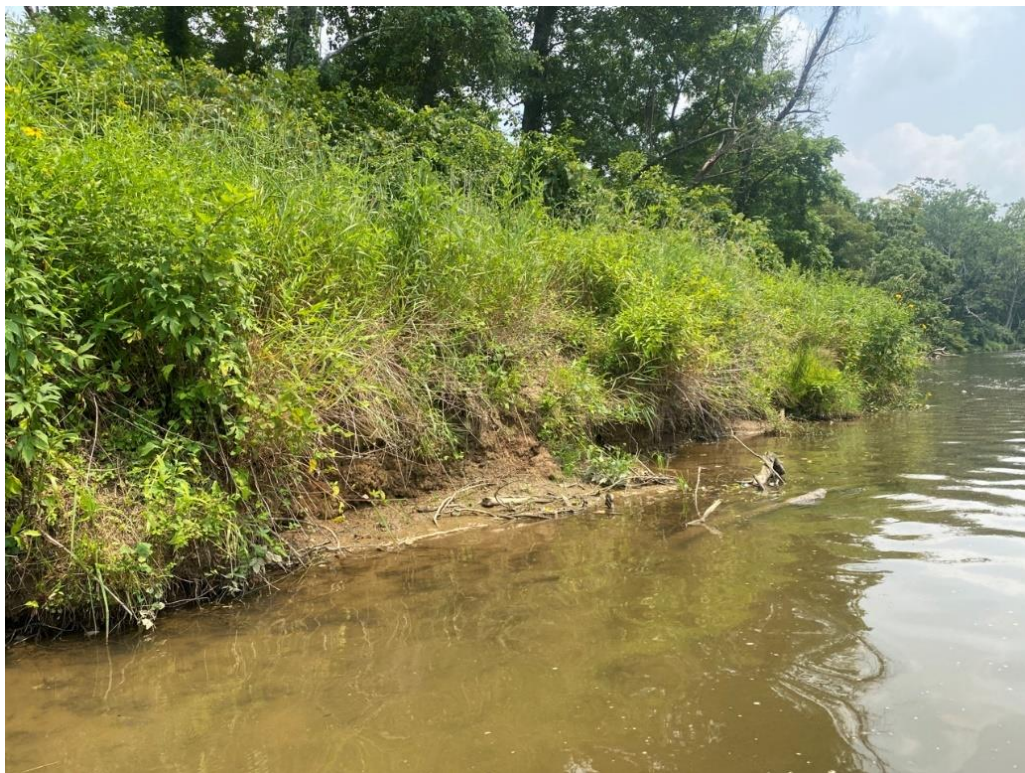
**Erosion Area 4; Category “High”**

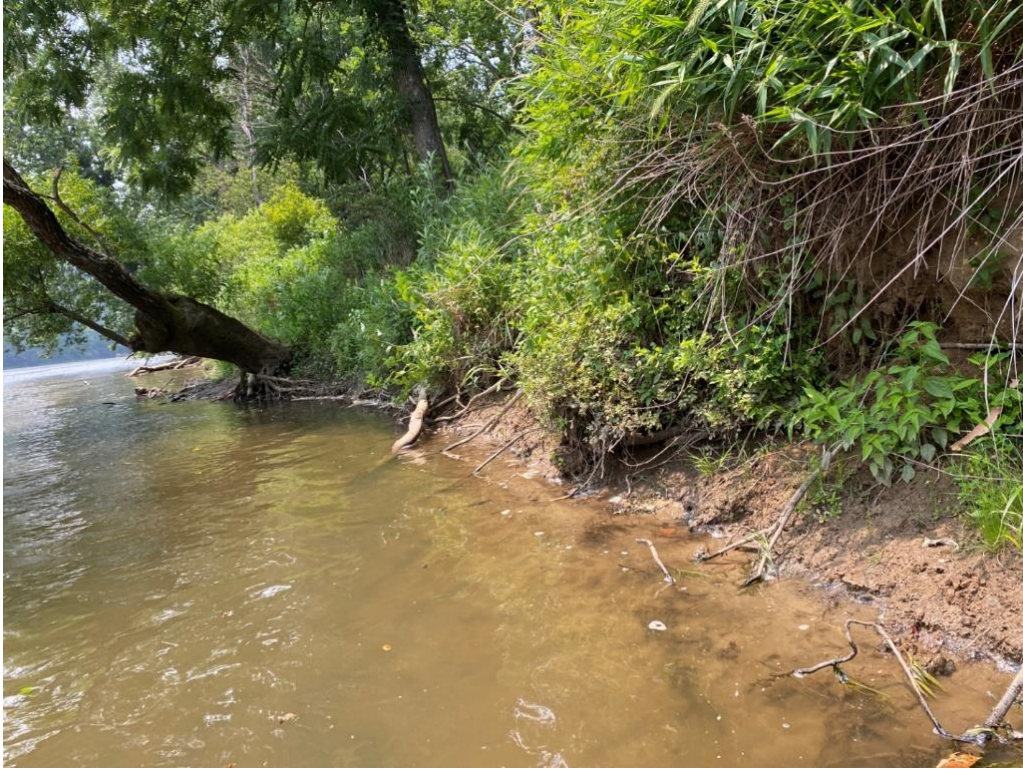
**Erosion Area 5; Category “High”**

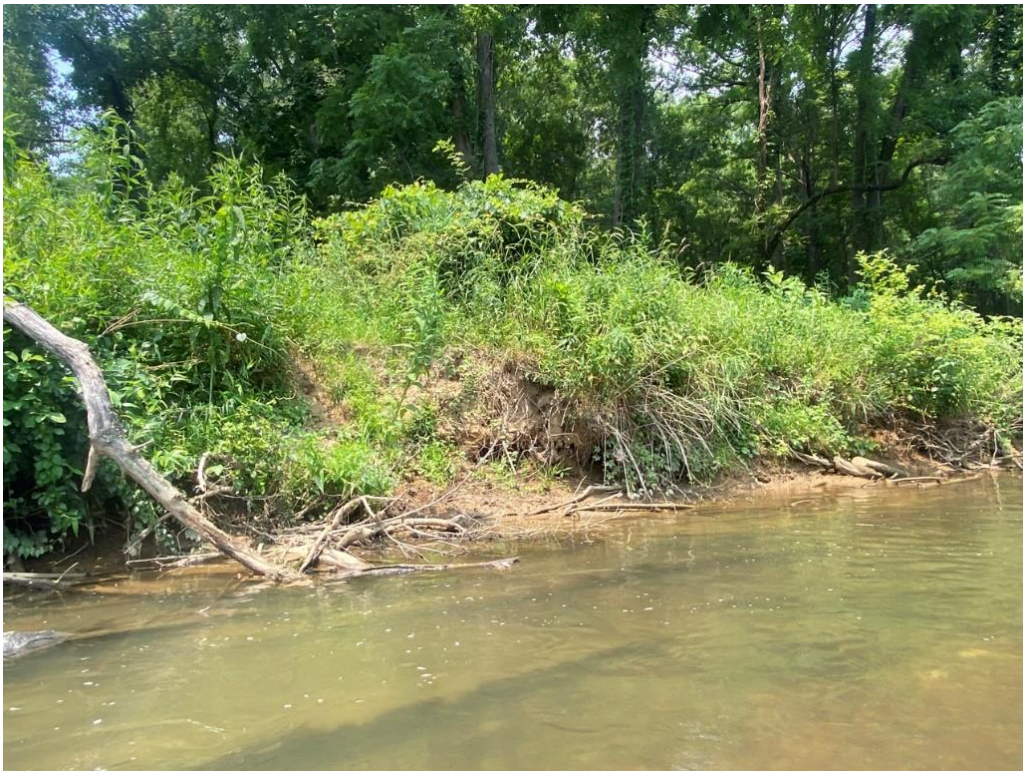
**Erosion Area 6; Category “High”**

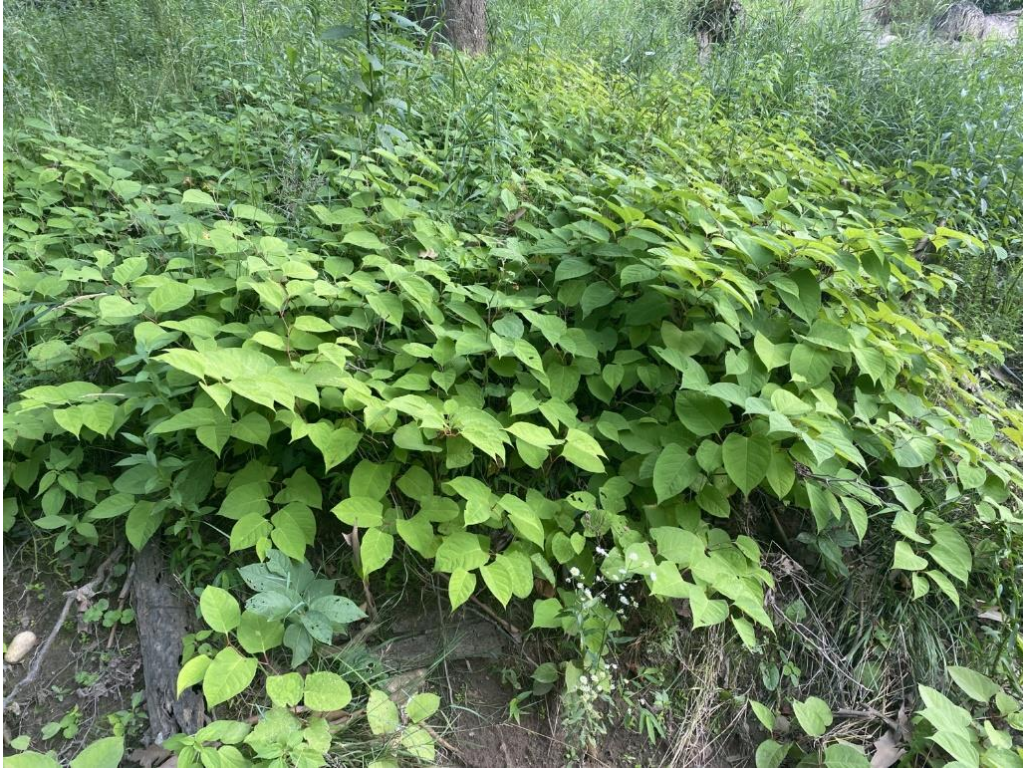
**Erosion Area 7; Category “Moderate”**

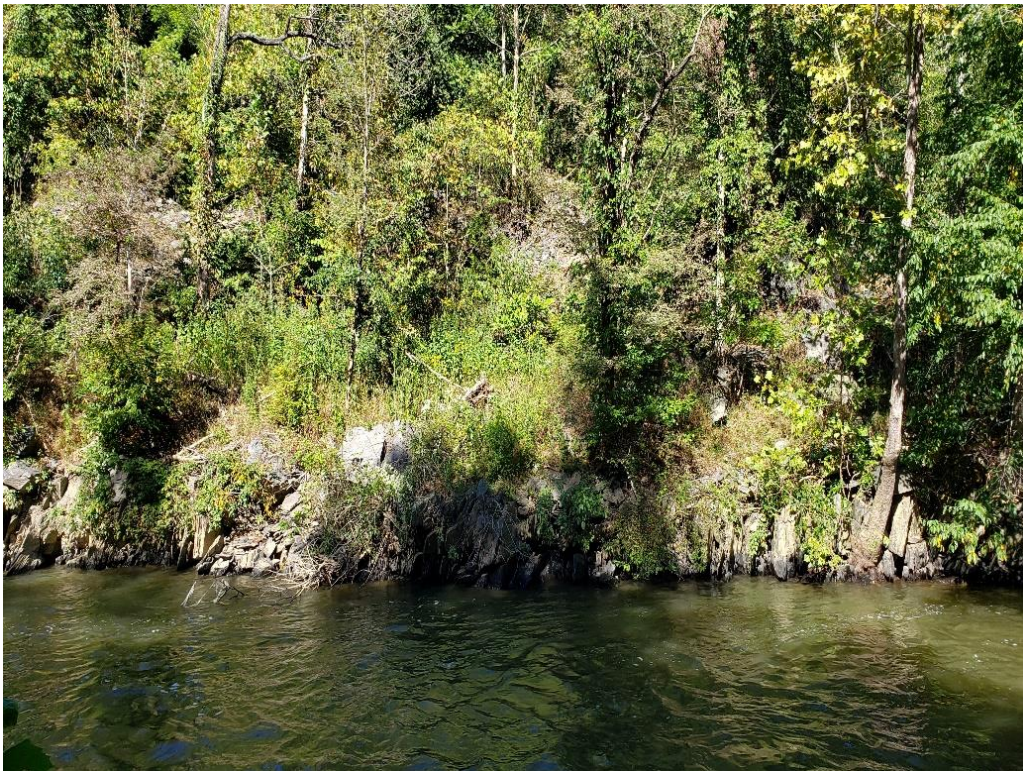
**Erosion Area 8; Category “Moderate”**

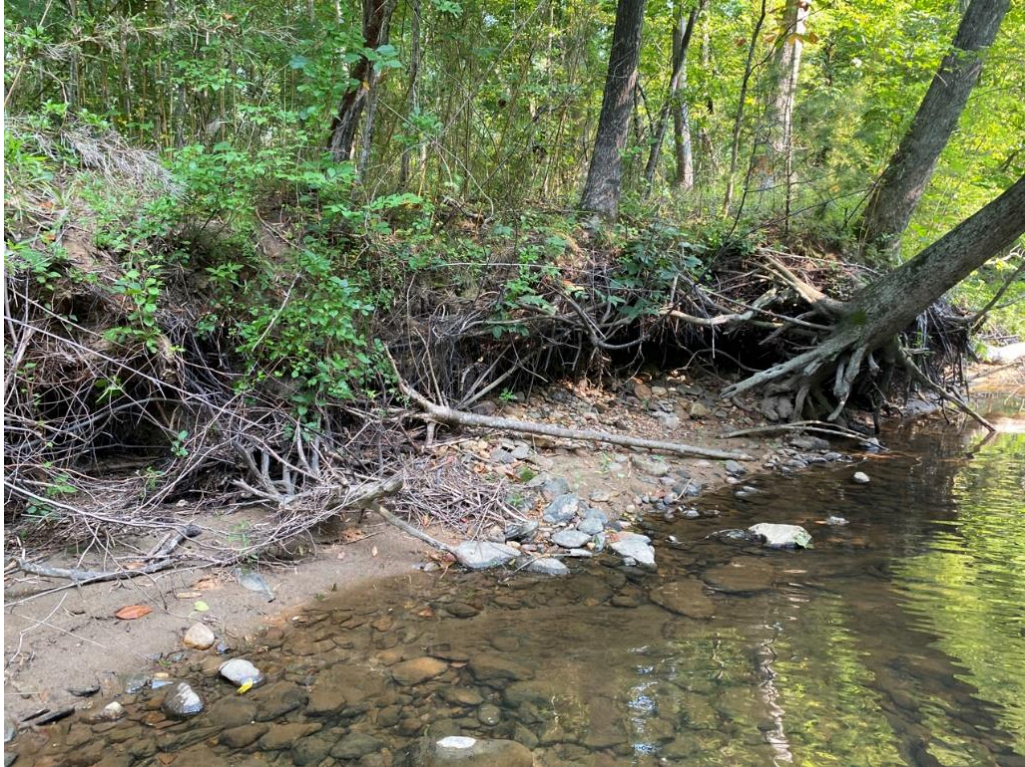
**Erosion Area 9; Category “High”**

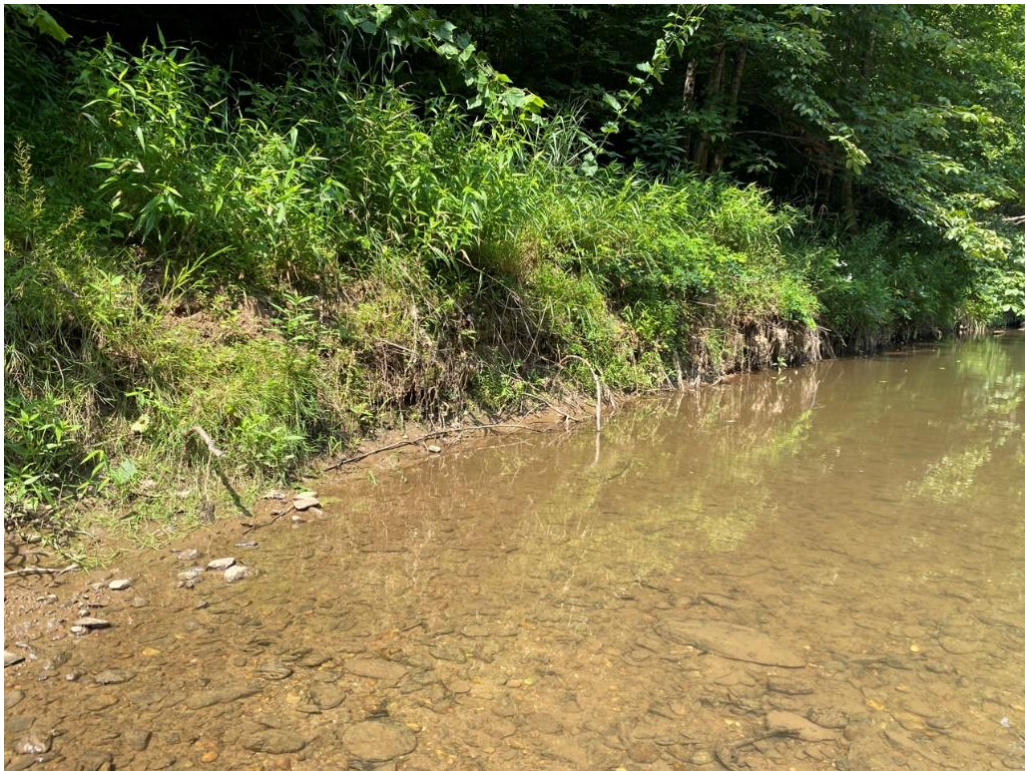
**Erosion Area 10; Category “Moderate”**

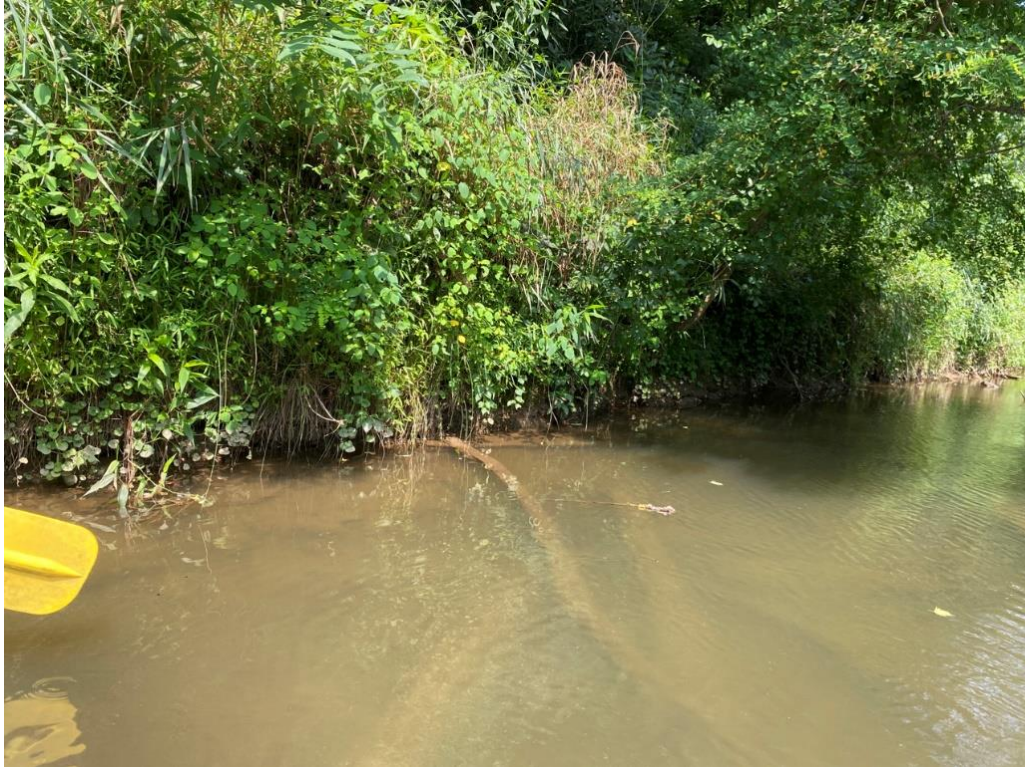
**Erosion Area 11; Category “Moderate”**

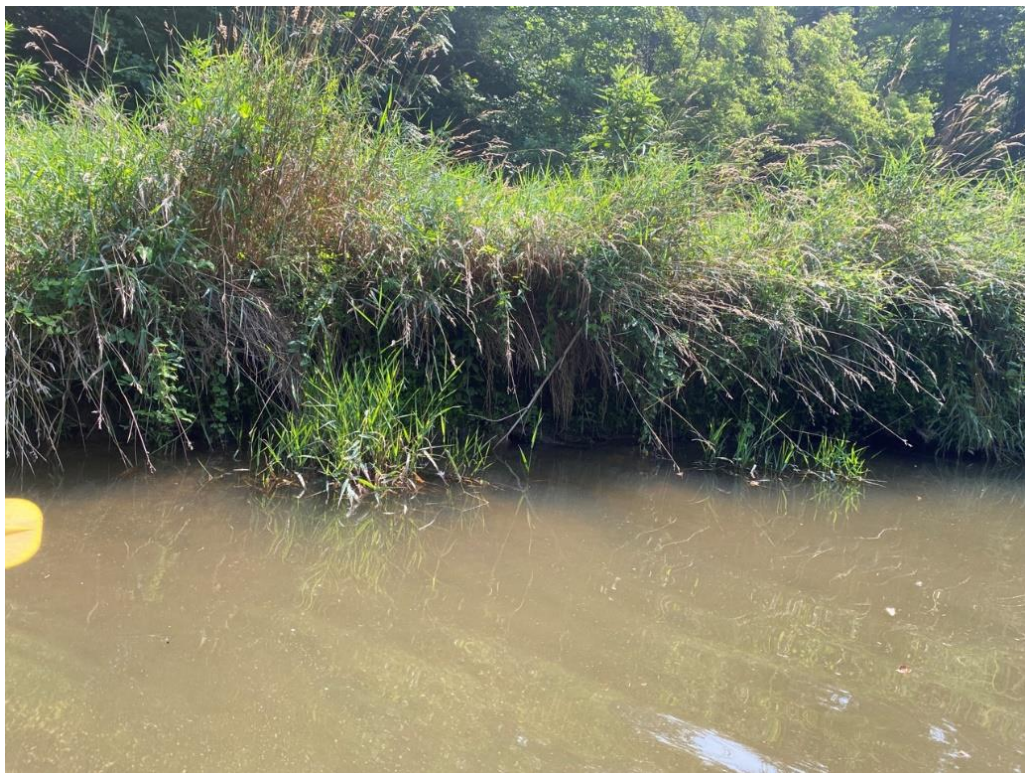
**Erosion Area 12; Category “Moderate”**

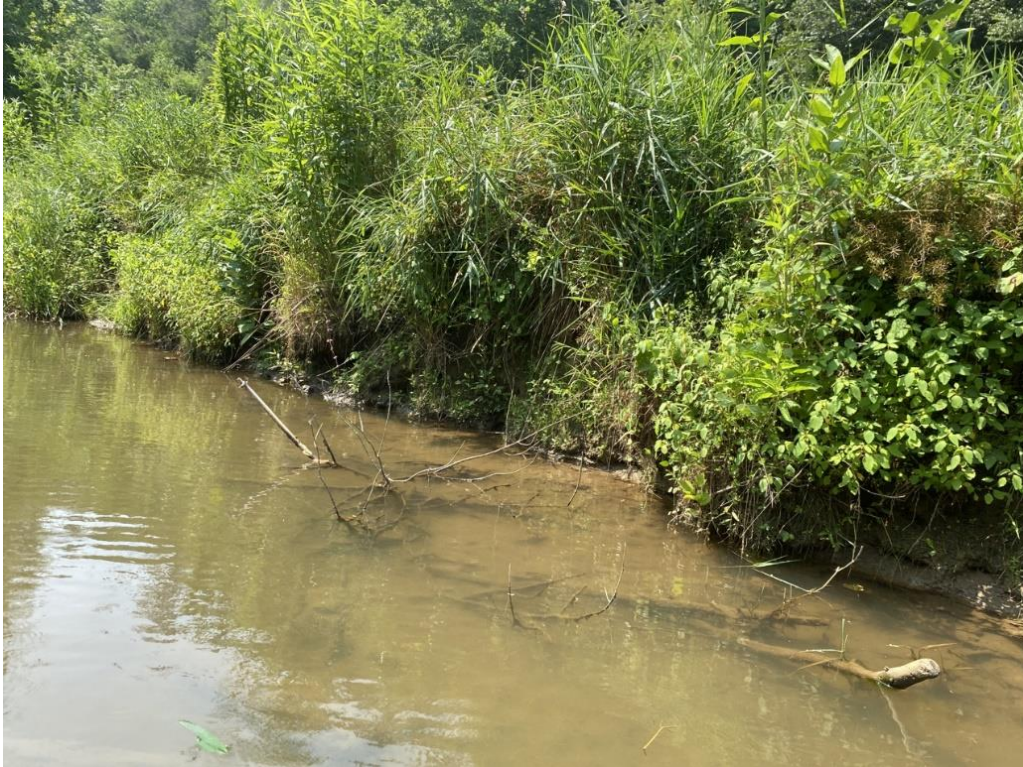
**Erosion Area 13; Category “Moderate”**

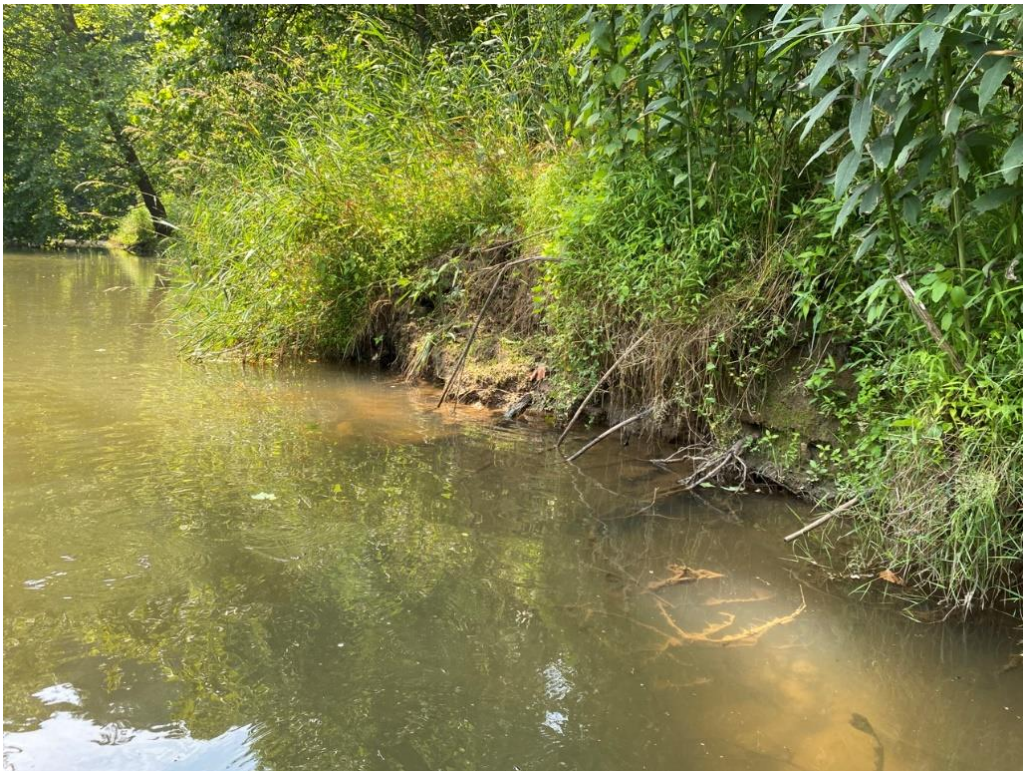
**Erosion Area 14; Category “Moderate”**

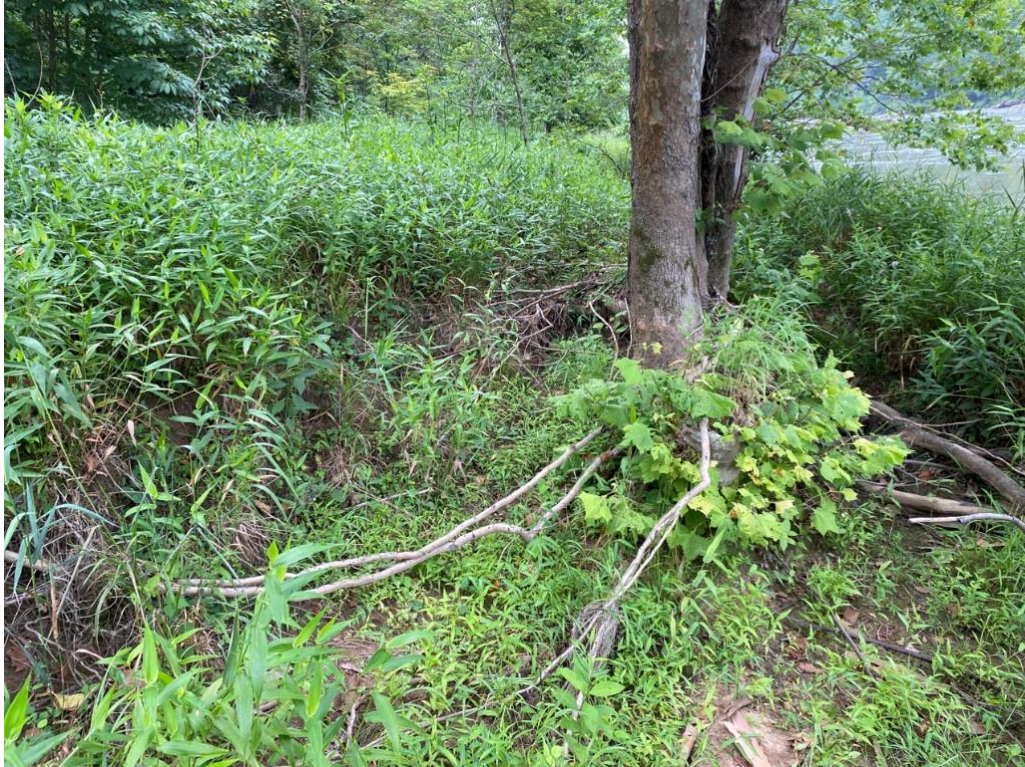
**Erosion Area 15; Category “Low”**
