**SUBJECT: Constantine Hydroelectric Project (FERC No. 10661)
Response to Final License Application Additional Information
Requests**

7. Shoreline Survey Photographs - AEP Constantine Project Area 2019

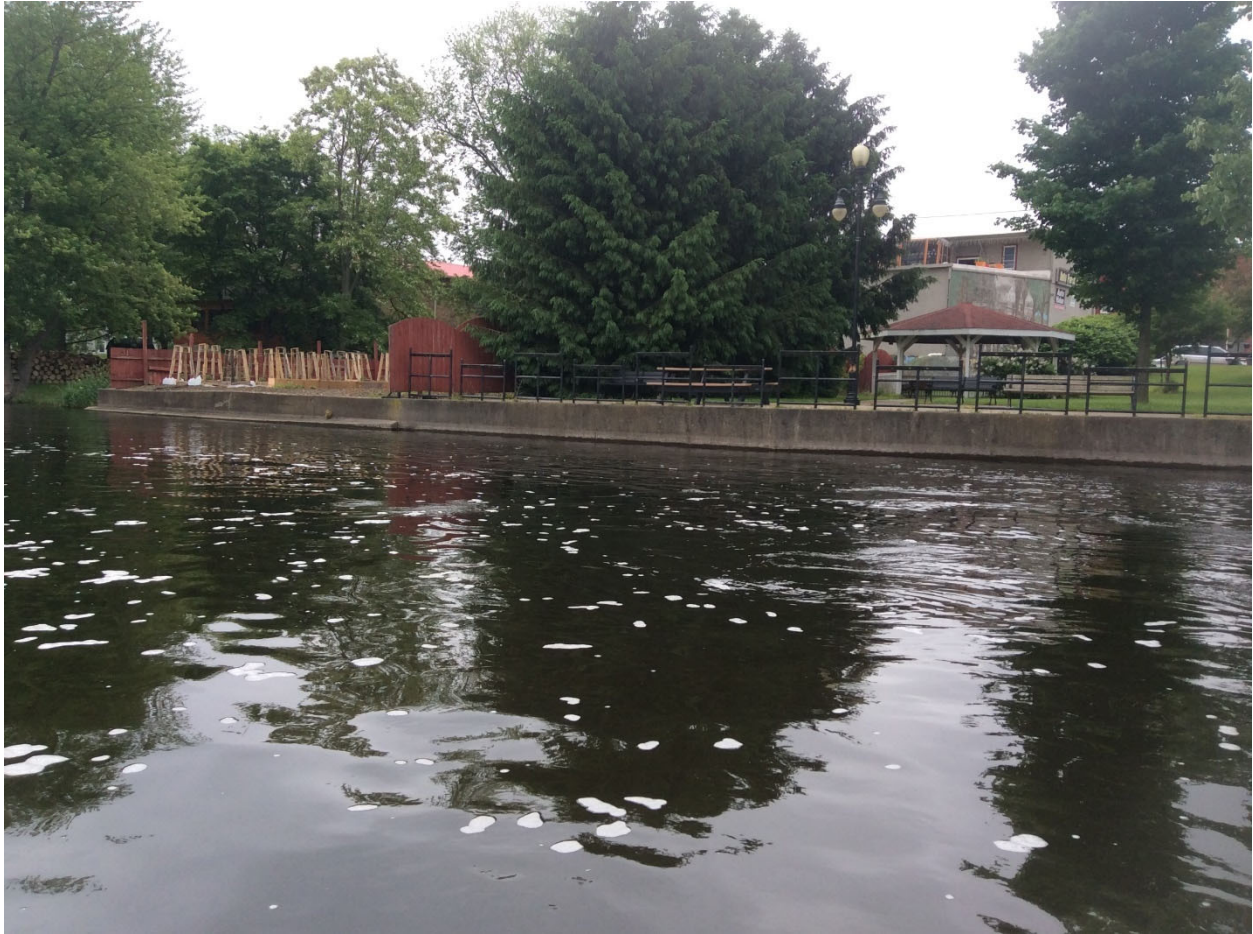
Figure 2. Site BA02: Example of shoreline armoring in the bypass reach area.

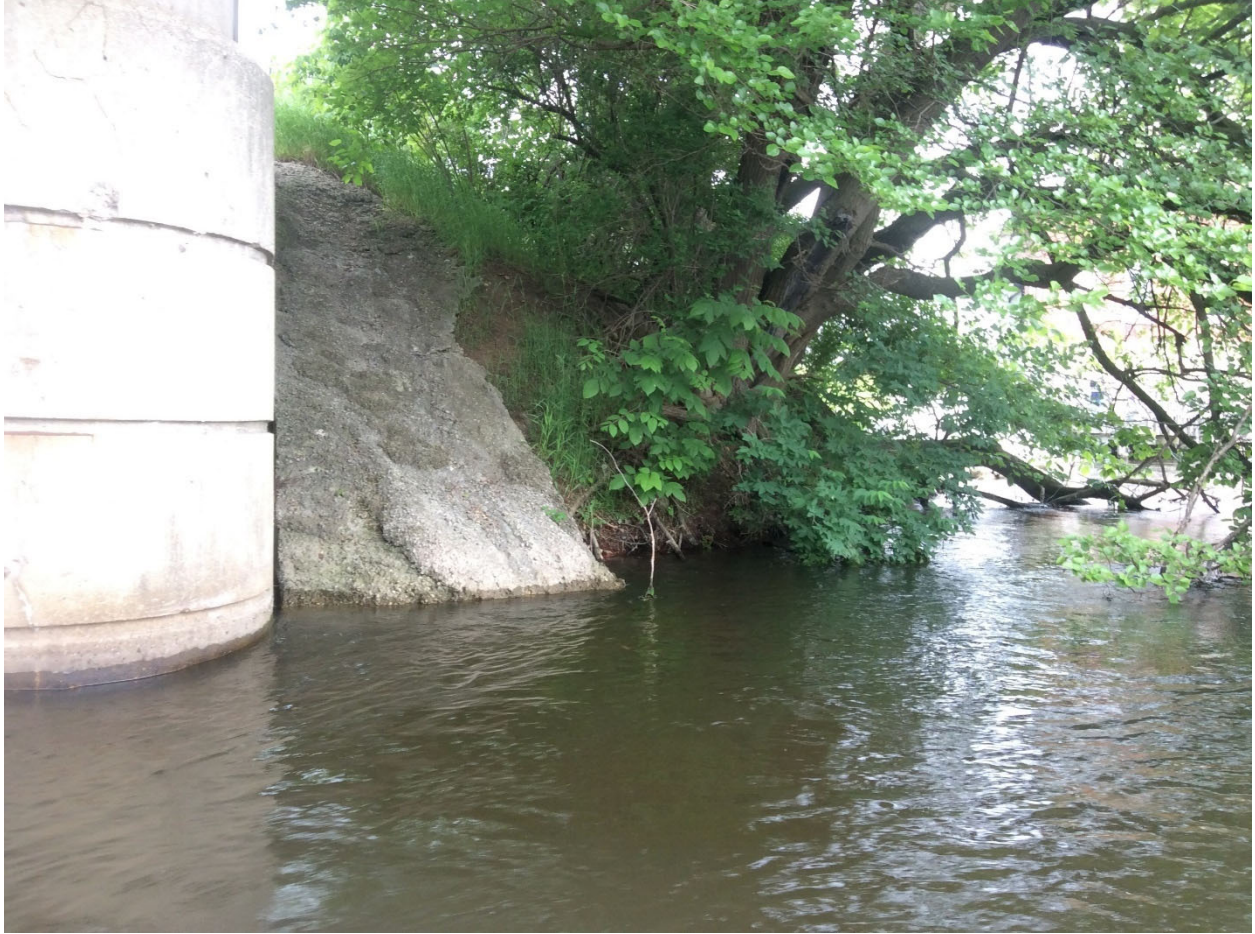
- 1) Site BA03 located at the downstream end of the Project. This site has an area of erosion located against concrete at the base of the bridge extending under the overhanging vegetation. This erosion area is likely caused by current hitting the bank from the tailrace.

Figure 3. Site BA03: Area of Moderate erosion located at the Business Route US-131 Bridge.

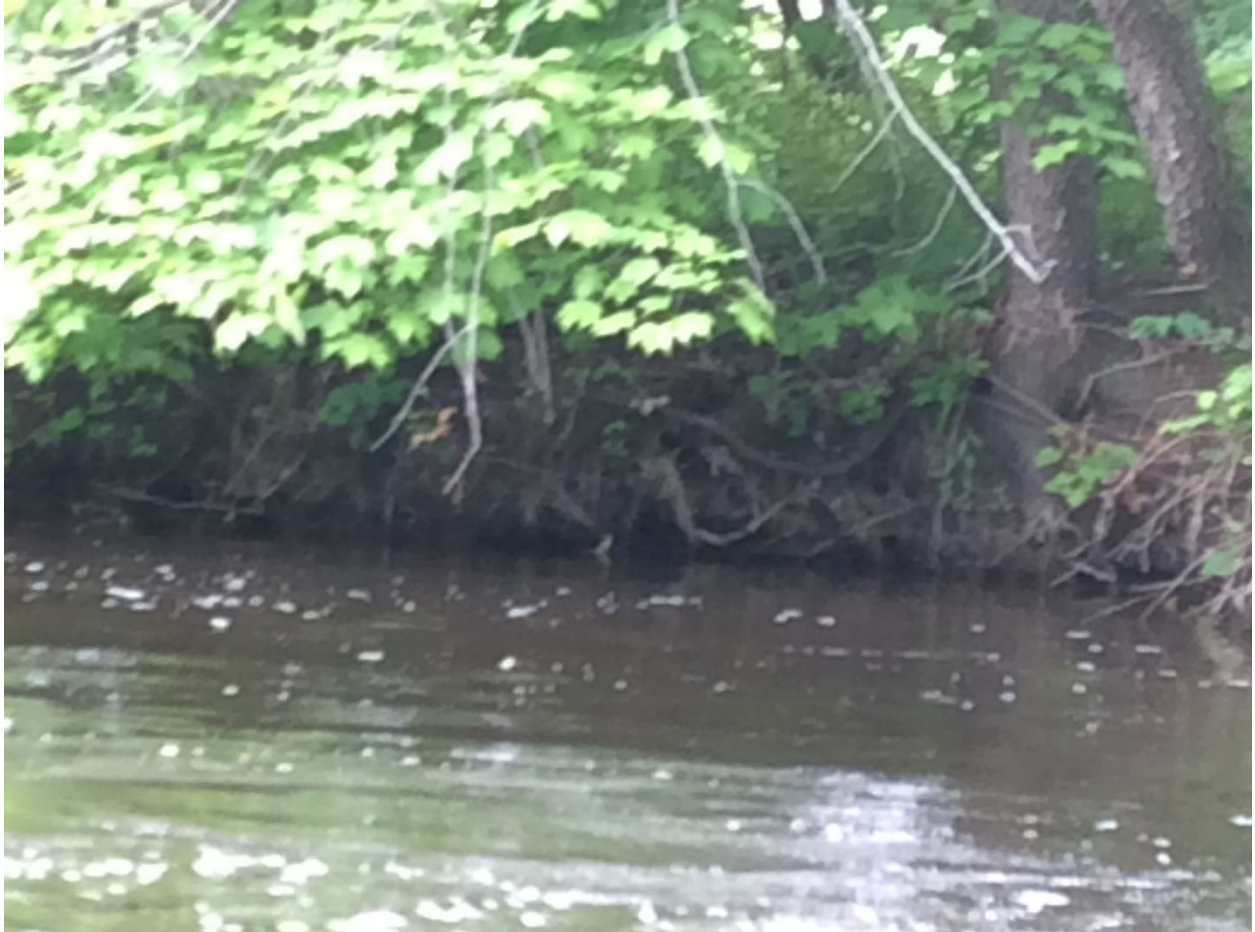
Figure 4. Site BA05: Moderate erosion near the water surface.

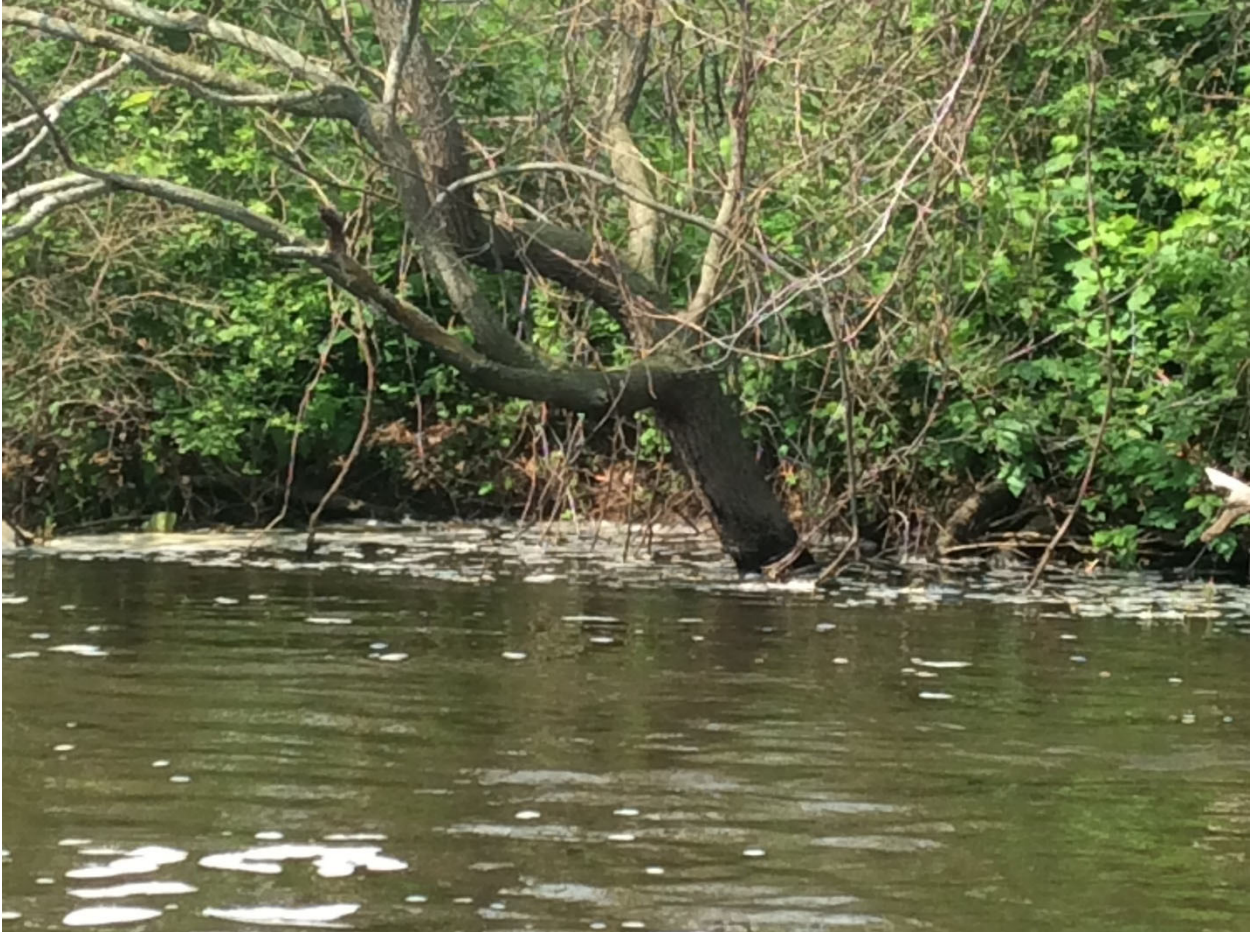
Figure 5. Site BA06: Moderate erosion near the water surface.

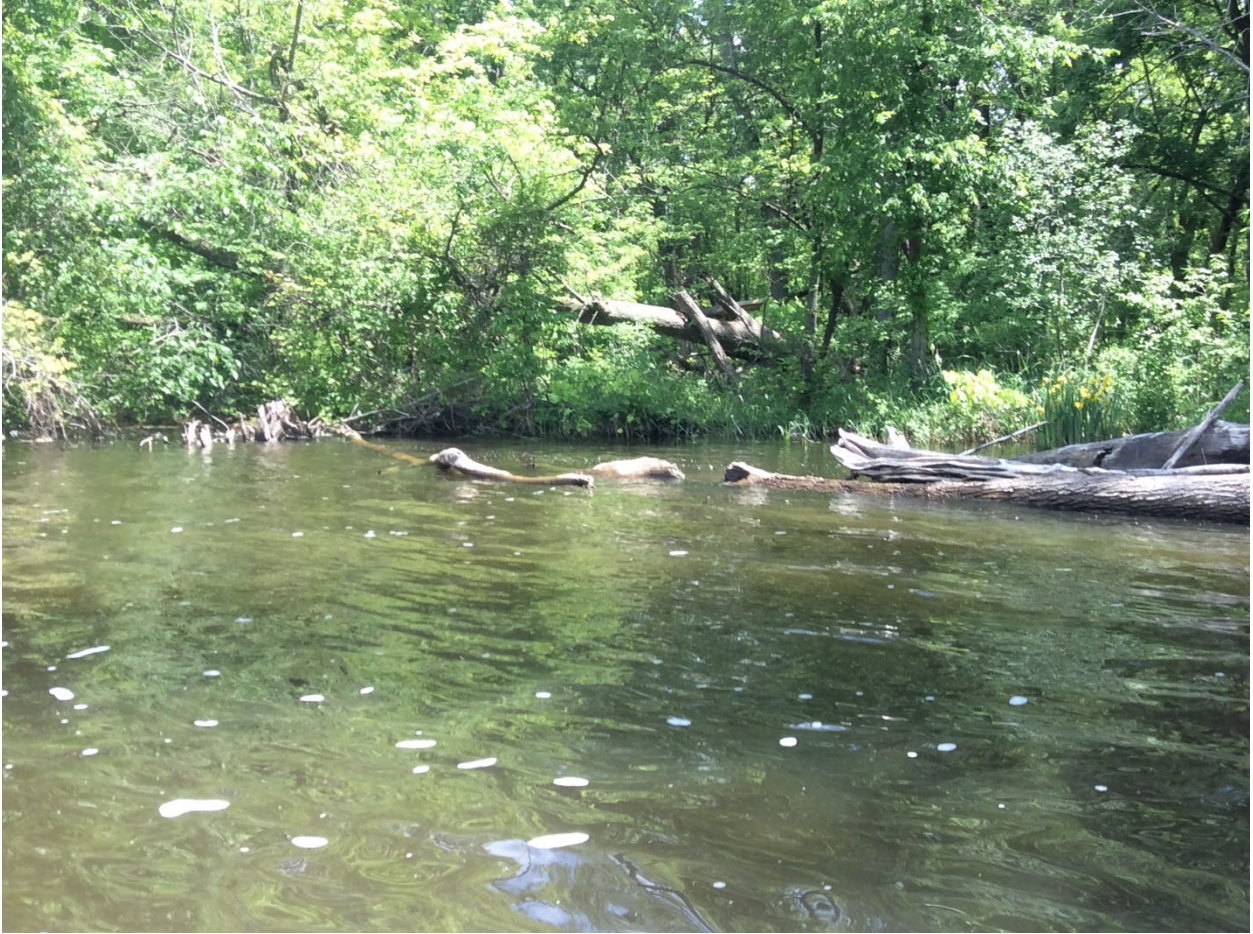
Figure 6. Site BA10:Very Low erosion category.

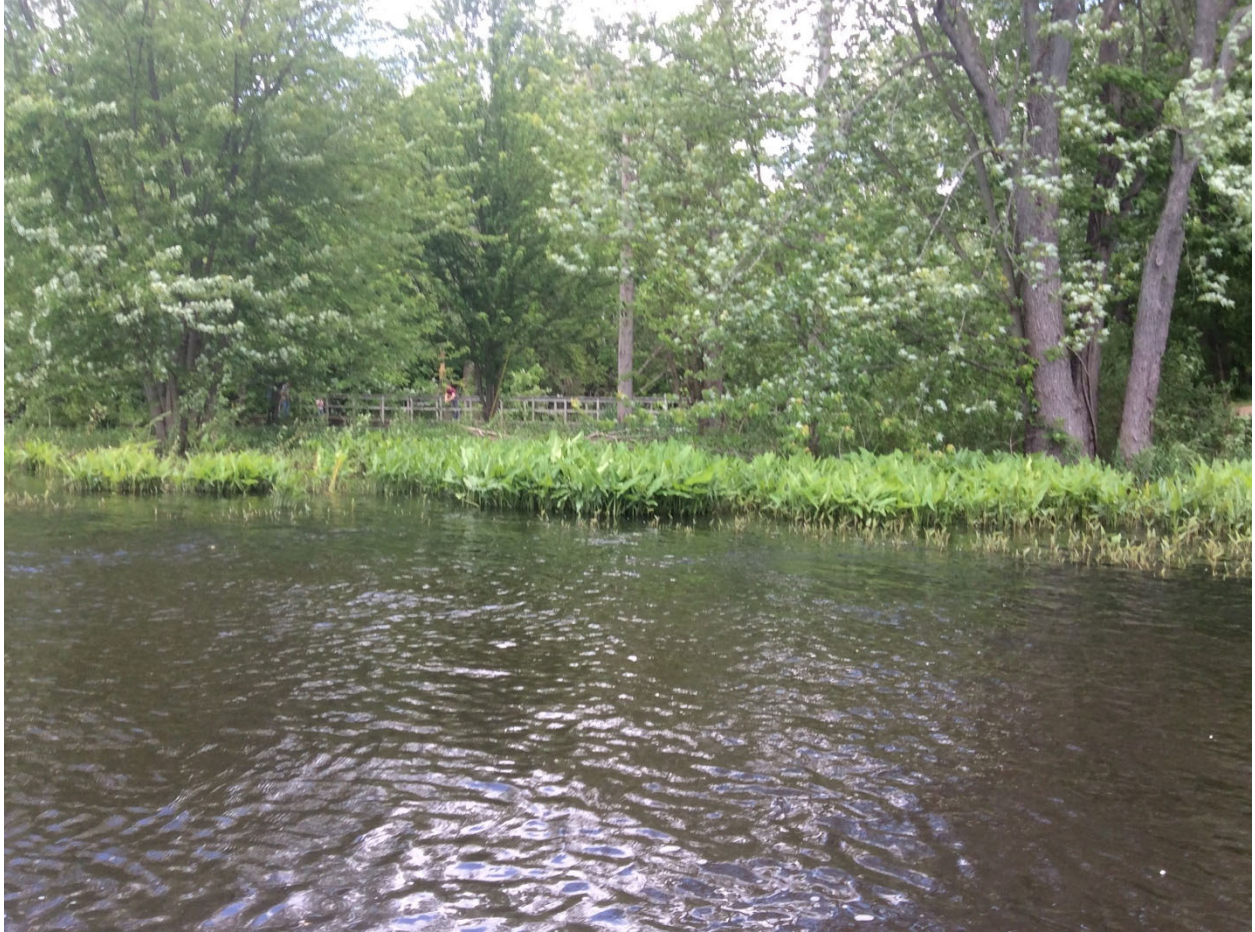
Figure 7. Site BA12:Very Low erosion category.

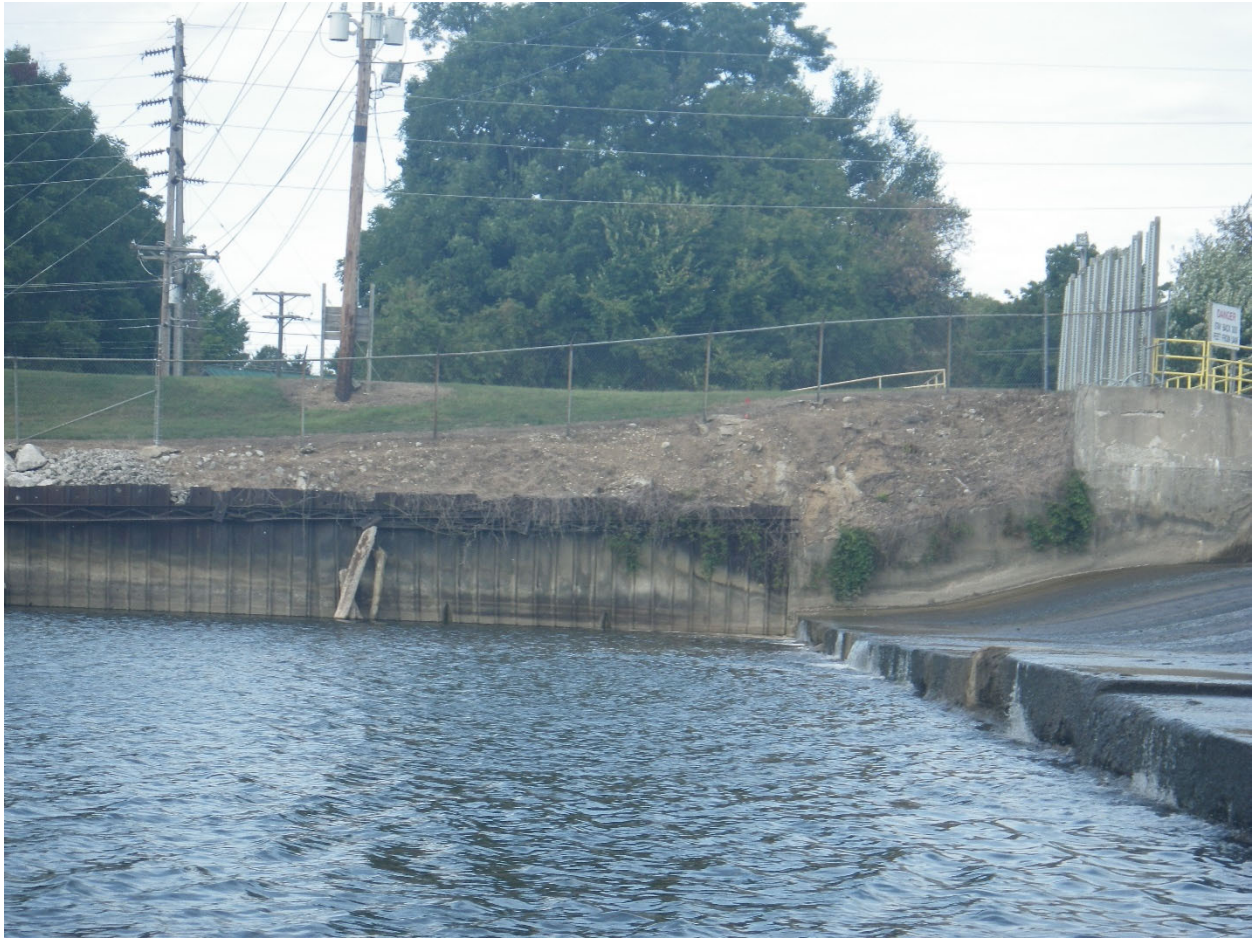
One localized spot of erosion was observed in September in the bypass reach. Figure 8 shows one localized erosion area of concern near the dam. The lack of vegetation above the steel bulkhead and concrete are allowing for increased erosion in this localized area. This site was not observed in June due to the higher water levels (Table 4) and current velocity in the bypass reach. The lower water levels in September allowed for access to the entire bypass reach up to the dam.

Figure 8. Area of localized very high erosion risk in the bypass reach area

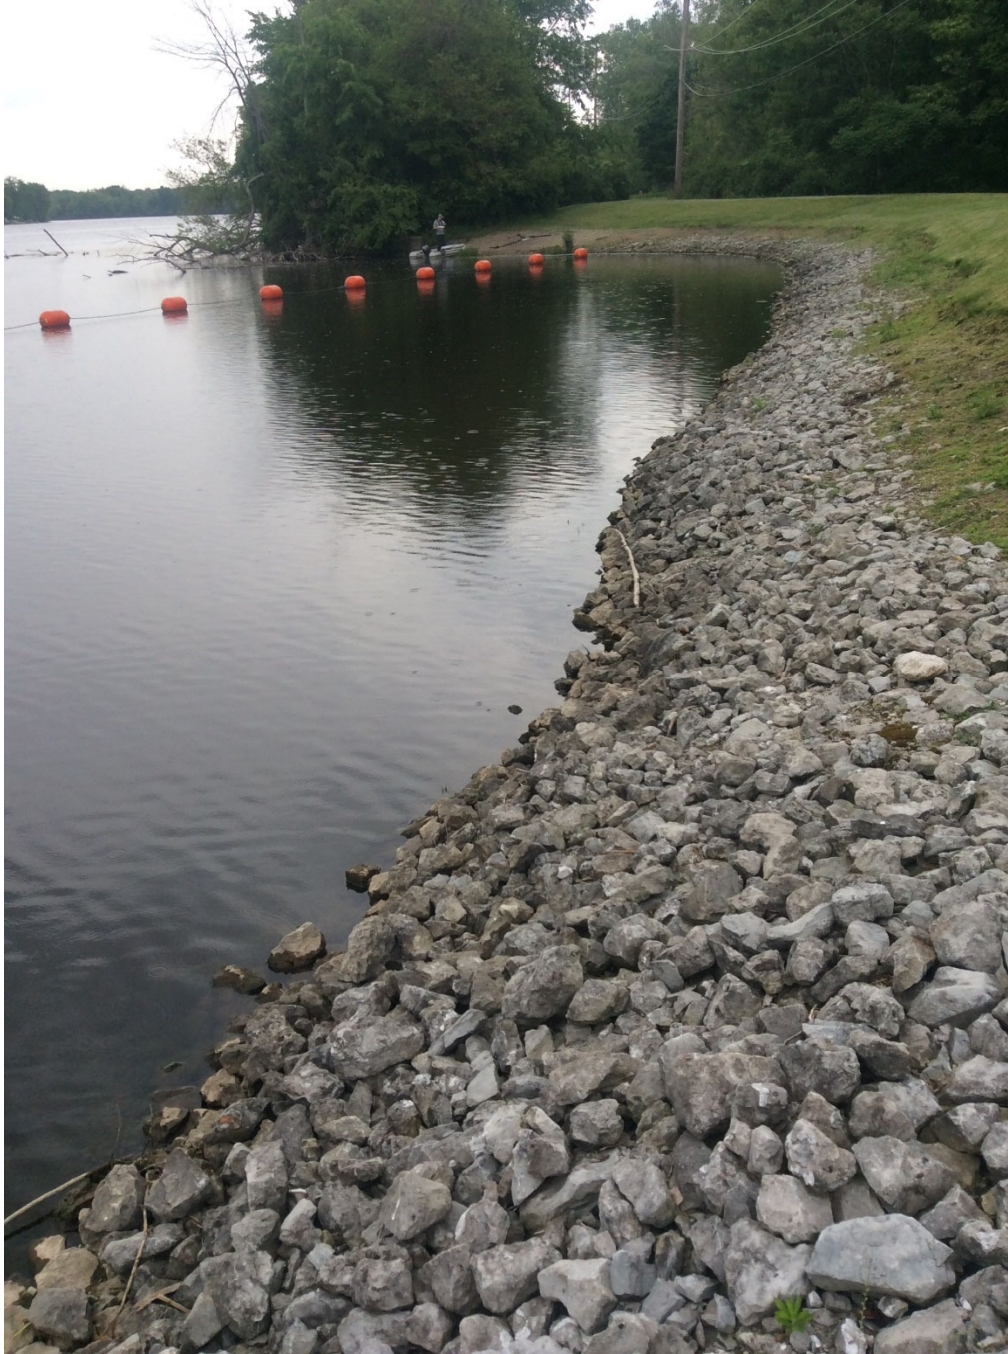
Figure 9. Site SJR45: Example of shoreline armoring.

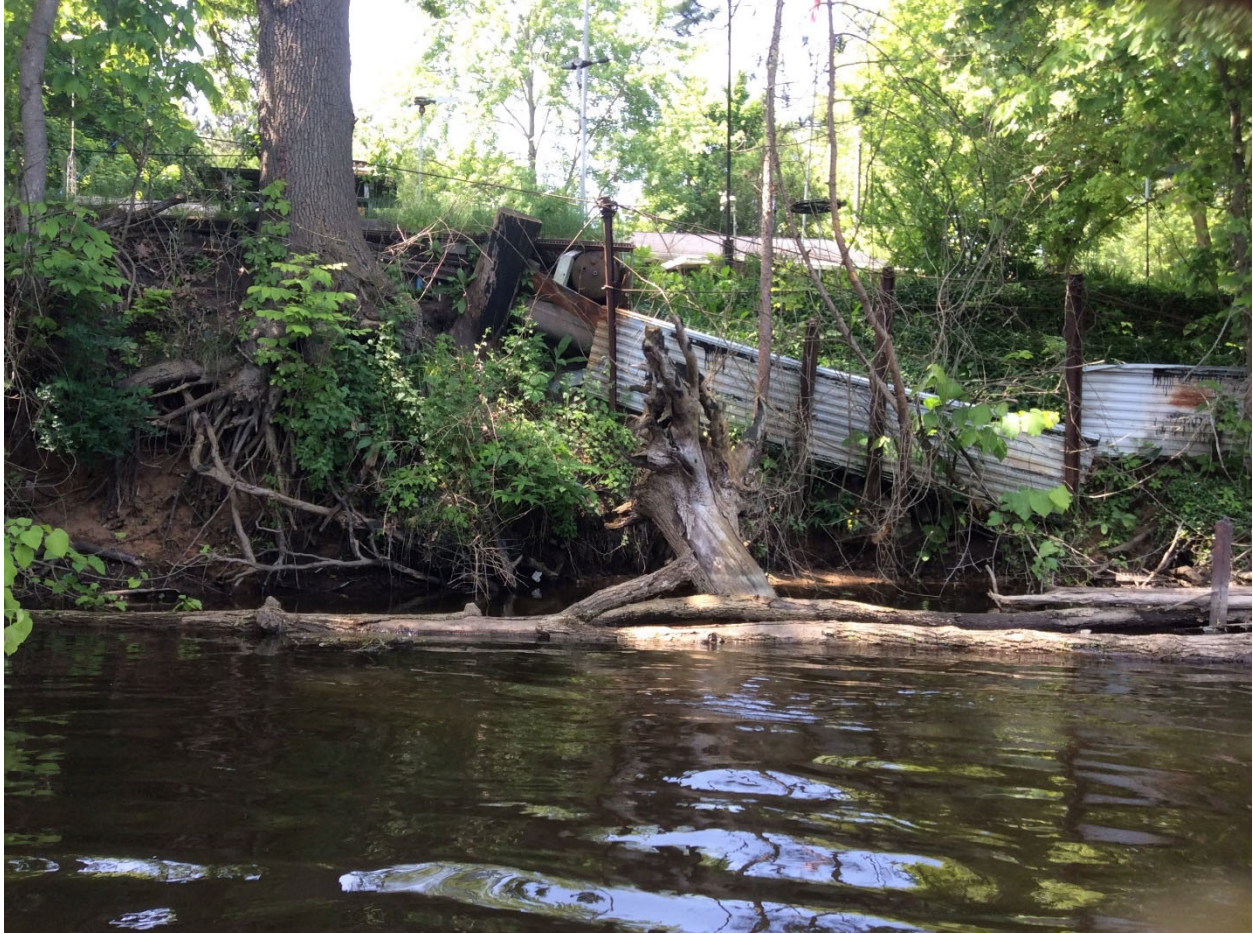
Figure 11. Site SJR09: Erosion along outside bend with roof of home in the background.

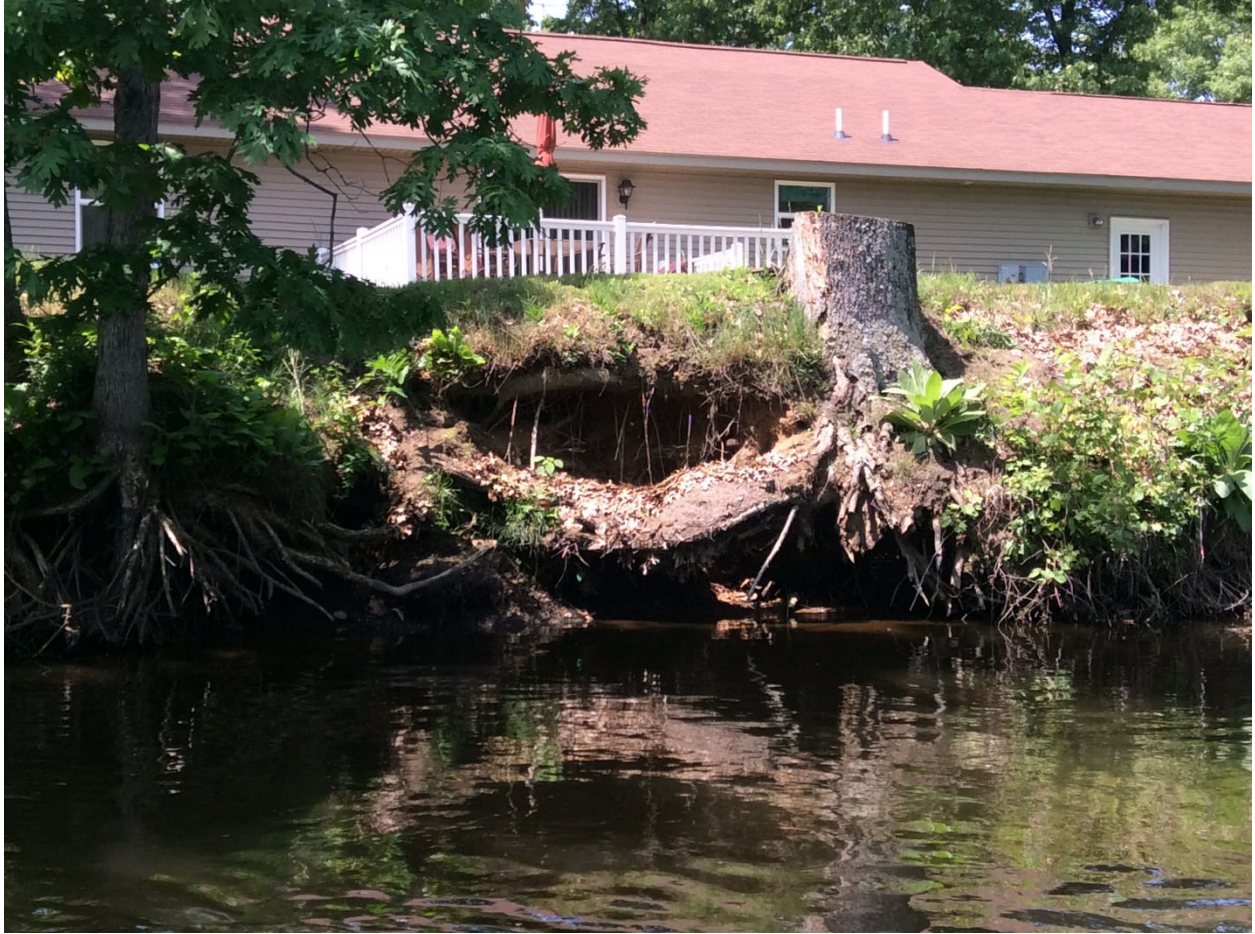
Figure 12. Site SJR10: Moderate erosion located along outside bend of river with home in background.

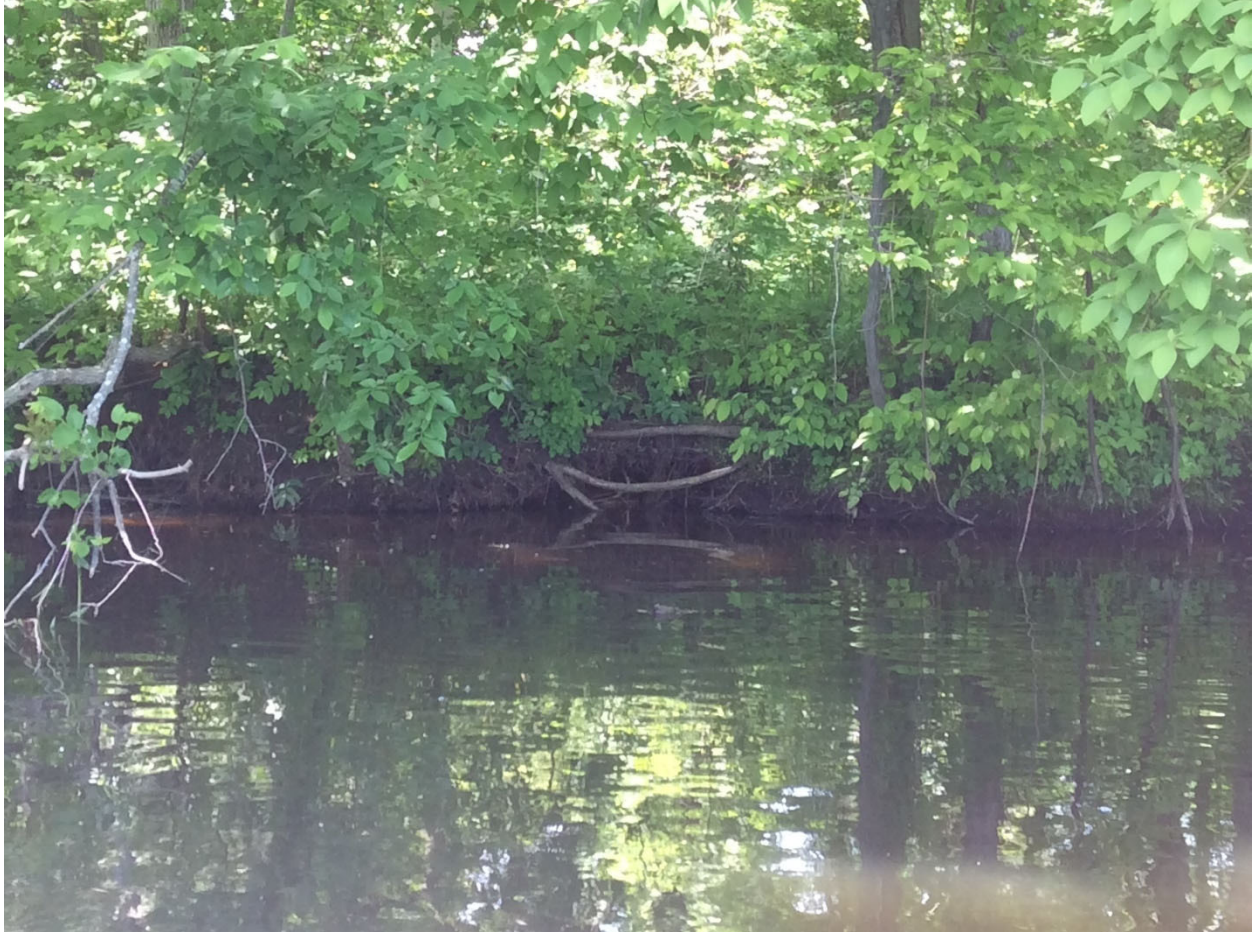
Figure 13. Site SJR15: Moderate erosion associated with an increase in bank angle.

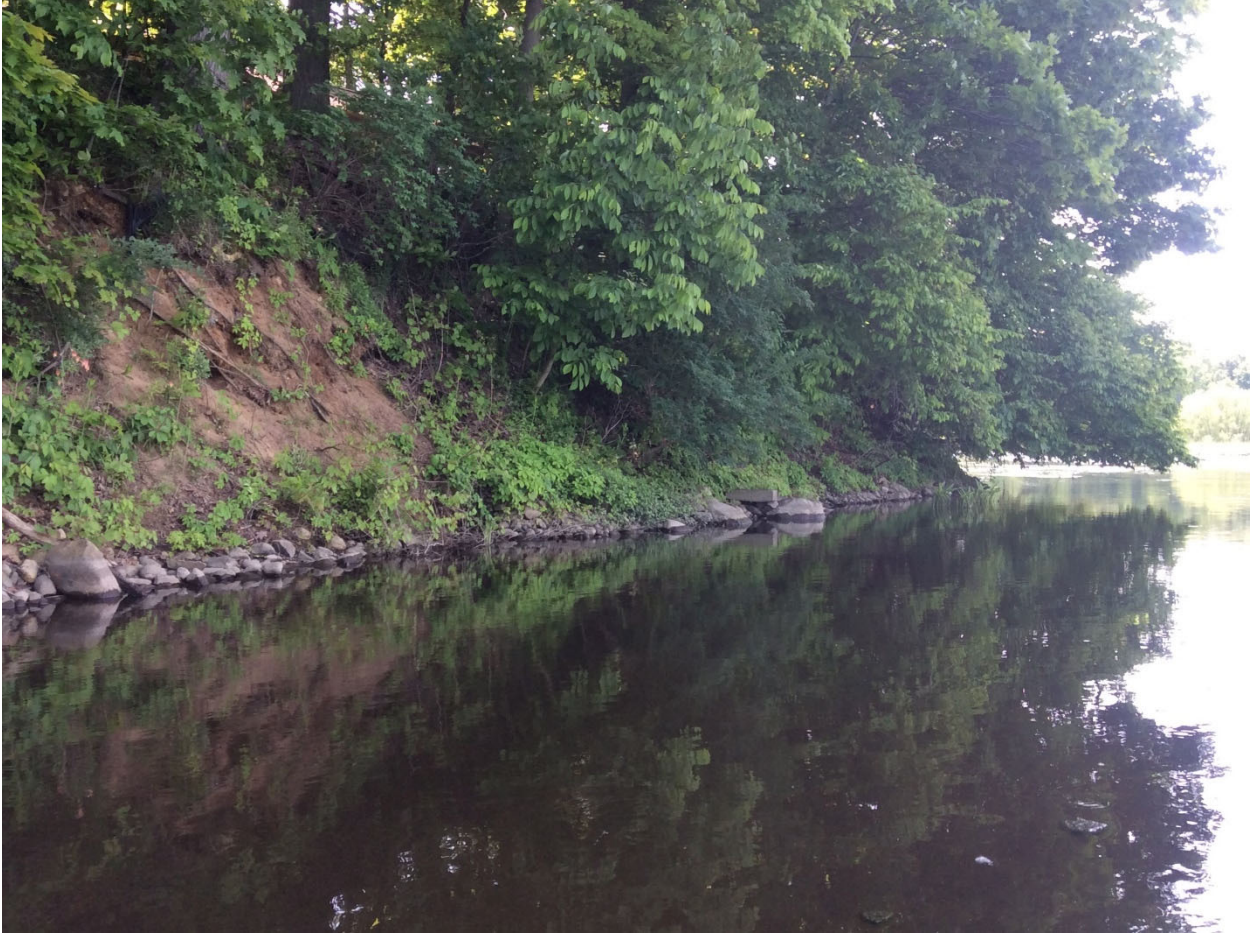
Figure 14. Site SJR18: Moderate erosion associated with an increase in bank angle and a decrease in root density.

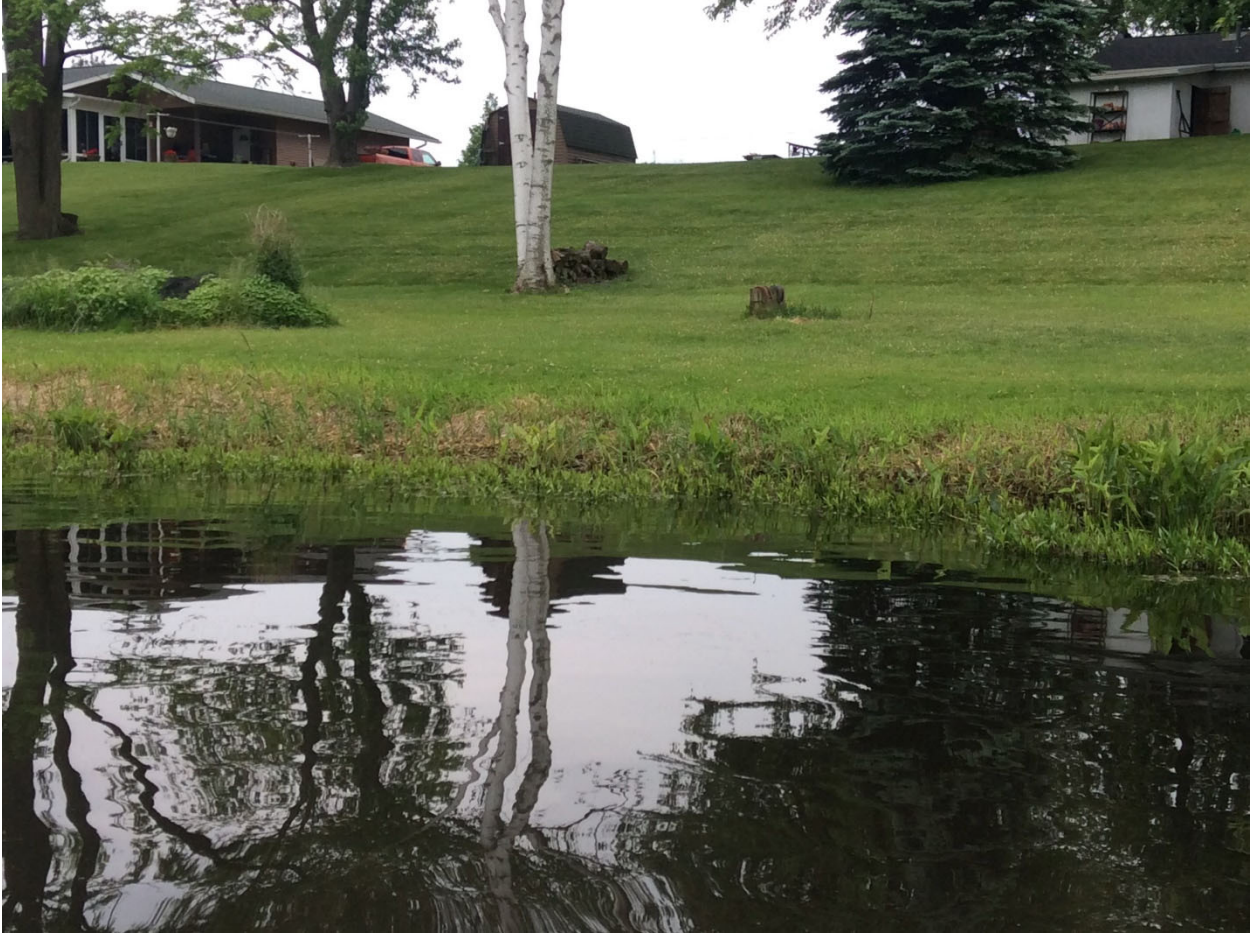
Figure 15. Site SJR27: Developed site along reservoir with Low erosion.

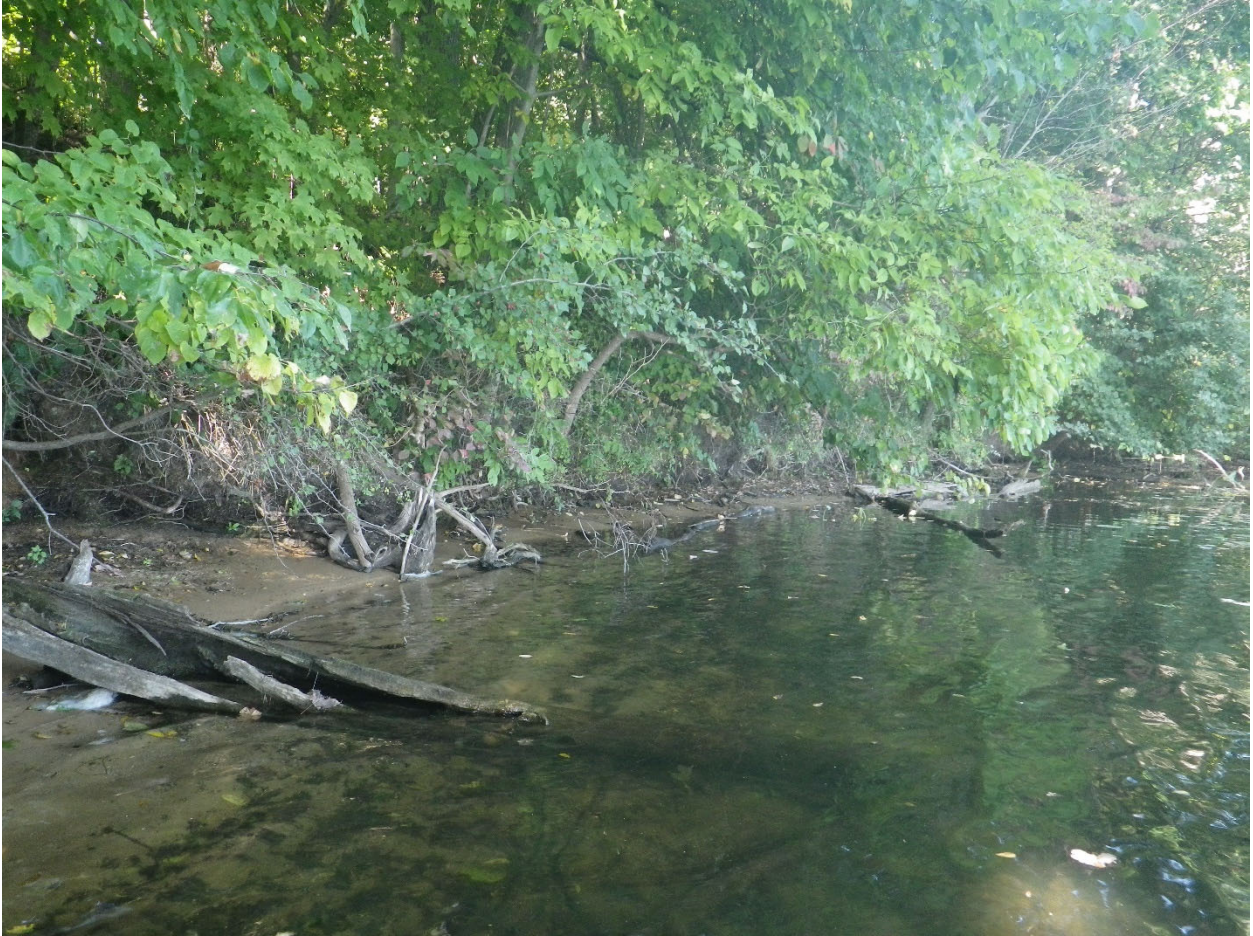
Figure 17. Site SJR12V2: Moderate erosion category present due to an increase in bank angle.

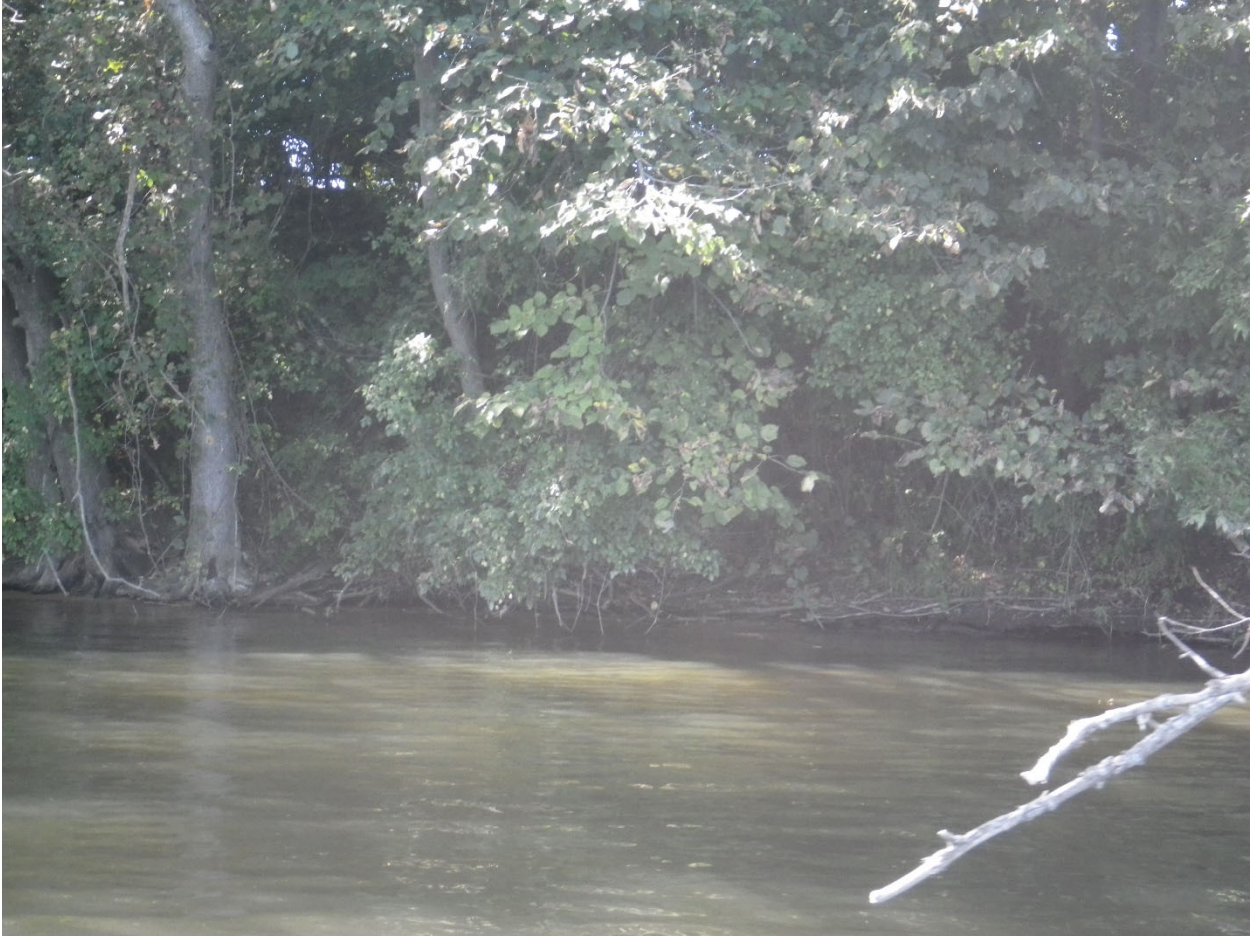
Figure 18. Site SJR16V2: Moderate erosion only due to the bank angle.

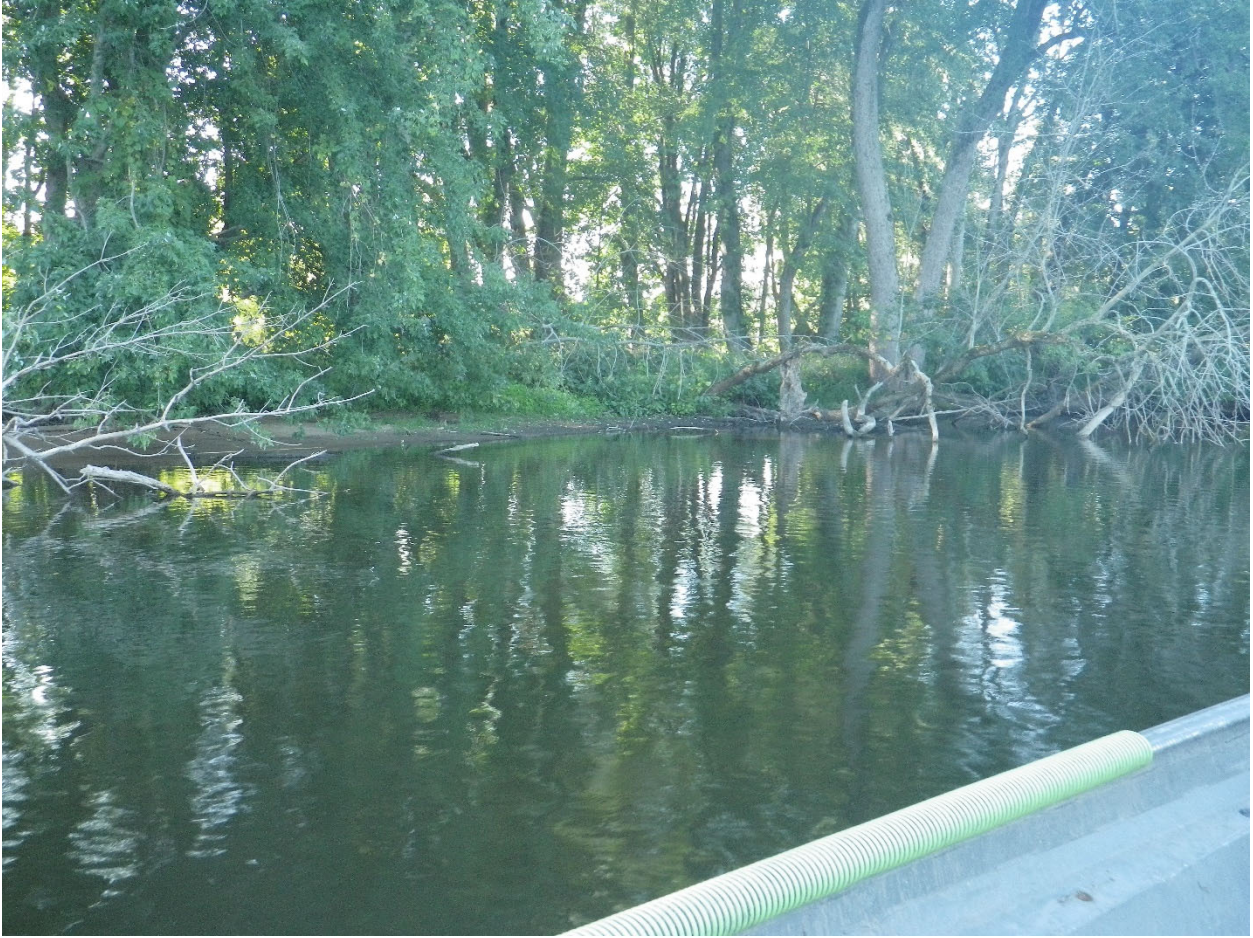
Figure 19. Site SJR02V2: Low erosion score category with low bank angle and adequate surface protection across site.

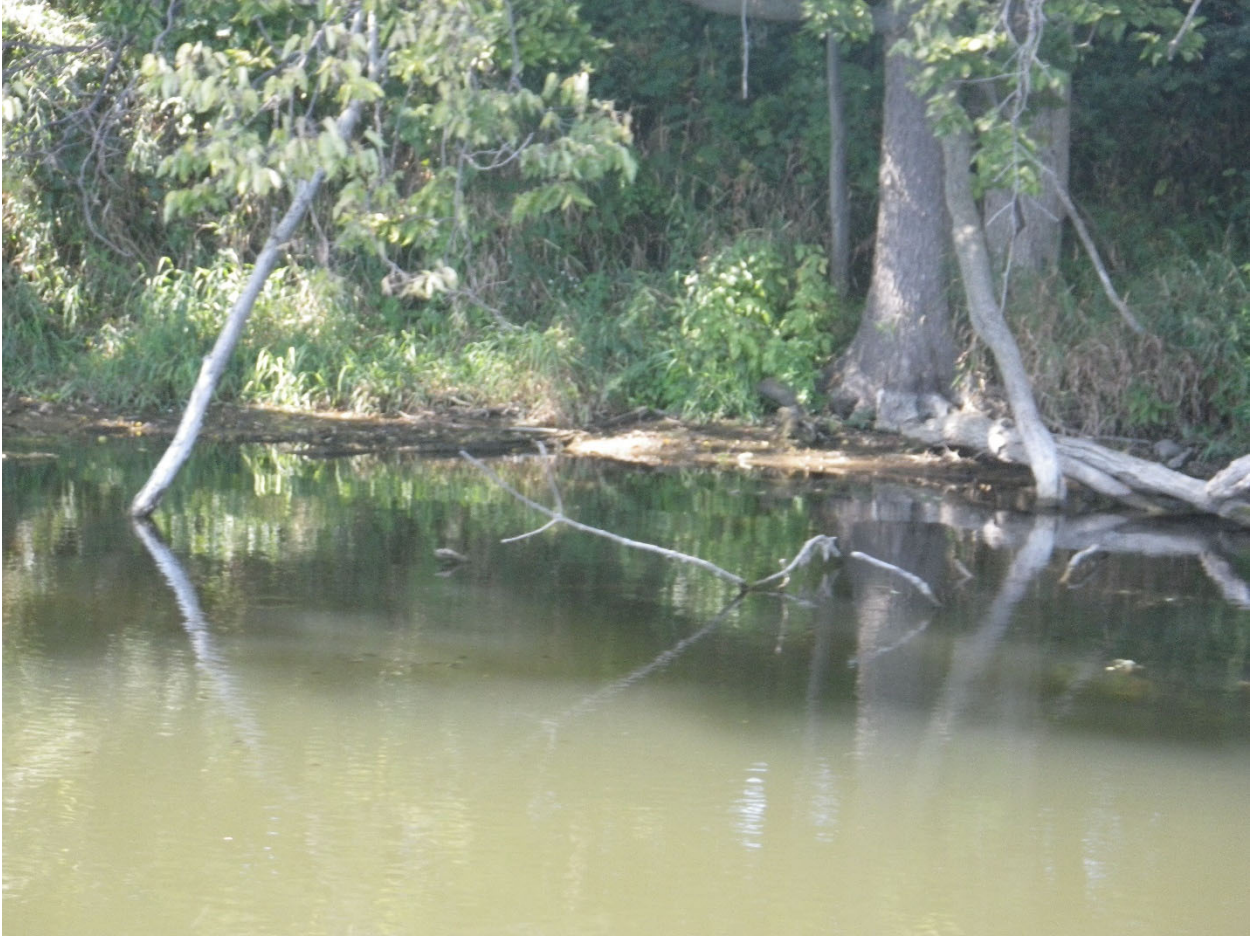
Figure 20. Site SJR19V2: Low erosion score category.
