# Updated Study Report

Byllesby-Buck Hydroelectric Project  
(FERC No. 2514)

*November 17, 2021*

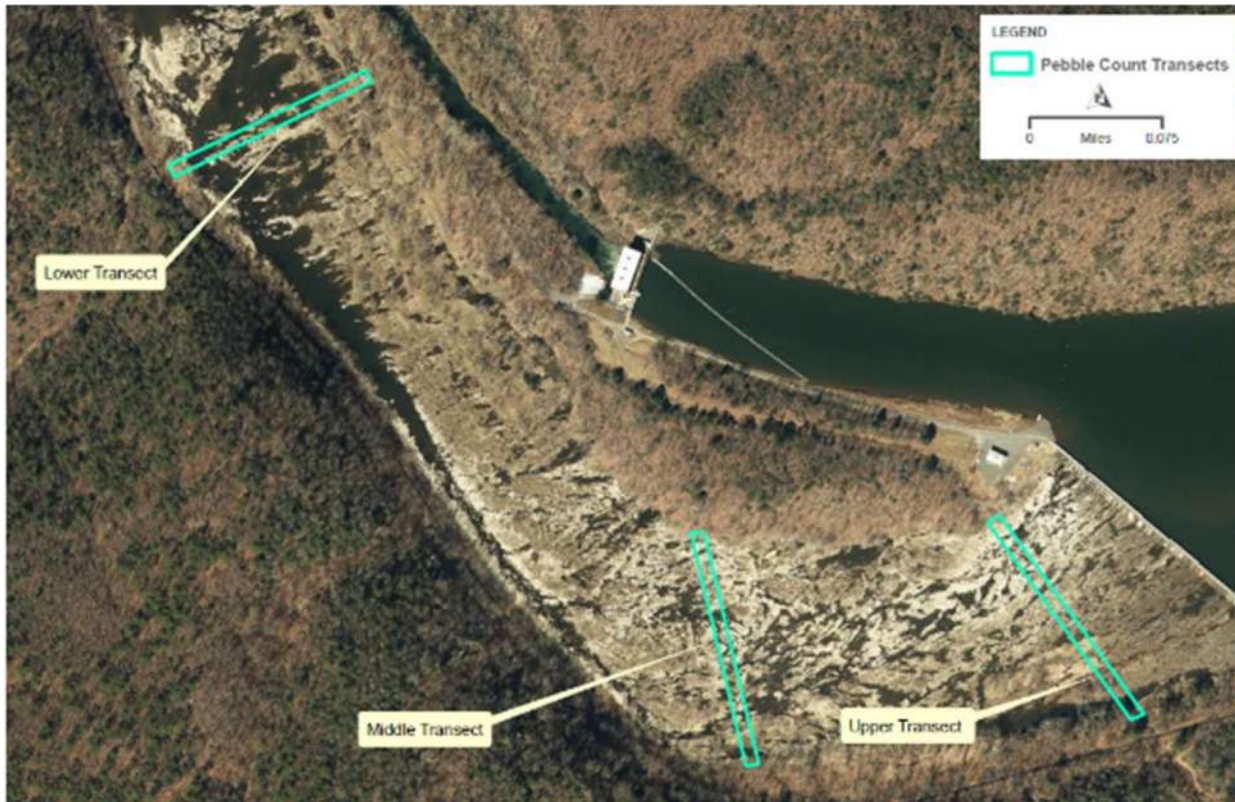
# Particle Size Distribution Results – Buck Bypass

## Percent Bedrock

Upper Transect 52%

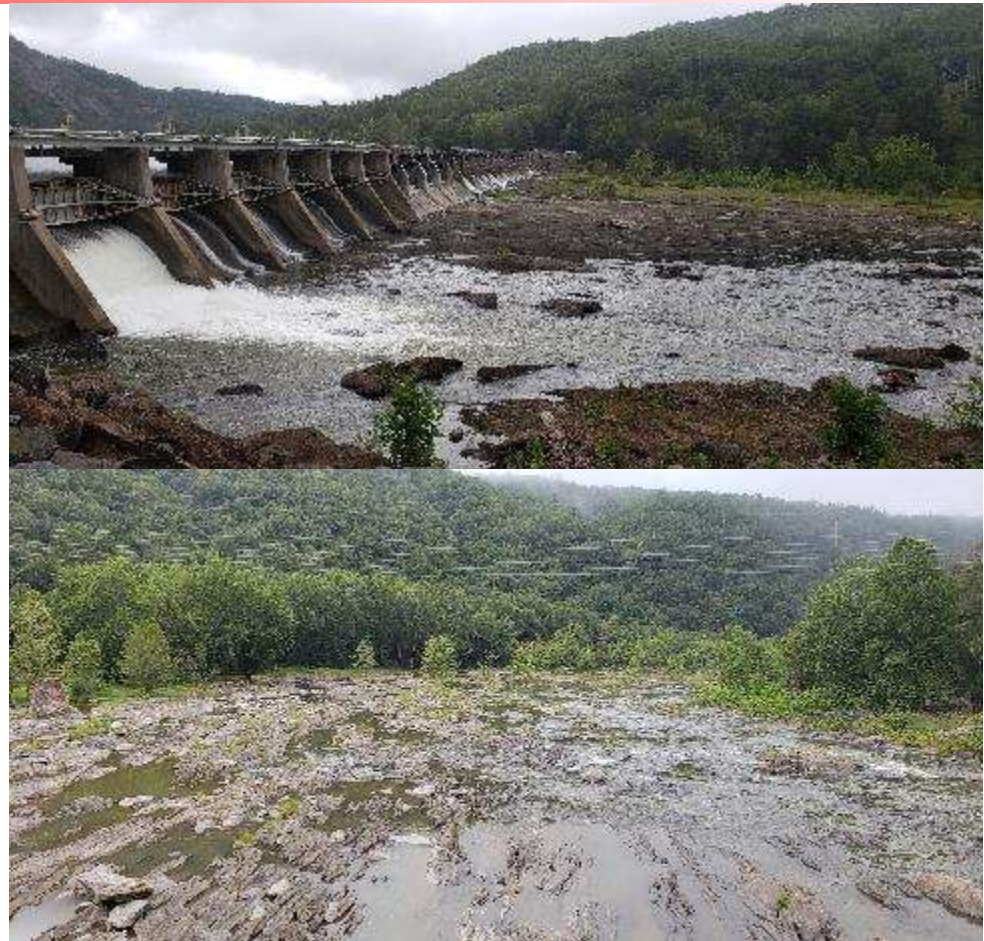
Buck Upper Bypass Reach  
9.10.2020 210.7 cfs

- Leakage: 17.1 cfs
  - Low: 210.7 cfs (shown)
  - Middle: 354 cfs
  - High: 714 cfs
- 
- Level loggers also recorded water surface elevations during higher bypass flow events

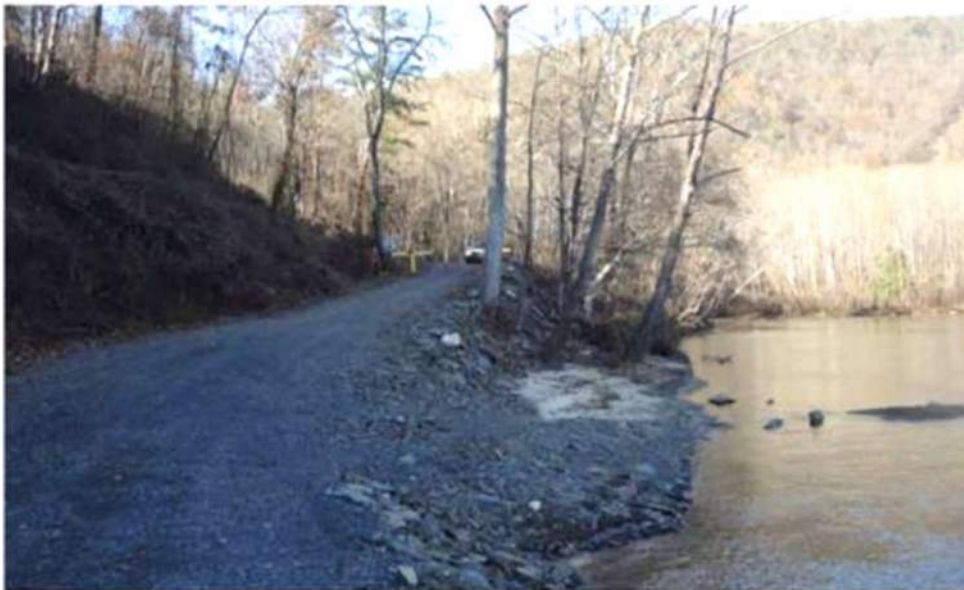
Photo 4-3: Canoe portage put-in and maintenance road accessing it from the parking area

Includes a 10-space gravel parking area, portage/no-fishing signs, a gate, and a canoe portage in a relatively flat, sandy area. The signage at this facility is in good condition with adequate directional information.

No potential enhancements identified for this site.

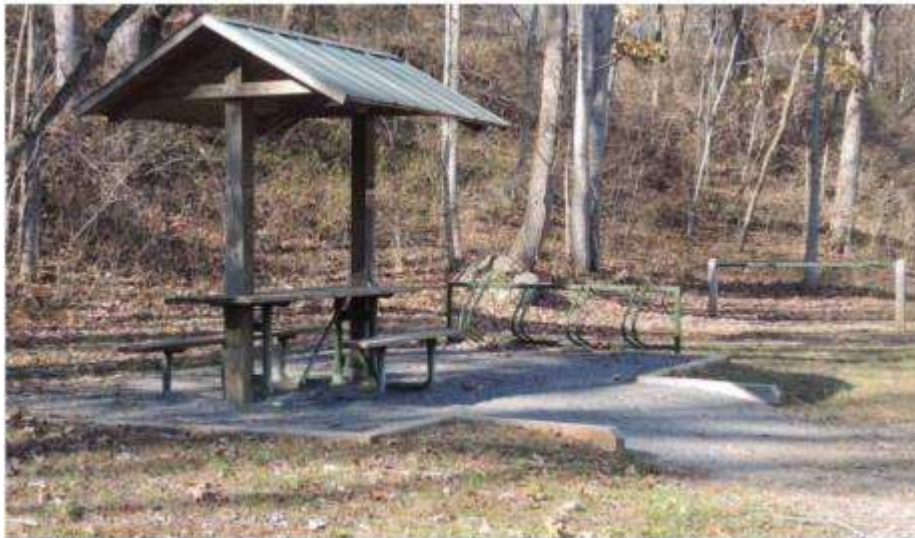
Photo 5-2: Picnic shelter, bike rack and hitching rail

Upper area includes a picnic table shelter, bike rack and hitching trail. An informal car pull-off and trail accessing the picnic area. The bike rack, hitching rail, and shelter (ADA accessible) is in good condition.

- Maintenance or replacement of amenities at lower area.

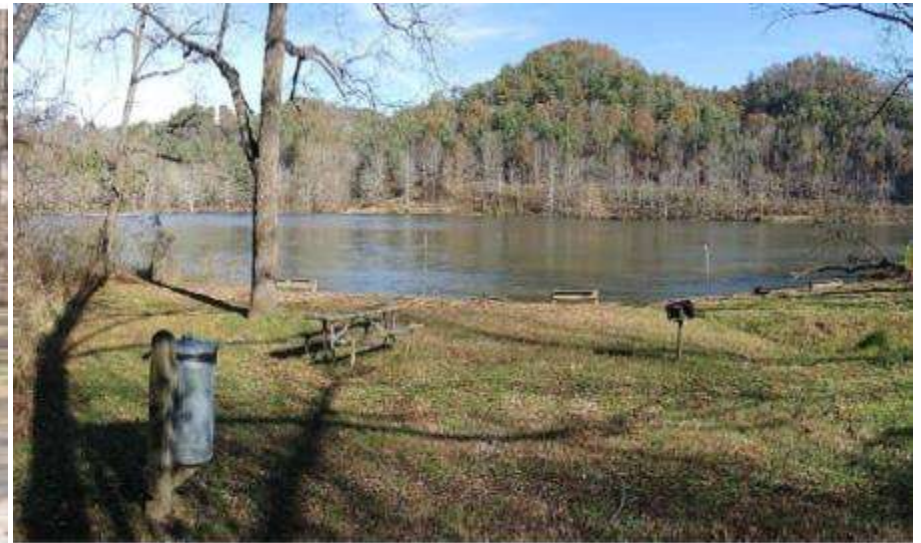
Photo 5-4: Lower picnic area

Lower area includes trash can, barbeque grill (severely corroded), picnic table, bird nesting box, two lantern hooks, two fire rings, and three benches. The trash can is in good condition and is regularly serviced. One bench is missing a slat and the lantern hook is older but usable.

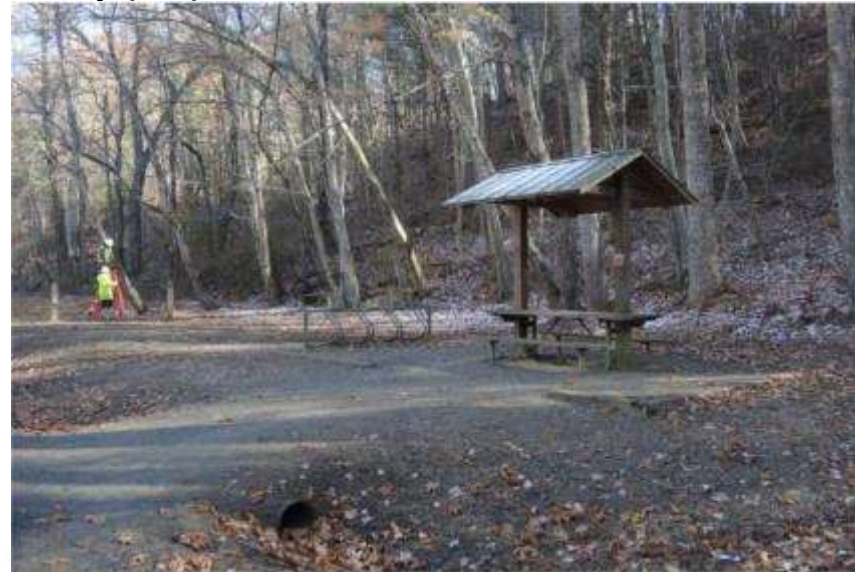
Photo 6-8: Picnic shelter with bike rack and hitching post

- The picnic shelter is in good condition while the table is older but usable.
- Paint on the hitching rail and bike rack is chipped but the amenities are usable.

- Improved signage for educational and safety purposes.

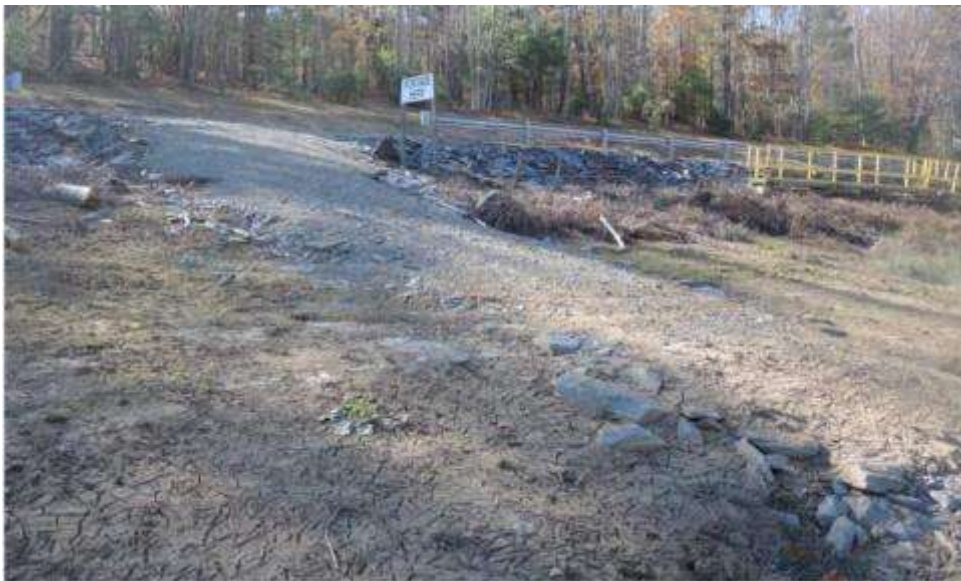
Includes a take-out above and a put-in below Buck Dam. Portage route via an asphalt maintenance road, gravel access road, and a gravel walking trail (0.27 miles). There is an unlined trash can at the put-in. The signage is in good condition.

Photo 7-1: Upper canoe portage take-out. Note that water elevation was low when picture was taken, so the put-out length is not usually this long.

- Improved safety and regulatory signage are recommended at this site.

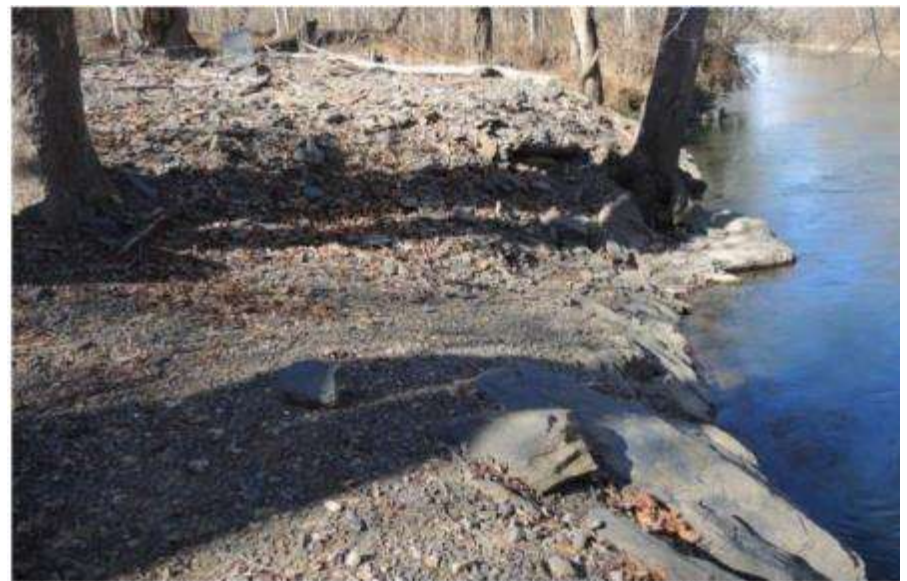
Photo 7-9: Water access at put-in location facing downstream. Note the steep access, deep water, and narrow land strip.
