**Subject: Byllesby-Buck Hydroelectric Project (FERC No. 2514-186)
Filing of Initial Study Report and Schedule for Virtual ISR Meeting**

Appalachian Power Company (Appalachian or Licensee), a unit of American Electric Power (AEP), is the Licensee, owner, and operator of the two-development Byllesby-Buck Hydroelectric Project (Project) (Project No. 2514), located on the upper New River in Carroll County, Virginia.

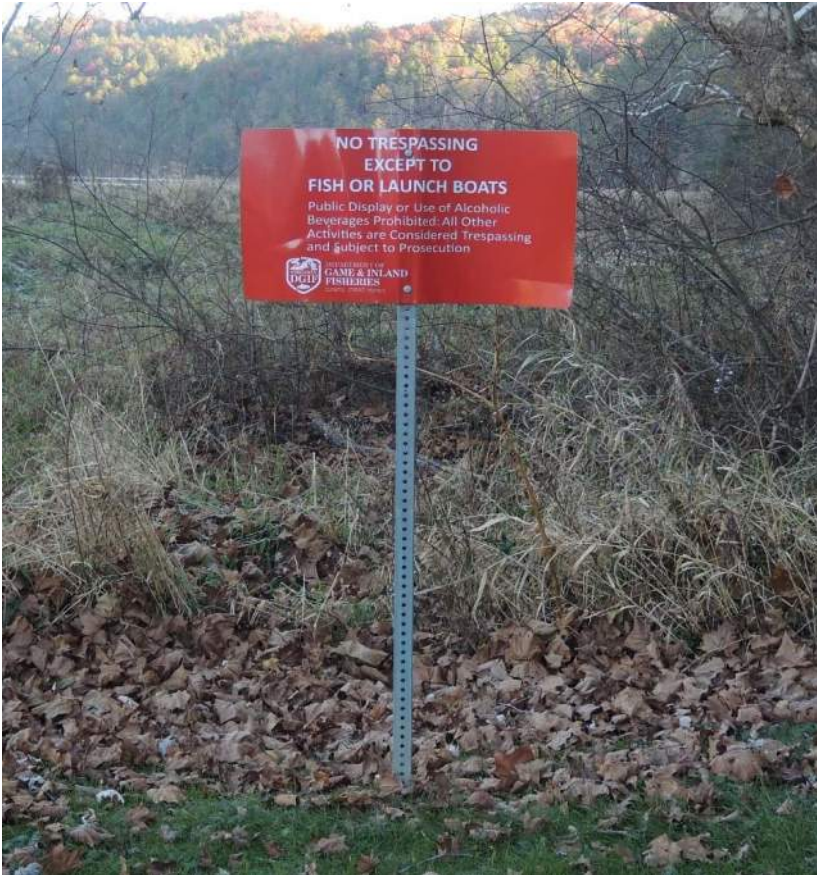
Photo 1-5: Damaged Sign

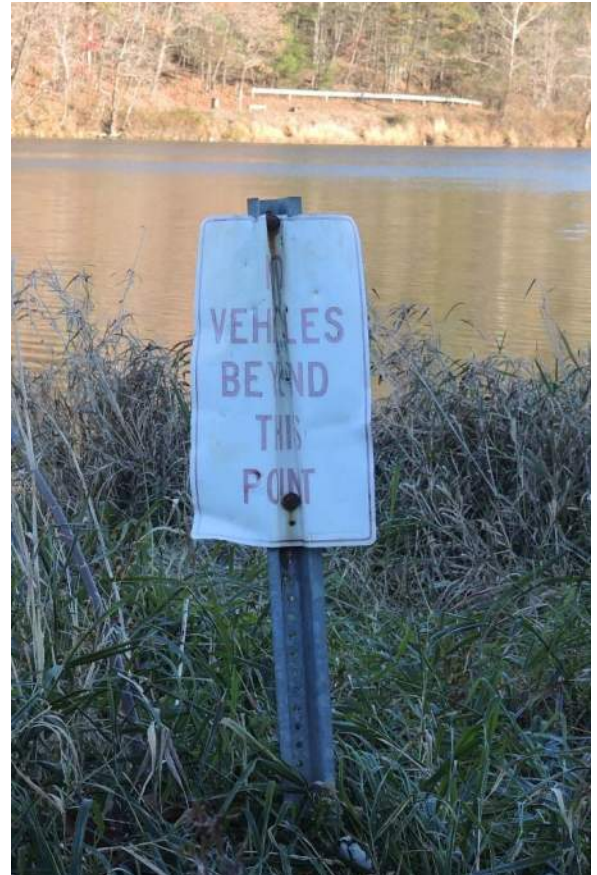
Photo 1-6: Damaged Sign

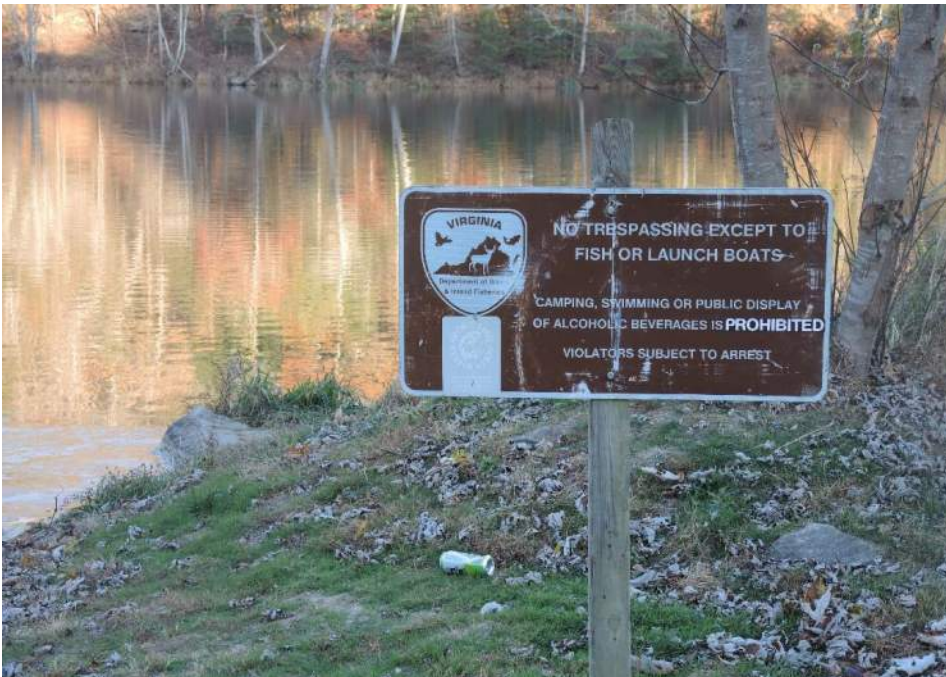
Photo 1-7: Damaged Sign

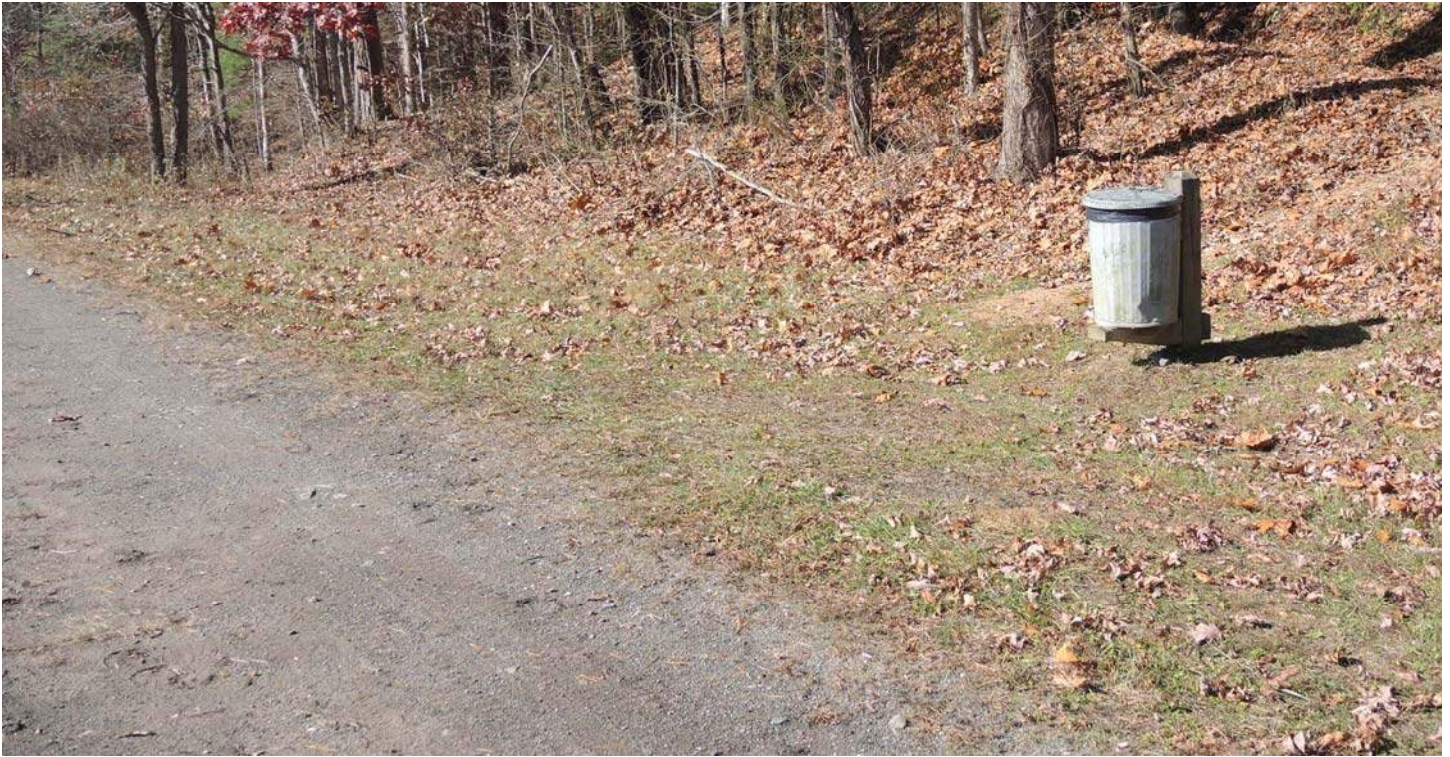
Photo 2-3: Trash can across the trail from the fishing site. Can has a dent at the bottom.

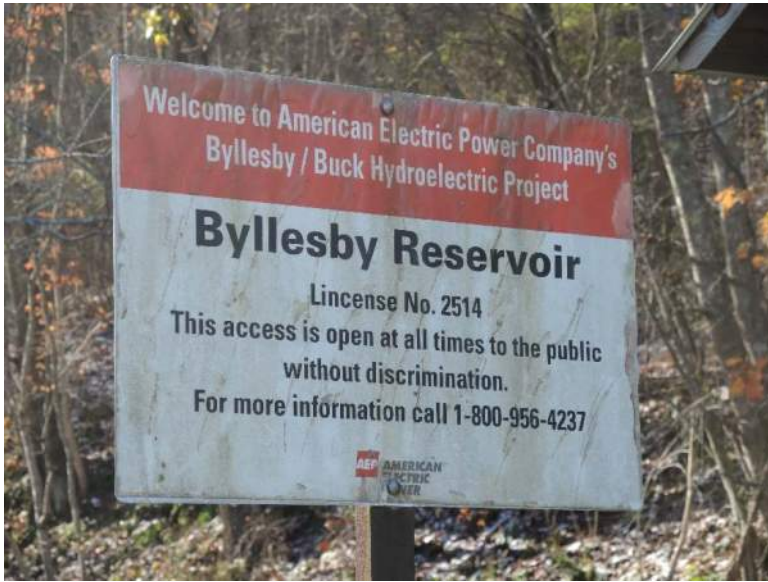
Photo 3-3: Dirty sign

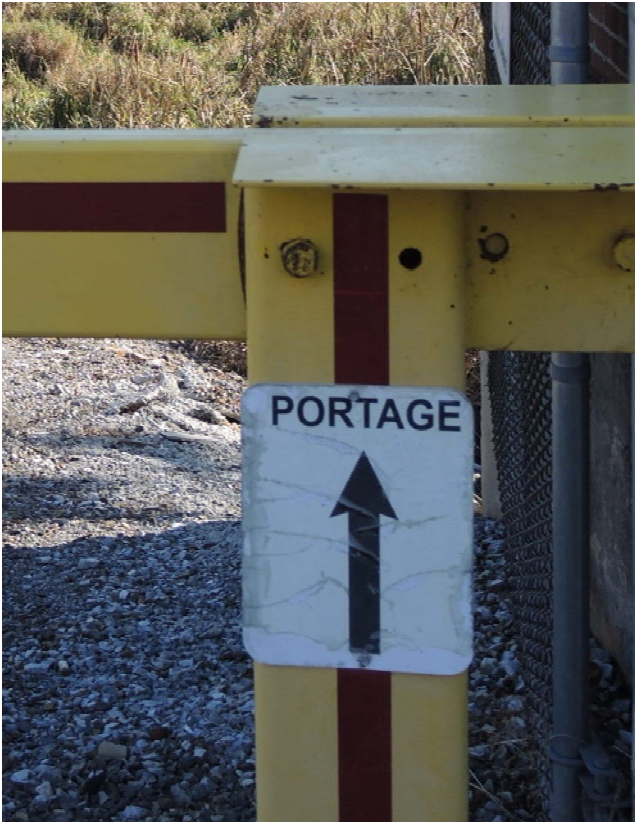
Photo 3-6: Portage sign on gate is very small and cracking/peeling

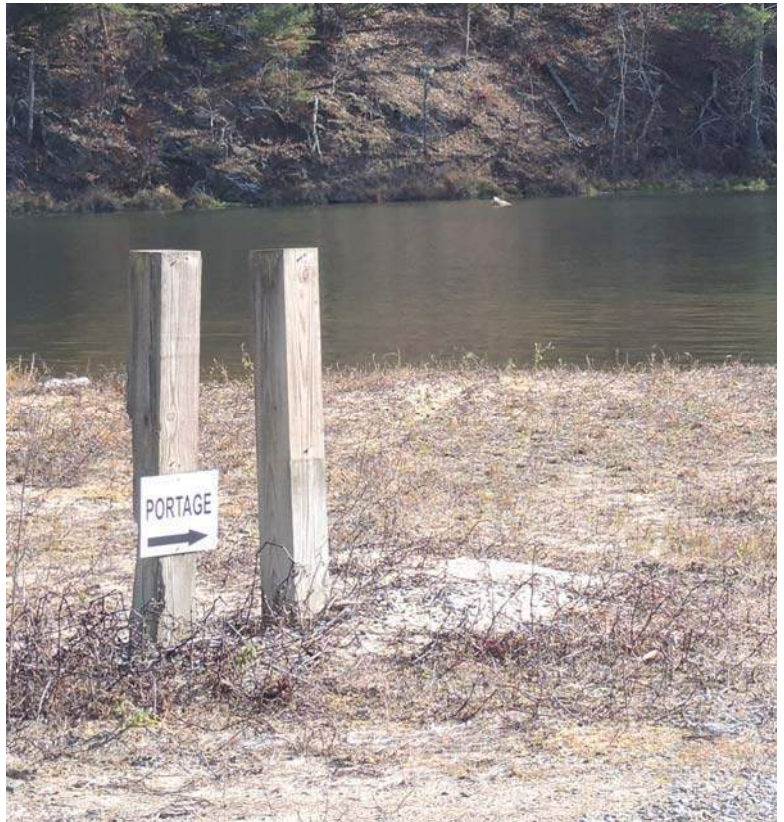
Photo 3-7: Portage sign along trail and river is small, does not fit posts and needs replaced

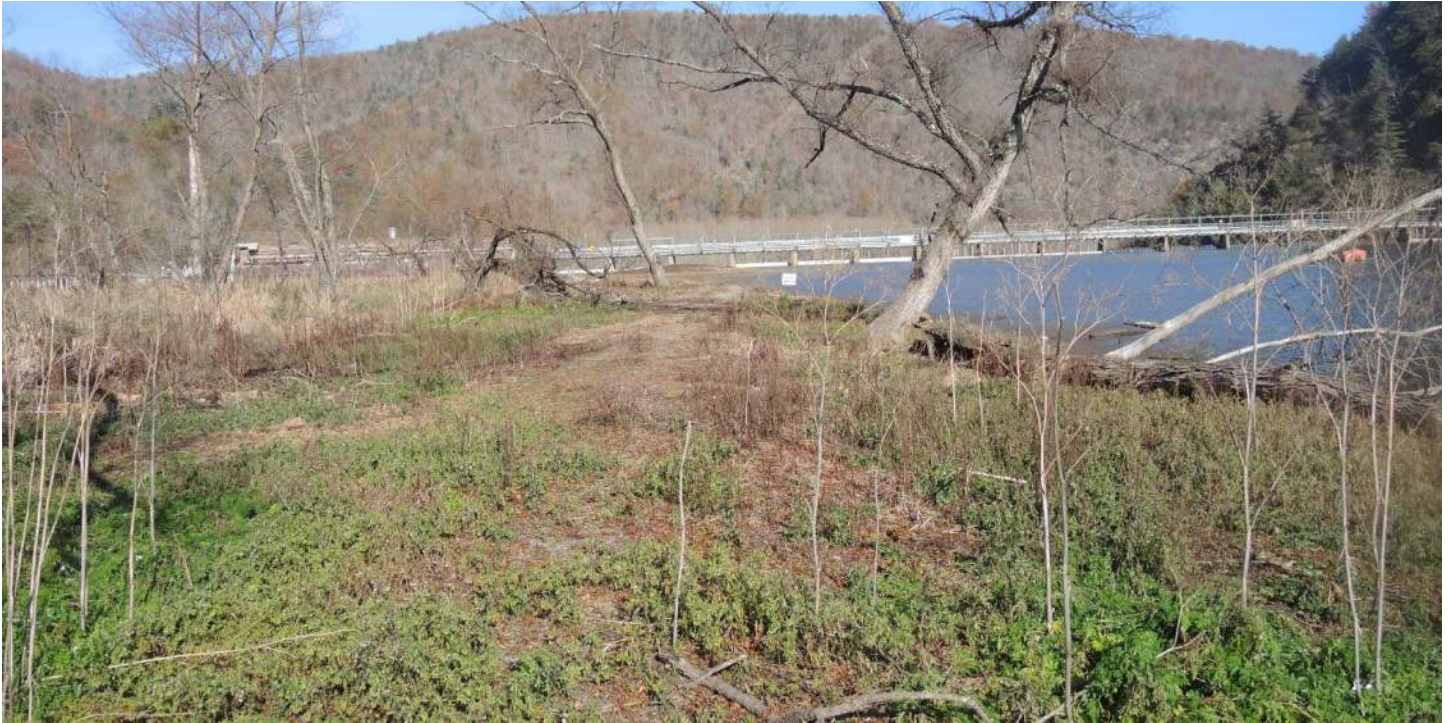
Photo 3-11: Section of trail near the portage take-out is grown over with vegetation and needs to be resurfaced to provide sufficient walking surface and to clarify trail route.

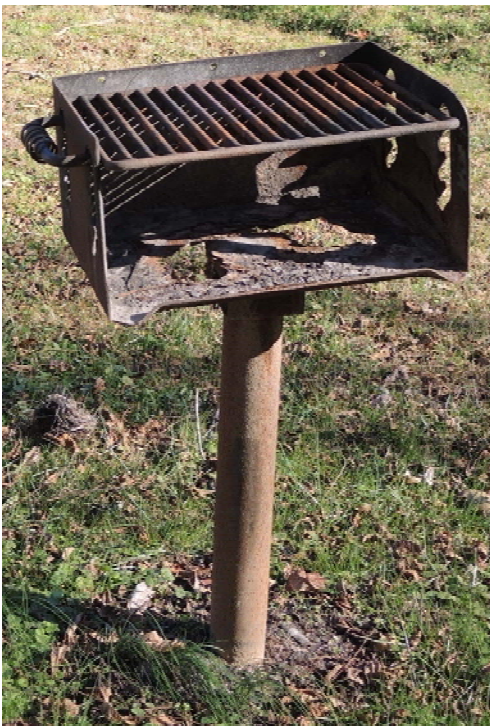
Photo 5-6: BBQ grill with rusted out bottom

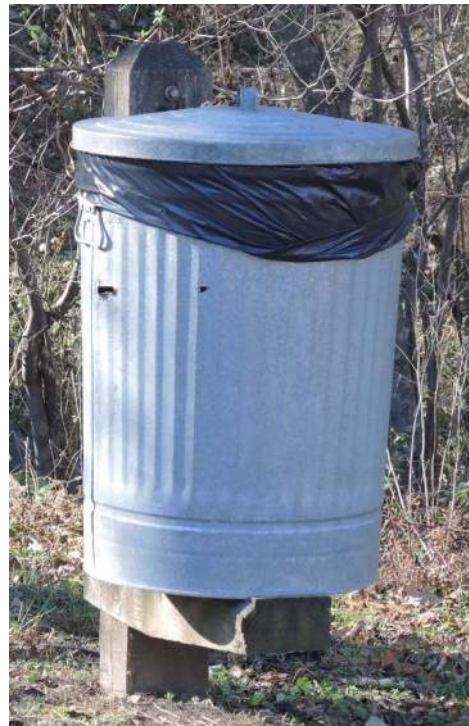
Photo 5-7: Trash can with holes in the side

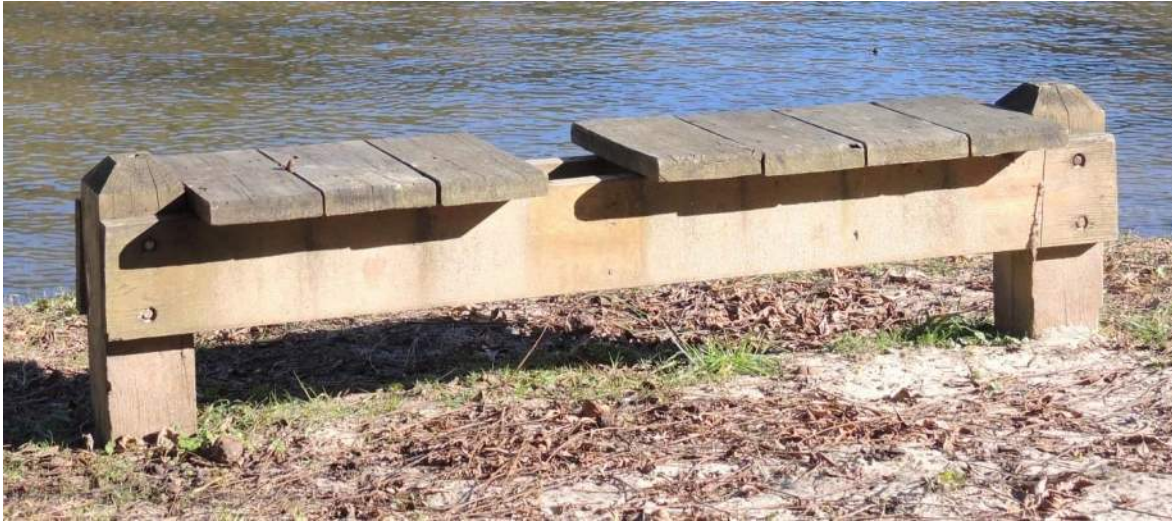
Photo 5-9: Bench with missing slat

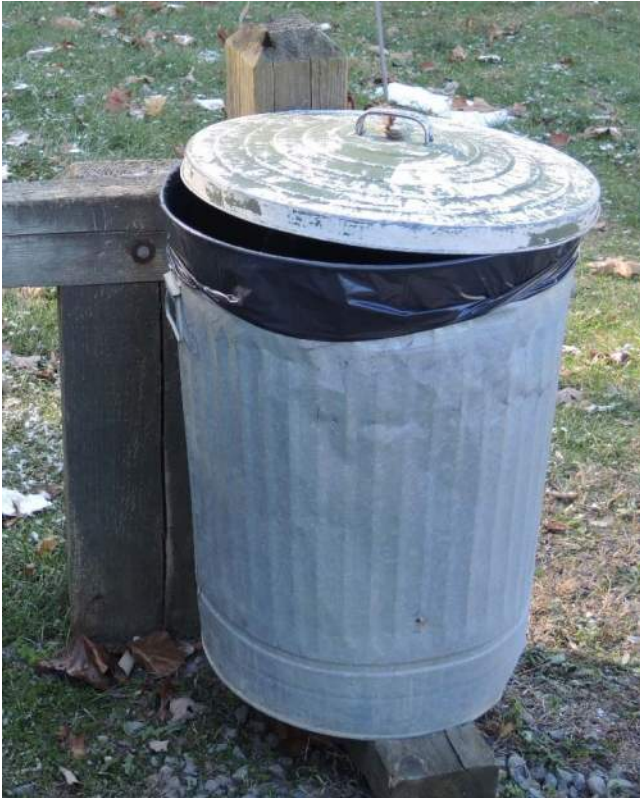
Photo 6-5: Trash can at parking lot with dents and faded lid

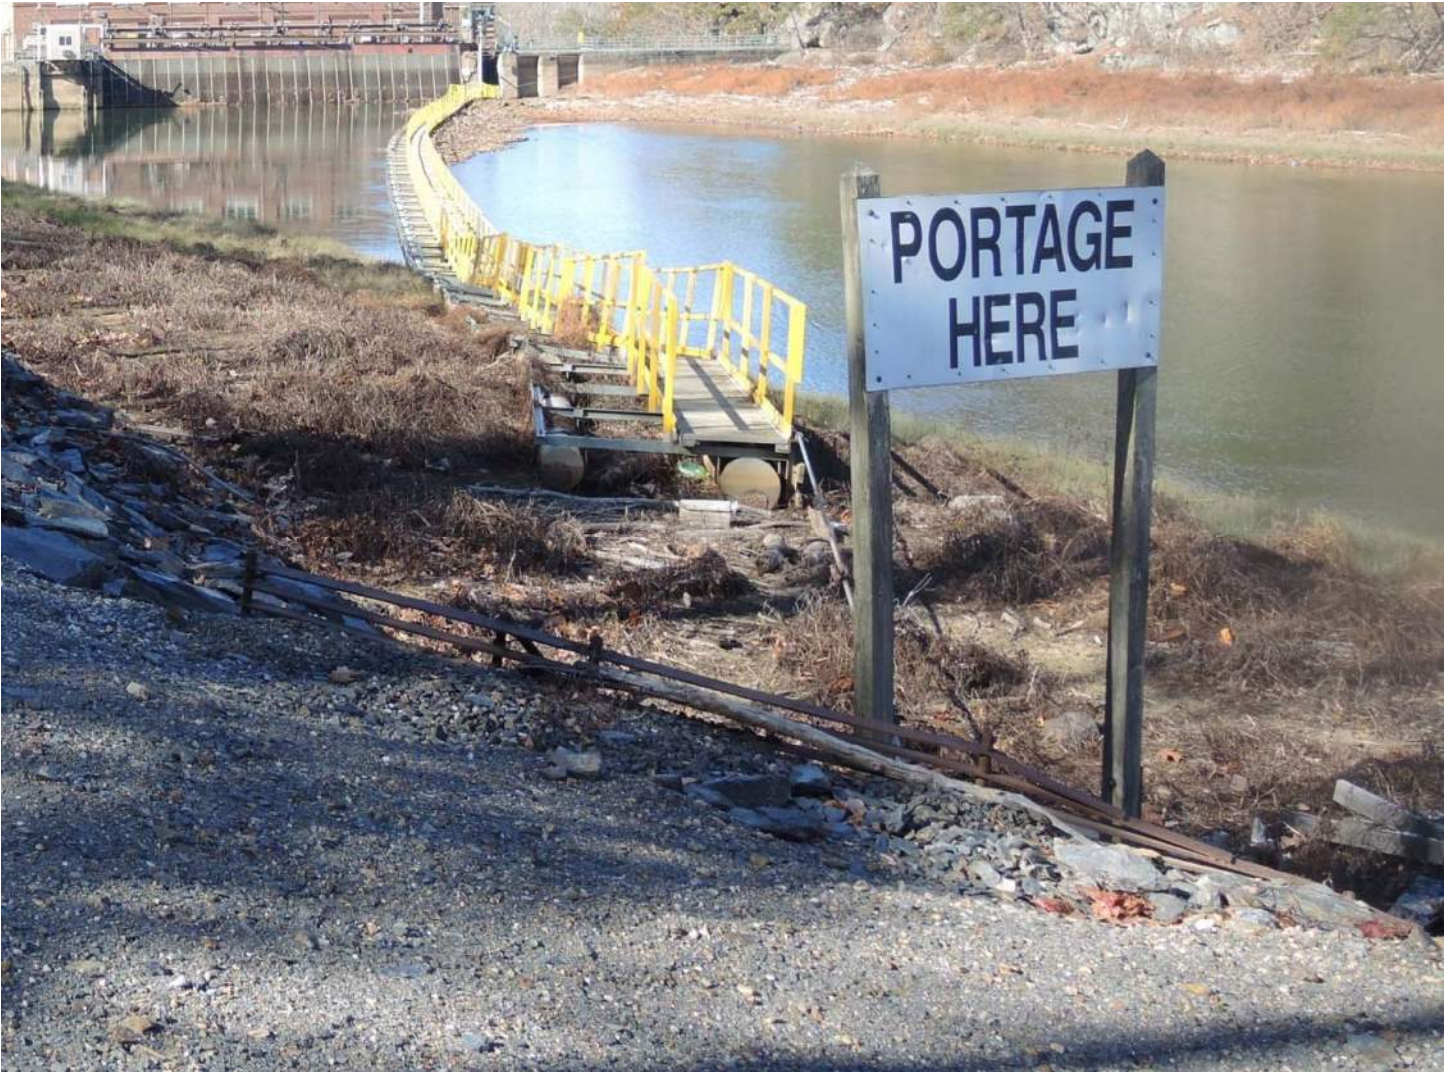
Photo 7-3: Sign at upper portage take-out has minor dents
