**Subject: Constantine Hydroelectric Project (FERC No. 10661)
Initial Study Report
Virtual Webex Meeting Scheduled for April 23, 2020**

Indiana Michigan Power Company (I&M), a unit of American Electric Power (AEP), is the Licensee, owner, and operator of the 1.2 megawatt Constantine Hydroelectric Project (Project) (FERC Project No. 10661). The Project is located along the St. Joseph River in St. Joseph County, Michigan.

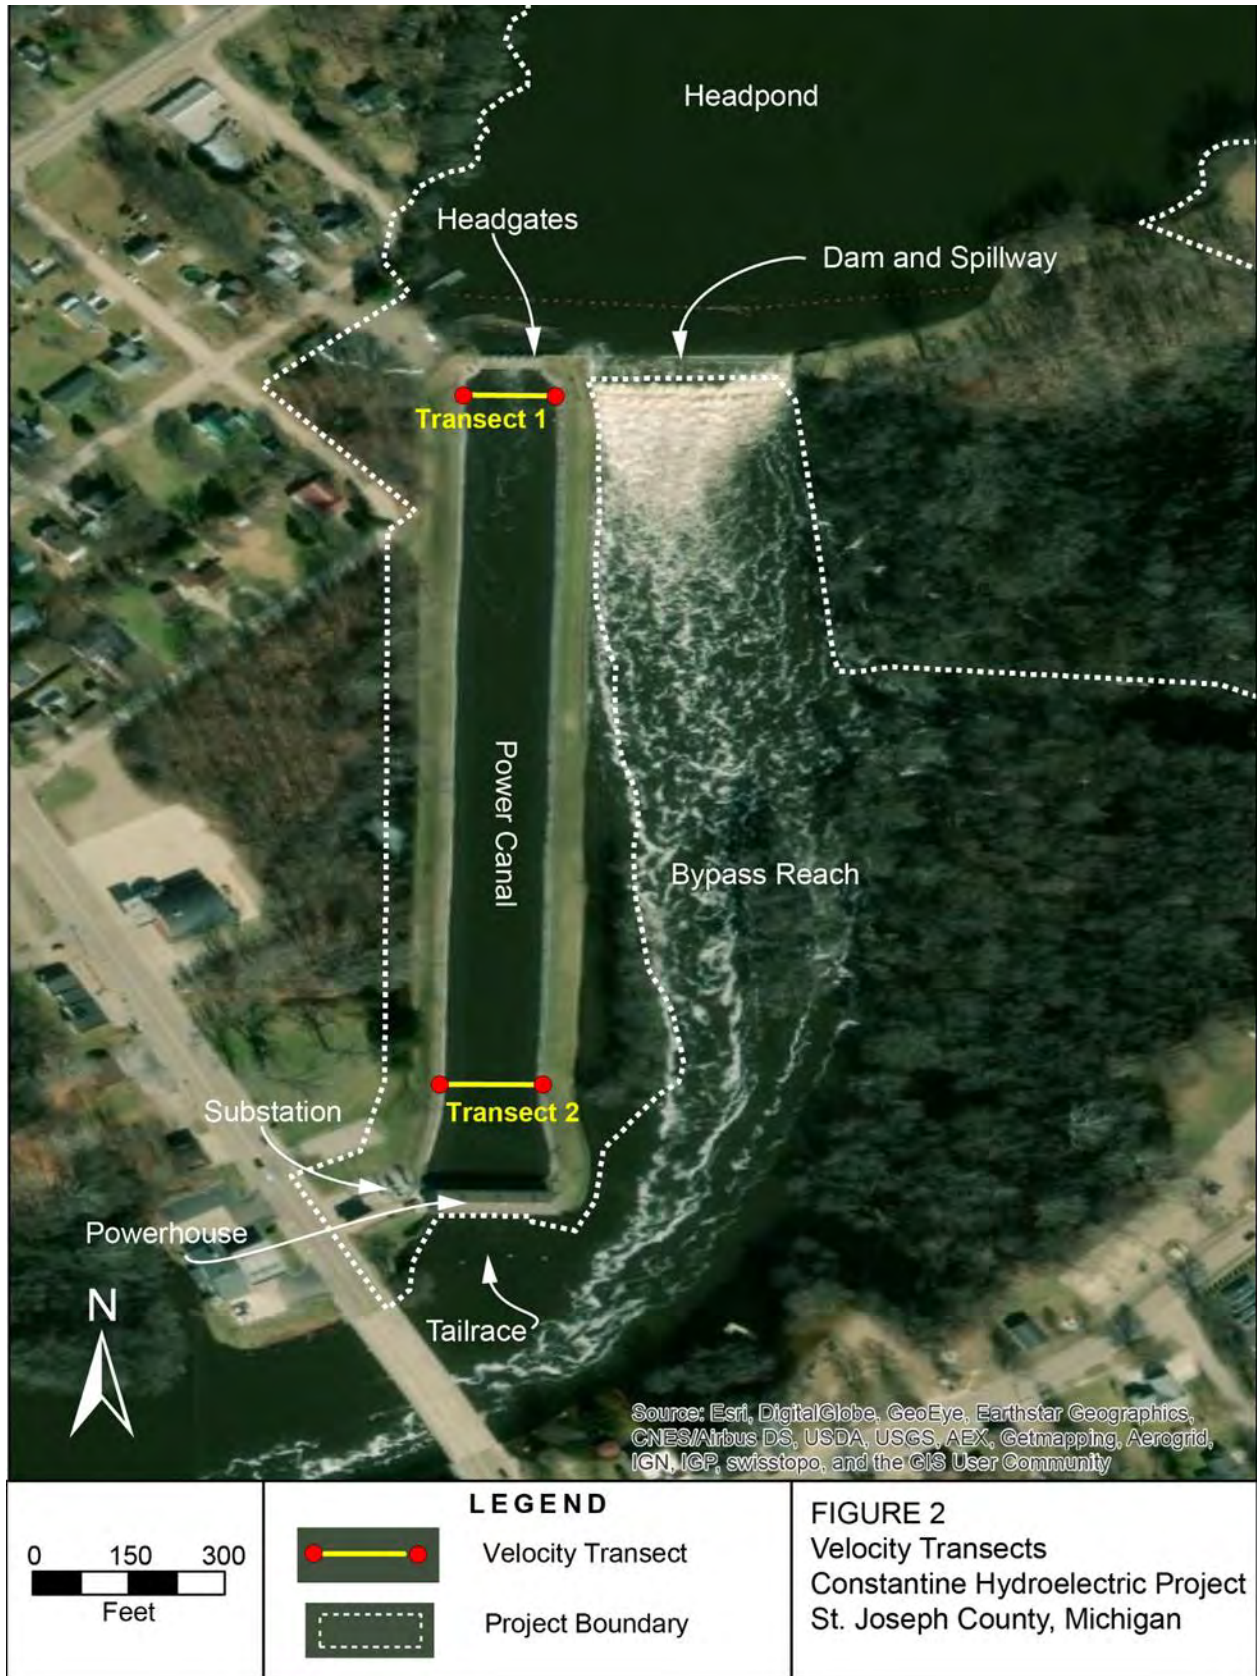
Figure 2. Velocity Transects

In order to confirm intake velocities at the Project, a survey was conducted at two locations within the Project's power canal (see Figure 2).

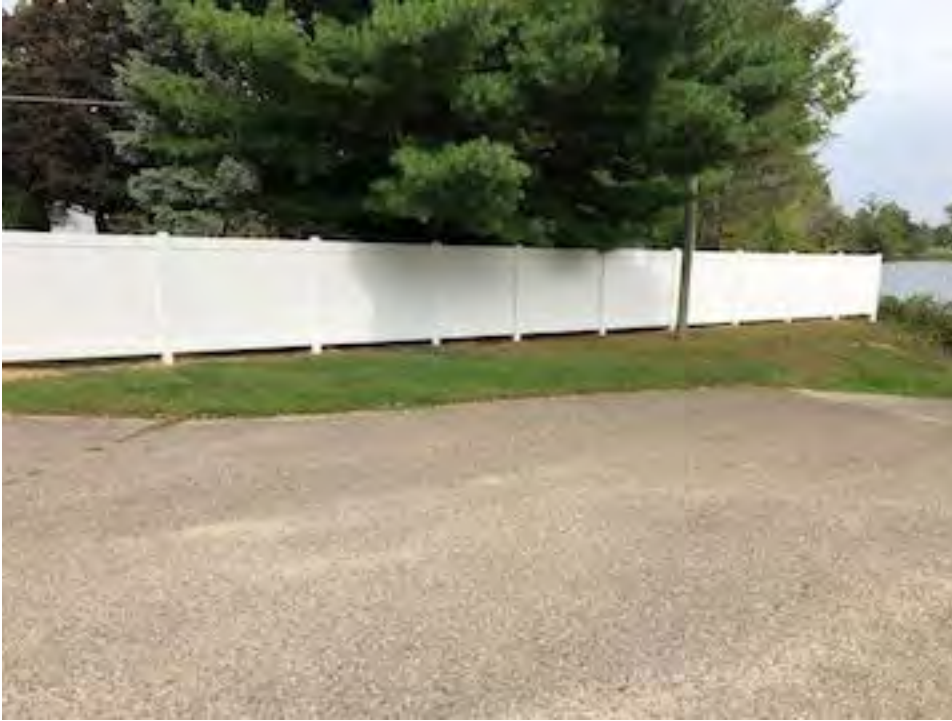
Collapsed Section of Privacy Fence at Entrance to Parking Area (41.84751, -85.66998)

Replaced Section of Fencing at Parking Area Entrance

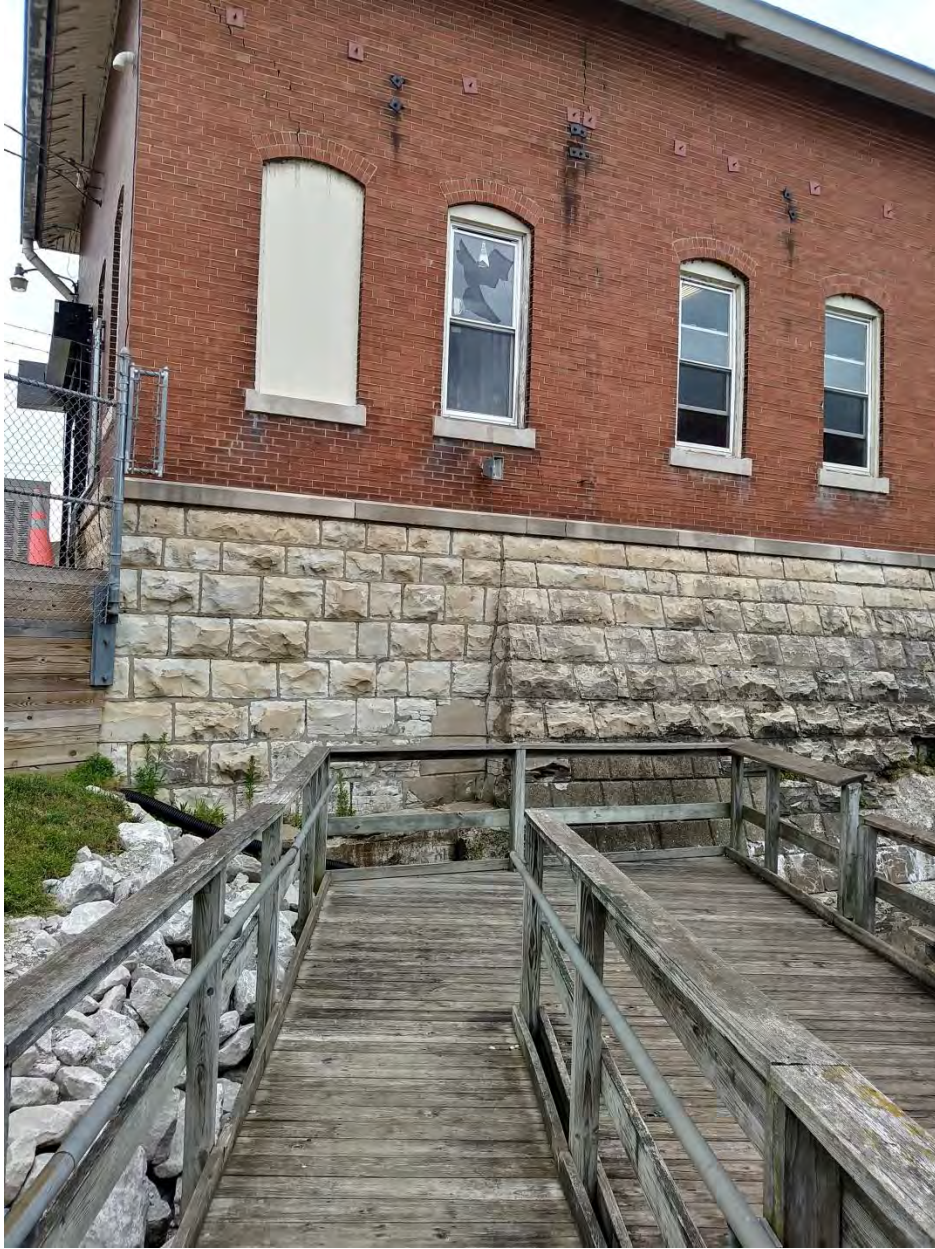
Broken Light and Window at Powerhouse Above Tailwater Fishing Access Platform
(41.8436, -85.6696)

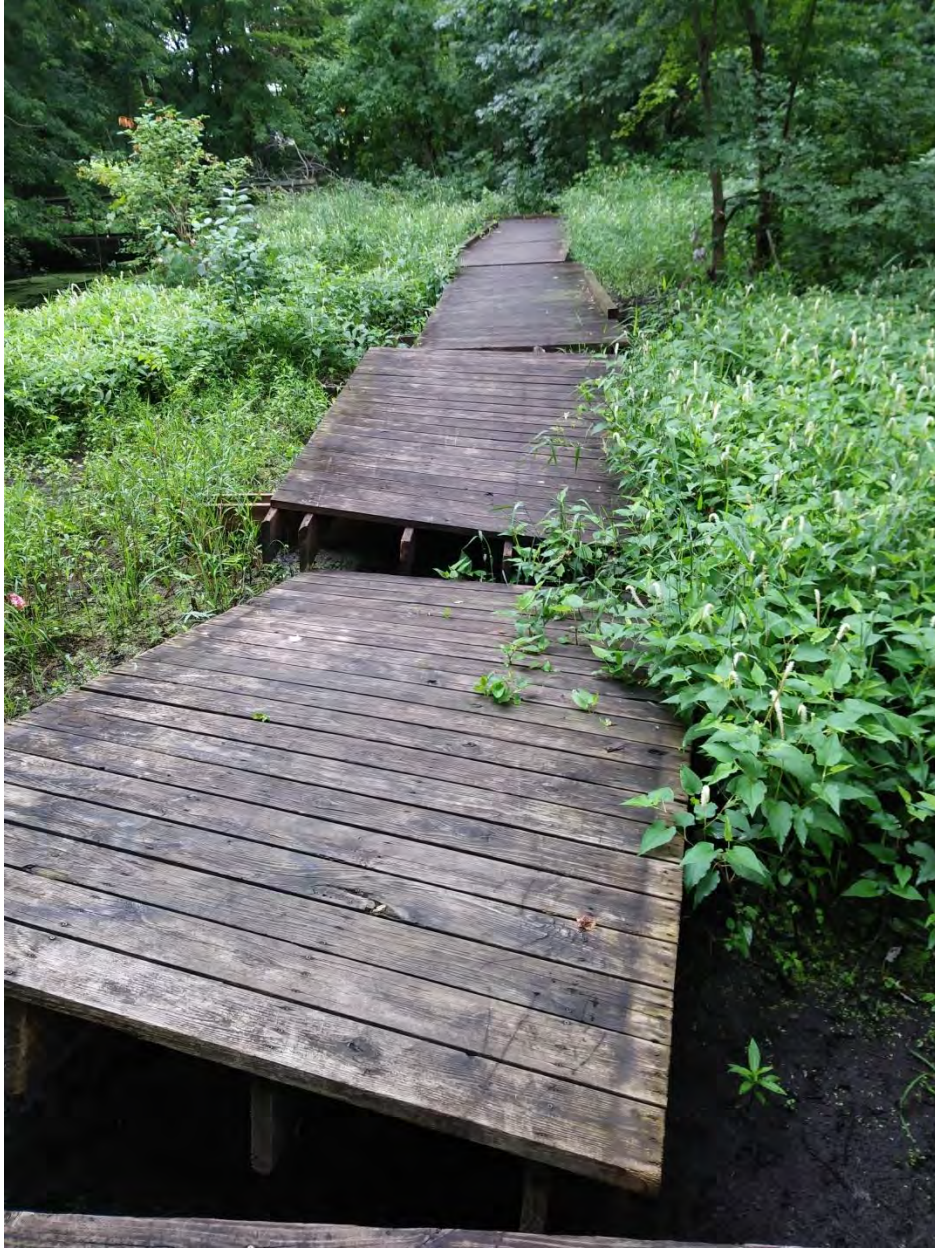
Riverview Park Boardwalk Damage (41.84421, -85.66796)

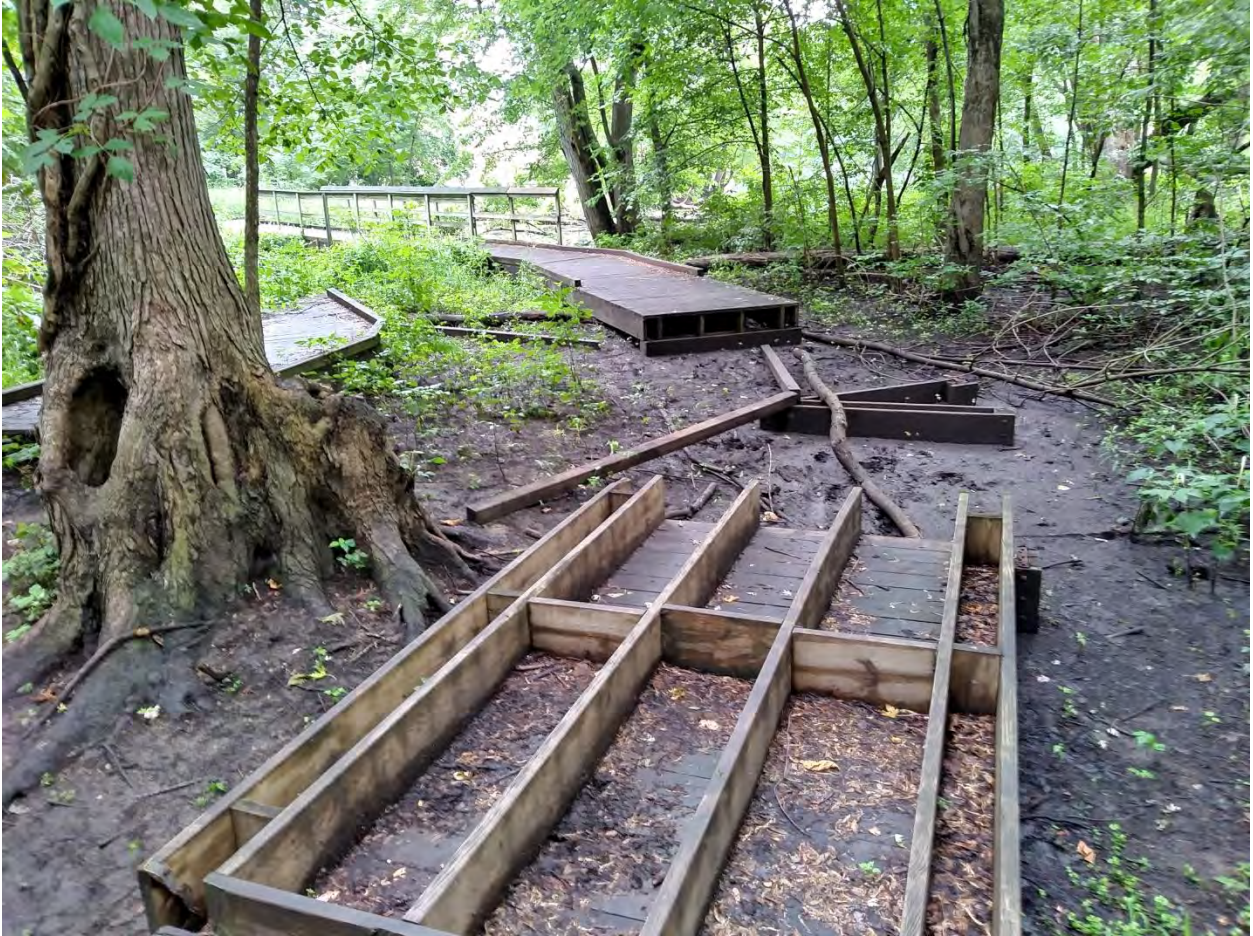
Riverview Park Boardwalk Damage (41.844105,-85.666832)

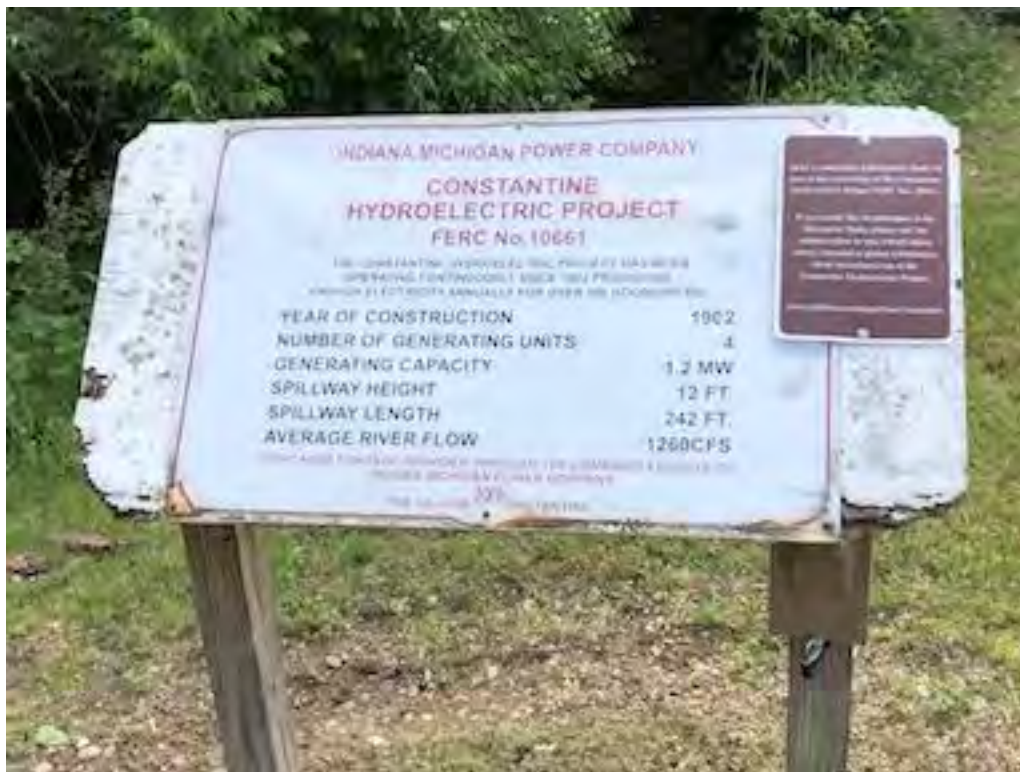
It seems like the sign should be replaced.

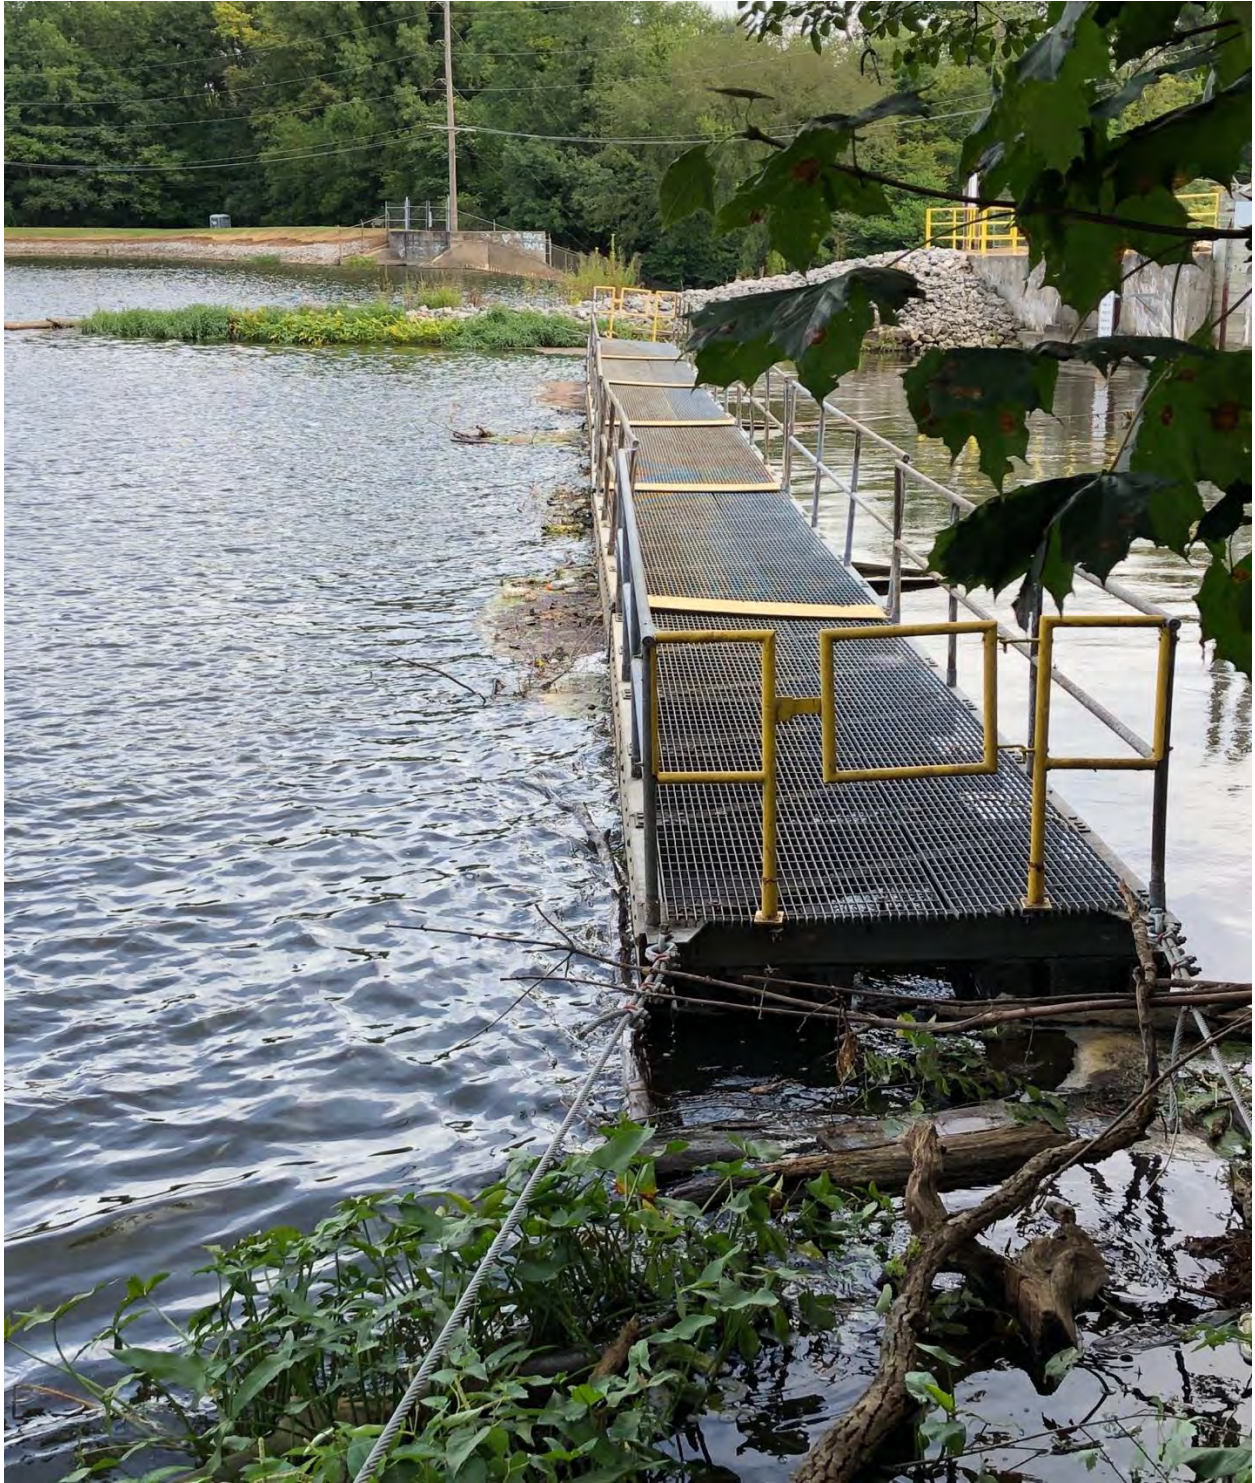
Fishermen asked about this bridge. It was put in for construction about a year ago and has created some problems for fishing. Why is it still there?
