Subject: Constantine Hydroelectric Project (FERC No. 10661)

Initial Study Report

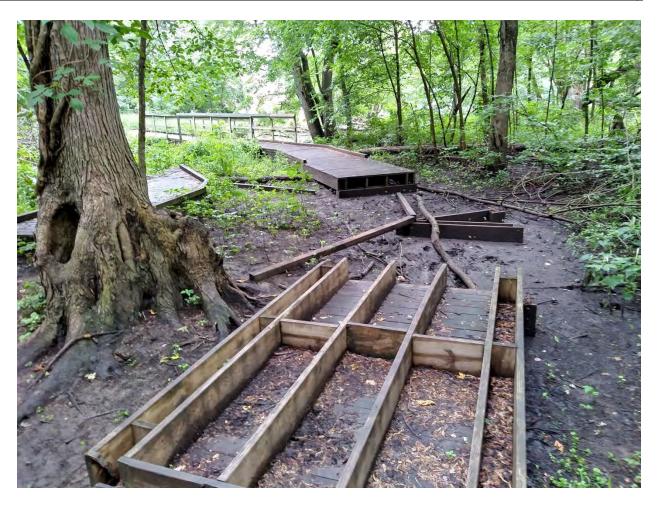
Riverview Park Boardwalk Damage (41.844105,-85.666832)

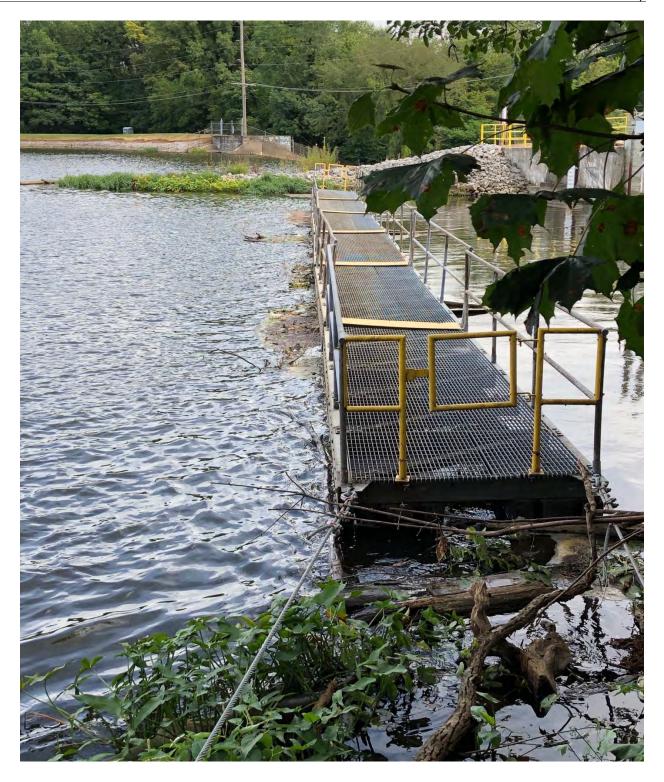
Fishermen asked about this bridge. It was put in for construction about a year ago and has created some problems for fishing. Why is it still there?

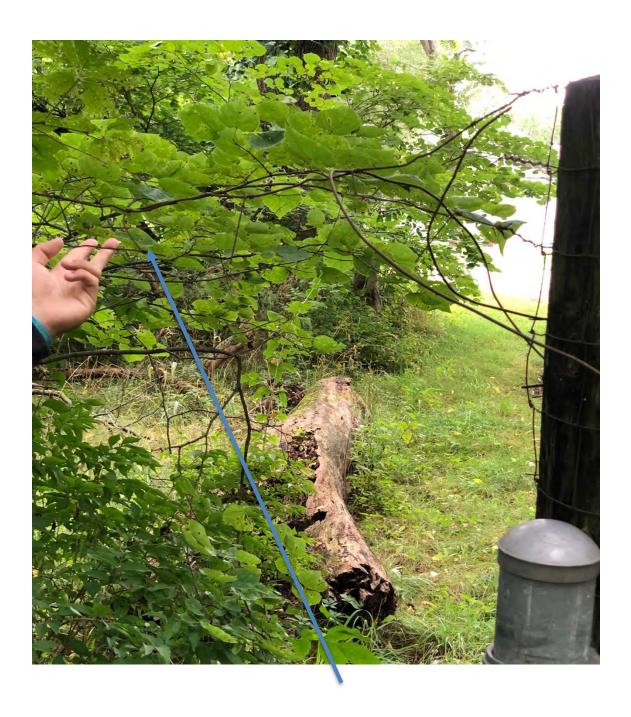
This is actually wire that is about the height of one's head. It is also sharp. It was a fence to prevent people from walking around the gate, but it is now just pieces of the fence left over.
