FINAL LICENSE APPLICATION

Volume II of V
Part 1 – Exhibit E

Byllesby-Buck Hydroelectric Project
(FERC No. 2514)

EXHIBIT E
ENVIRONMENTAL REPORT

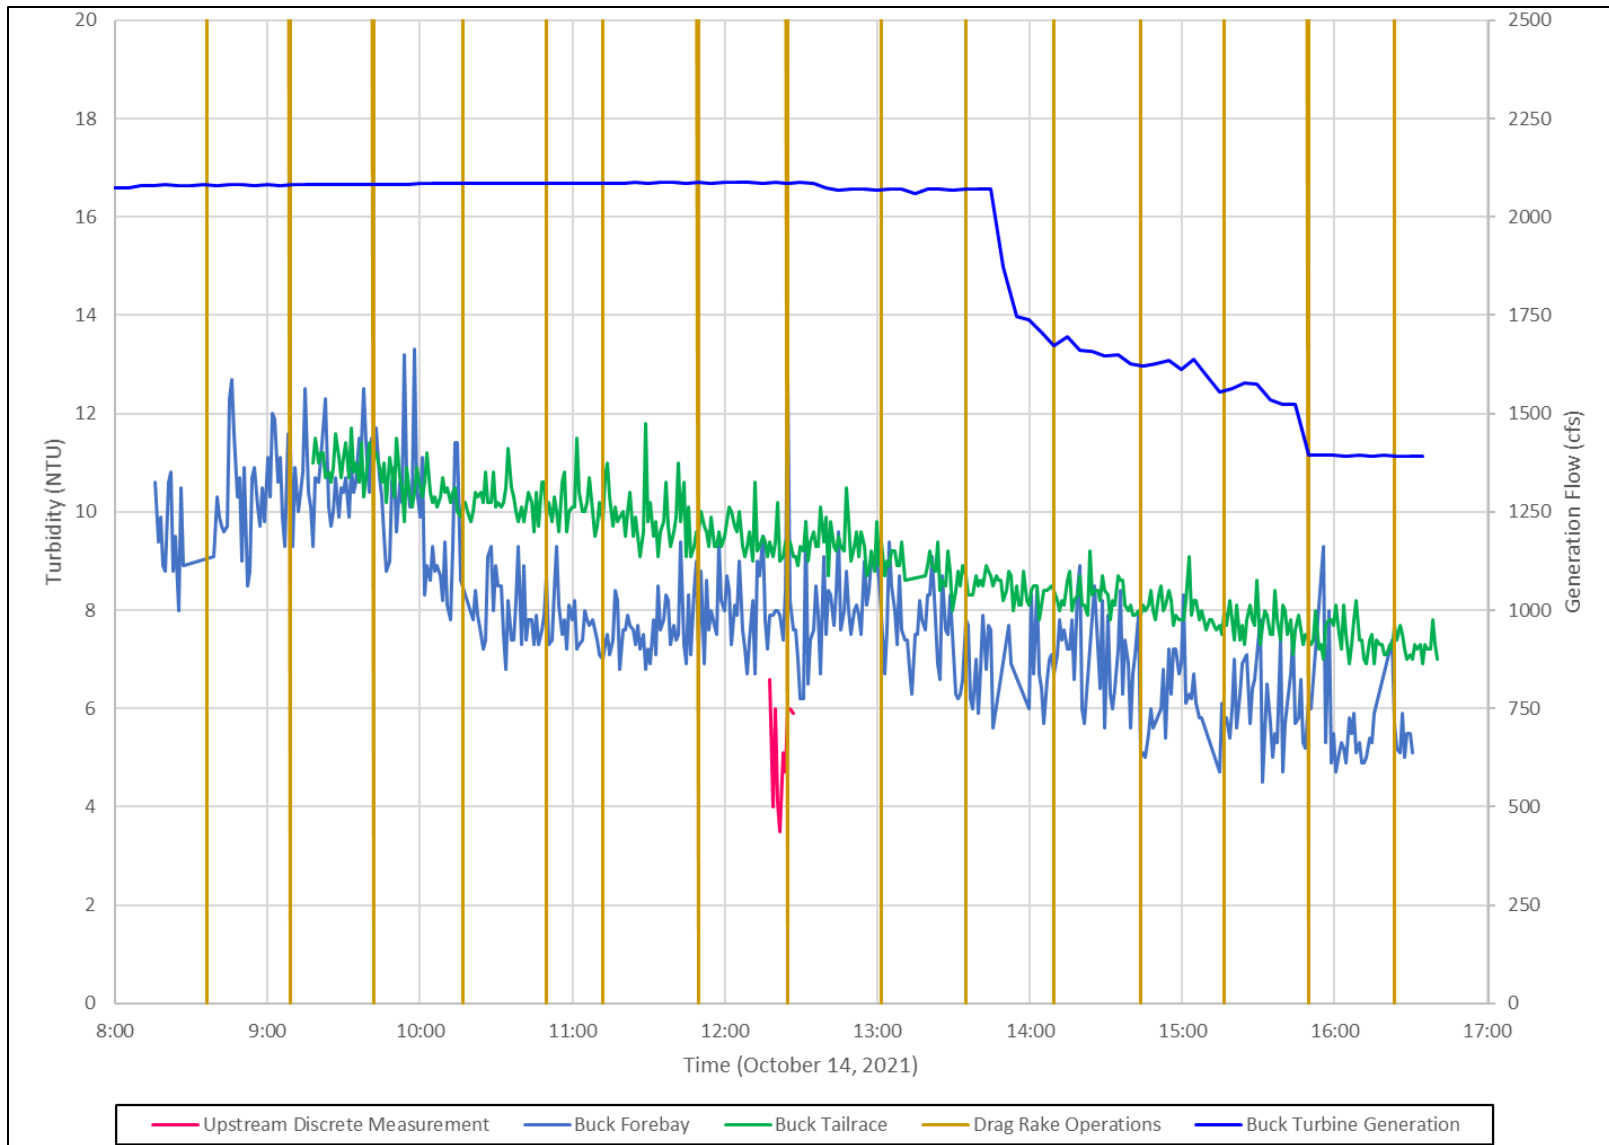
Figure E.7.2. Turbidity and Buck Generation and Drag Rake Operations, October 14, 2021

Due to the turbidity sensor failures and low frequency of drag rake operations during the one-week study period, a second phase was added to the original study to collect turbidity data at the Buck forebay and tailrace monitoring locations⁴ over a one-day period on October 14, 2021. During this second phase, generation at the Buck Development was held relatively steady and the drag rakes were operated approximately every 30 minutes throughout the sampling period. This resulted in 15 discrete drag rake operating events (Figure E.7.2). Turbidity values in the tailrace were slightly higher than in the forebay, but low overall (ranging from approximately 5–12 Nephelometric turbidity units [NTU]). Drag rake operations are provided on this figure and there is no discernable effect on turbidity concentrations in the tailrace immediately following drag rake operations. A discrete measurement of turbidity concentrations at the Byllesby upstream monitoring location yielded a range of 4–6 NTU which represents turbidity concentrations of Project inflows during this second phase sampling event. Results indicate that during periods of low Project inflows, turbidity entering the Byllesby reservoir is correspondingly low, typically < 3.0 NTU. Turbidity concentrations in the Buck tailrace during the one-week study were also low and ranged from approximately 3.0–6.0 NTU⁵.

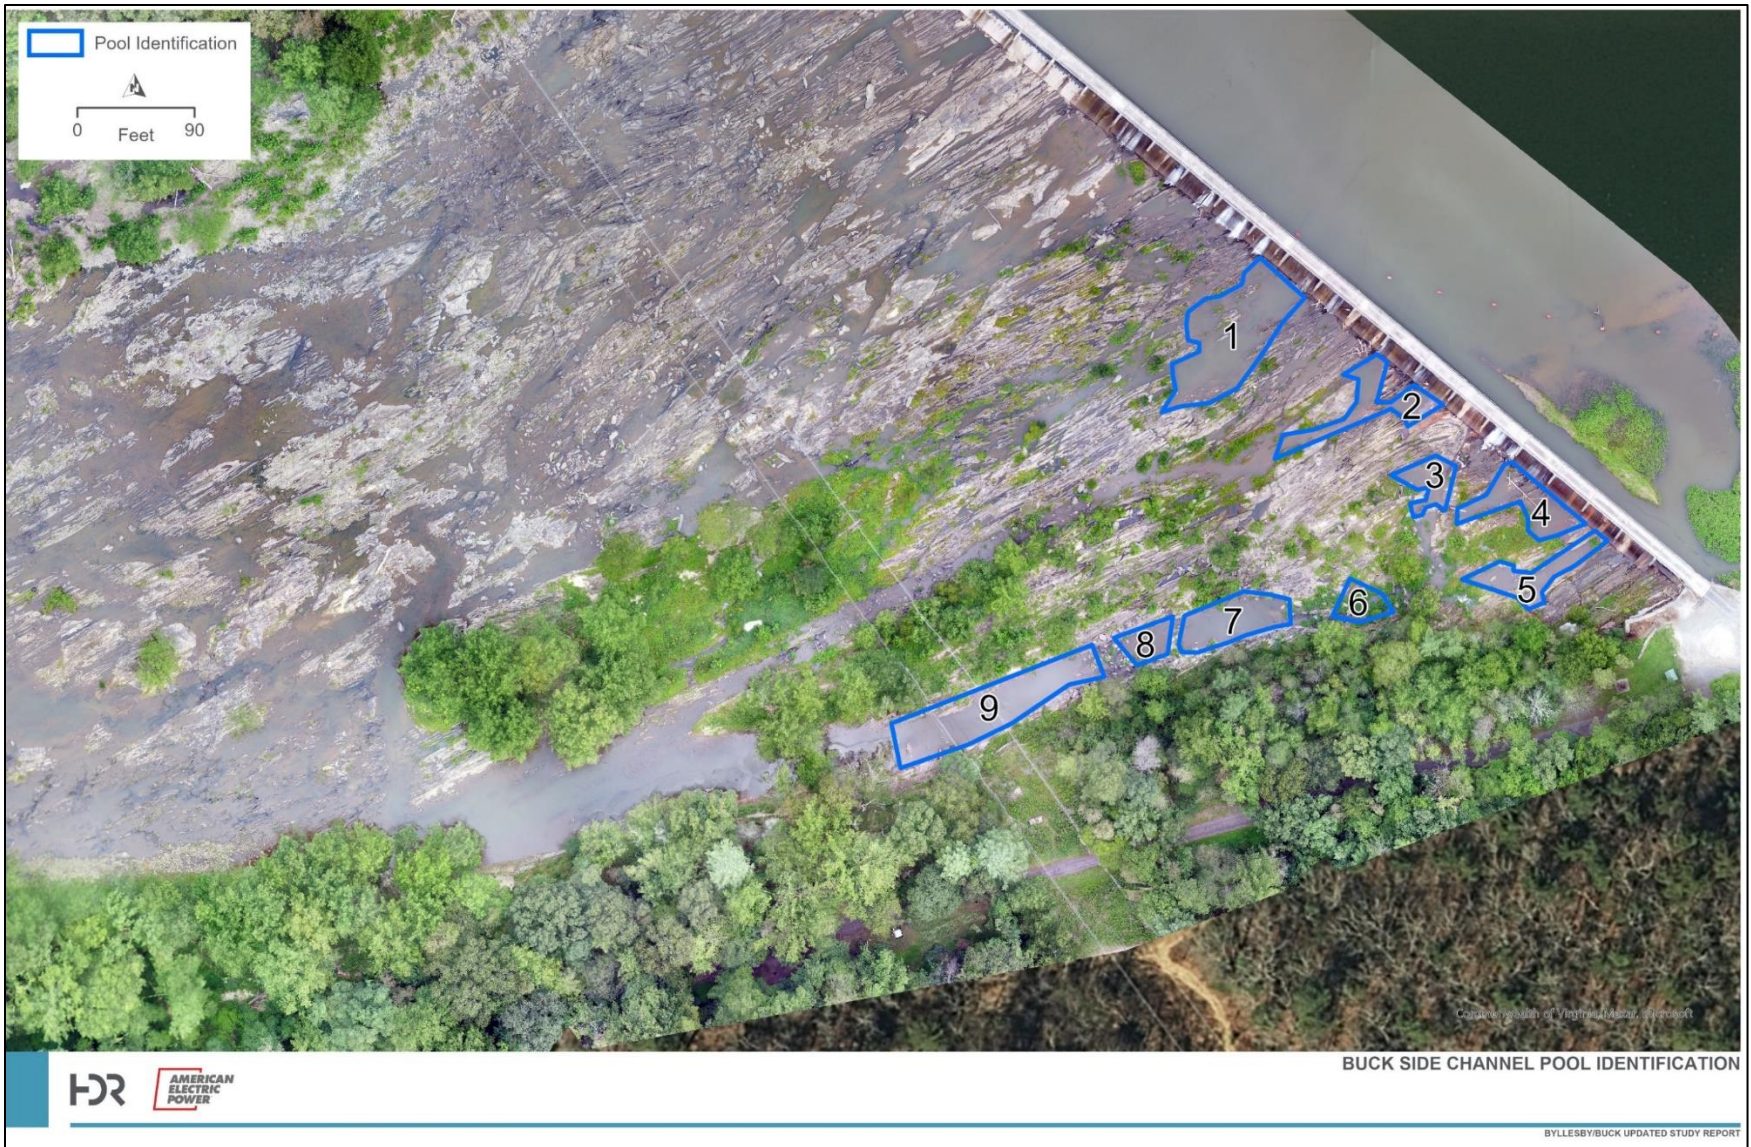
Figure E.9.8. Buck Left Descending Bank Pool Identification

Water surface elevations in Pool 9 (Figure E.9.8) are affected due to a backwater effect from a single gate opening (i.e., full gate opening of approximately 3,000 cfs depicted in Figure E.9.9) as the main flow path in the upper bypass reach intersects with the downstream end of Pool 9. When a single gate is open, ramping rates require hold points at 2 ft and 1 ft gate openings to allow time for water in the bypass reach to gradually recede. As a result, potential fish stranding in Pool 9 under single gate operations is minimized. The water surface elevations in Pools 8 and 7 are not affected by backwater from a single gate opening but begin to increase when a second gate is opened. Water surface elevations in Pool 6 are not affected until at least three spillway gates are opened and pools across the toe of the spillway (i.e., Pools 1 – 5) are not affected until five or more spillway gates are opened.

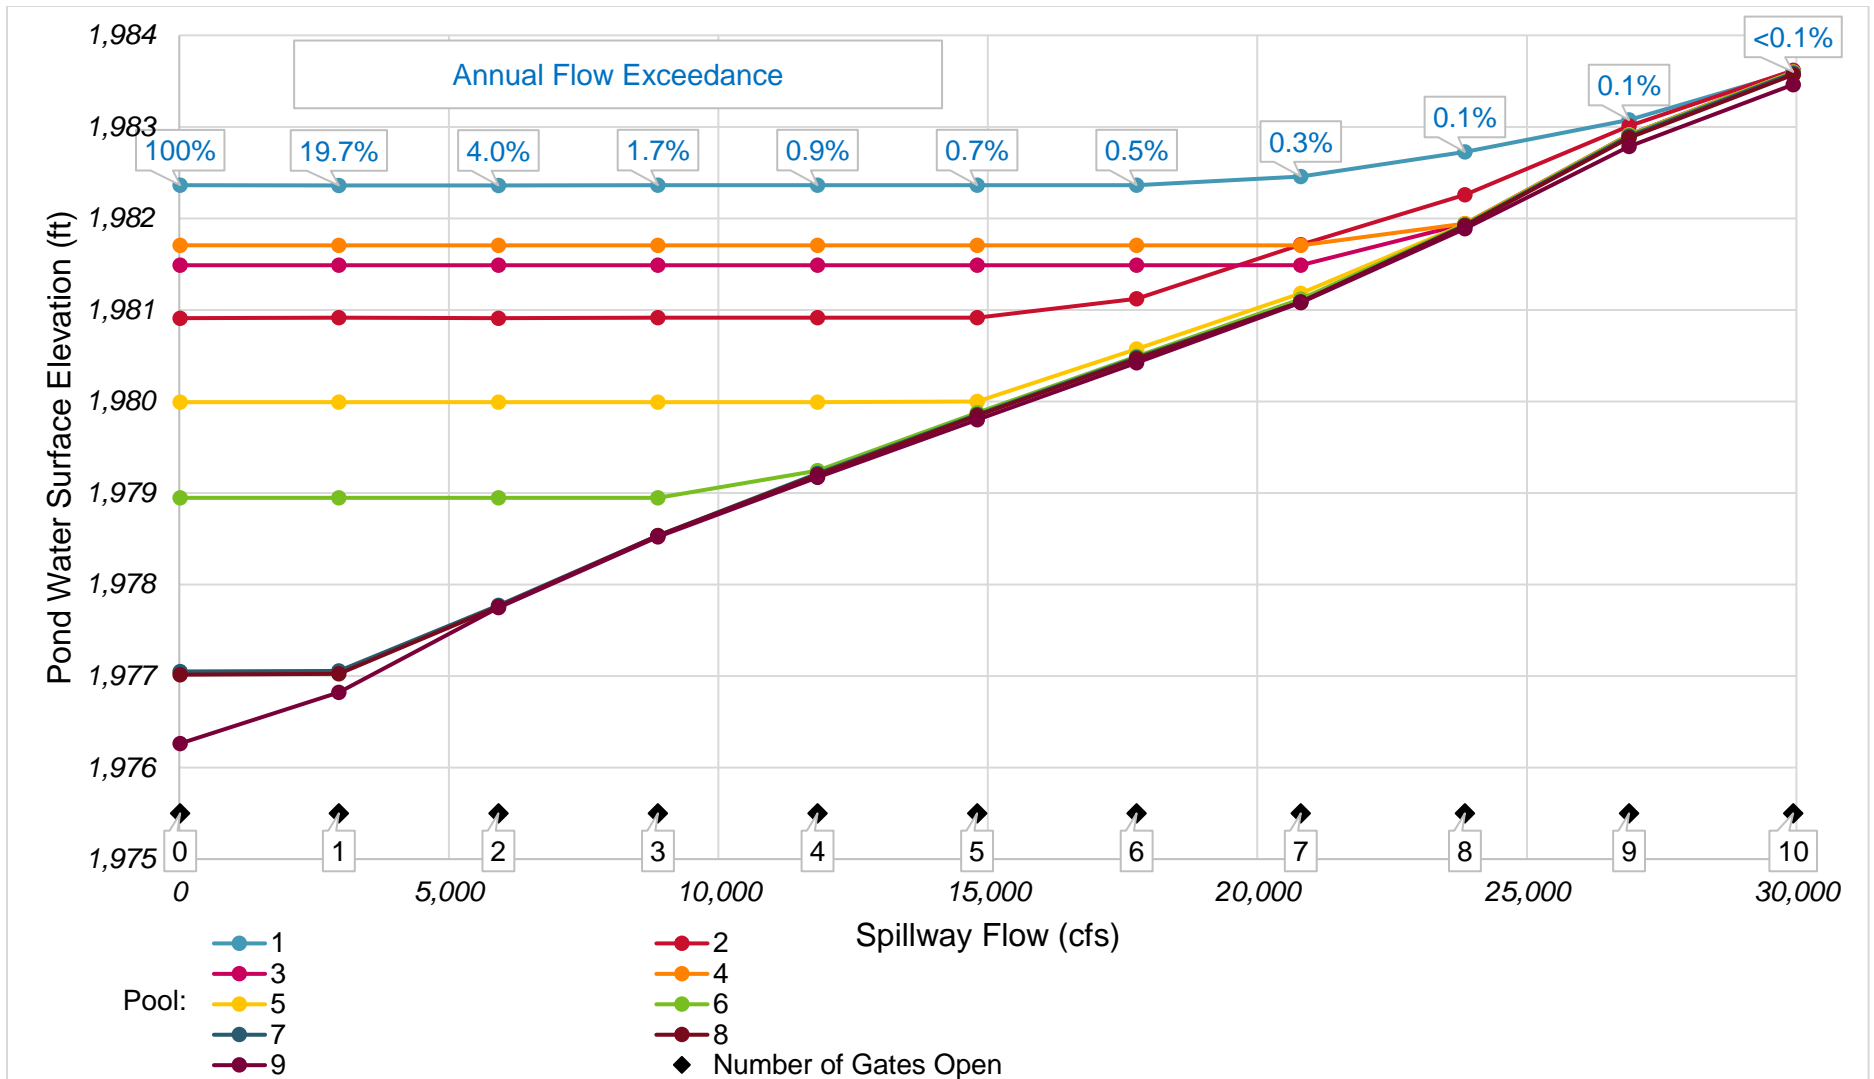
Figure E.9.9. Buck Left Descending Bank Pool Water Surface Elevations vs Spillway Flow with Annual Exceedance Probabilities

Based on annual flow exceedance probabilities, a single gate would be opened to some extent (either partially or fully) approximately 19.7 percent of the time. However, the probability of multiple gates opened at the same time is significantly lower. The probability of two gates opened at the same time is approximately 4.0 percent, which means the water surface elevations in Ponds 7 and 8 are not affected from bypass flow releases 96.0 percent of the time. The probability of three gates opened at the same time is approximately 1.7 percent, which means the water surface elevations in Pool 6 are not affected from bypass flow releases 98.3 percent of the time. The probability of five or more gates opened at the same time drops to less than 1 percent of the time, so water surface elevations in the pools located along the downstream toe of the spillway (i.e., below the flashboard sections), are rarely affected by bypass flow releases. As a result, the potential for fish stranding in this area is minimal and is mitigated by the current ramping rate requirements at the Buck Development.

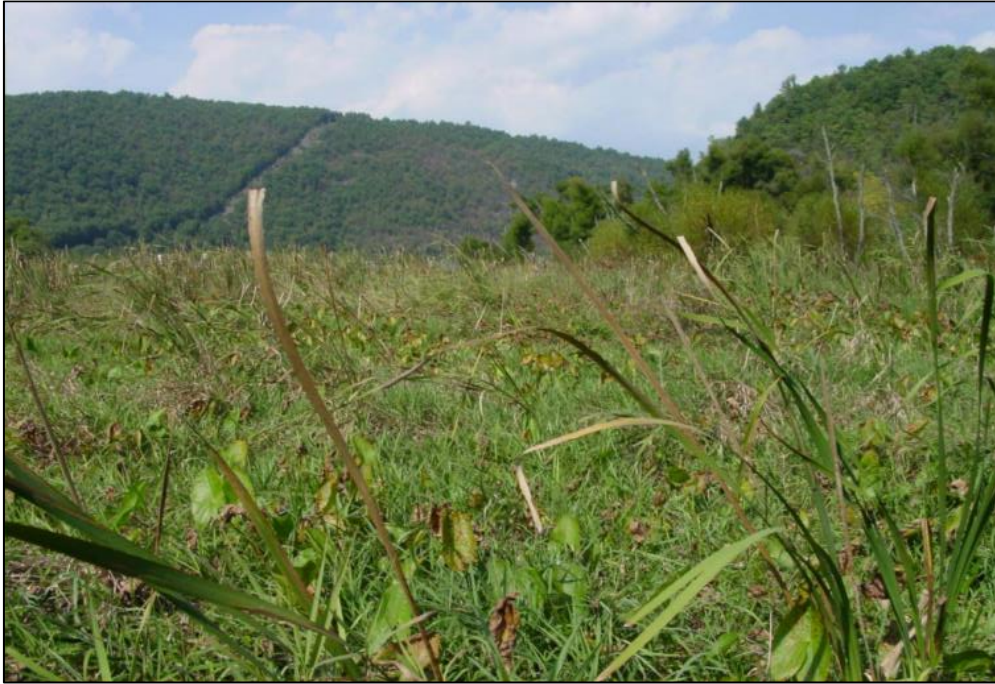
E.10.1) is an approximately 6-acre emergent wetland, created as mitigation for sediment removal conducted at the Project in 1997. This wetland is located approximately 500 ft upstream of the Byllesby Dam. Wetland vegetation at this location is at an elevation higher than the normal reservoir operating level.

Figure E.10.1. Representative Photograph of Byllesby Wetland (Photo from 2007)

The species composition of the approximately 6-acre wetland was documented through transect monitoring of this wetland from 2004 to 2007. The dominant species observed at this wetland in 2007 are listed in Table E.10-1. Species noted with an “*” were also noted as present (at the genus level) at wetlands within the larger Project Boundary during the 1990 survey conducted by Appalachian (Appalachian 1991a). Additional emergent wetland vegetation observed during the 1990 survey included water plantain (*Alisma* sp.), swamp milkweed (*Asclepia incarnata*), red willow dogwood (*Cornum amomum*), Joe-pye-weed (*Eupatorim* sp.), witch hazel (*Hamamelis virginia*), cardinal flower (*Lobelia cardinalis*), monkey flower (*Mimulus* sp.), green cone flower (*Rudbeckia* sp.), black willow, cord grass (*Spartina* sp.), and vervain (*Verbena* sp.).
