FINAL LICENSE APPLICATION

Niagara Hydroelectric
Project (FERC No. 2466)

Appendix E - Wetlands, Riparian, and Littoral Habitat Study Report

Appendix F - Shoreline Stability Assessment Study Report

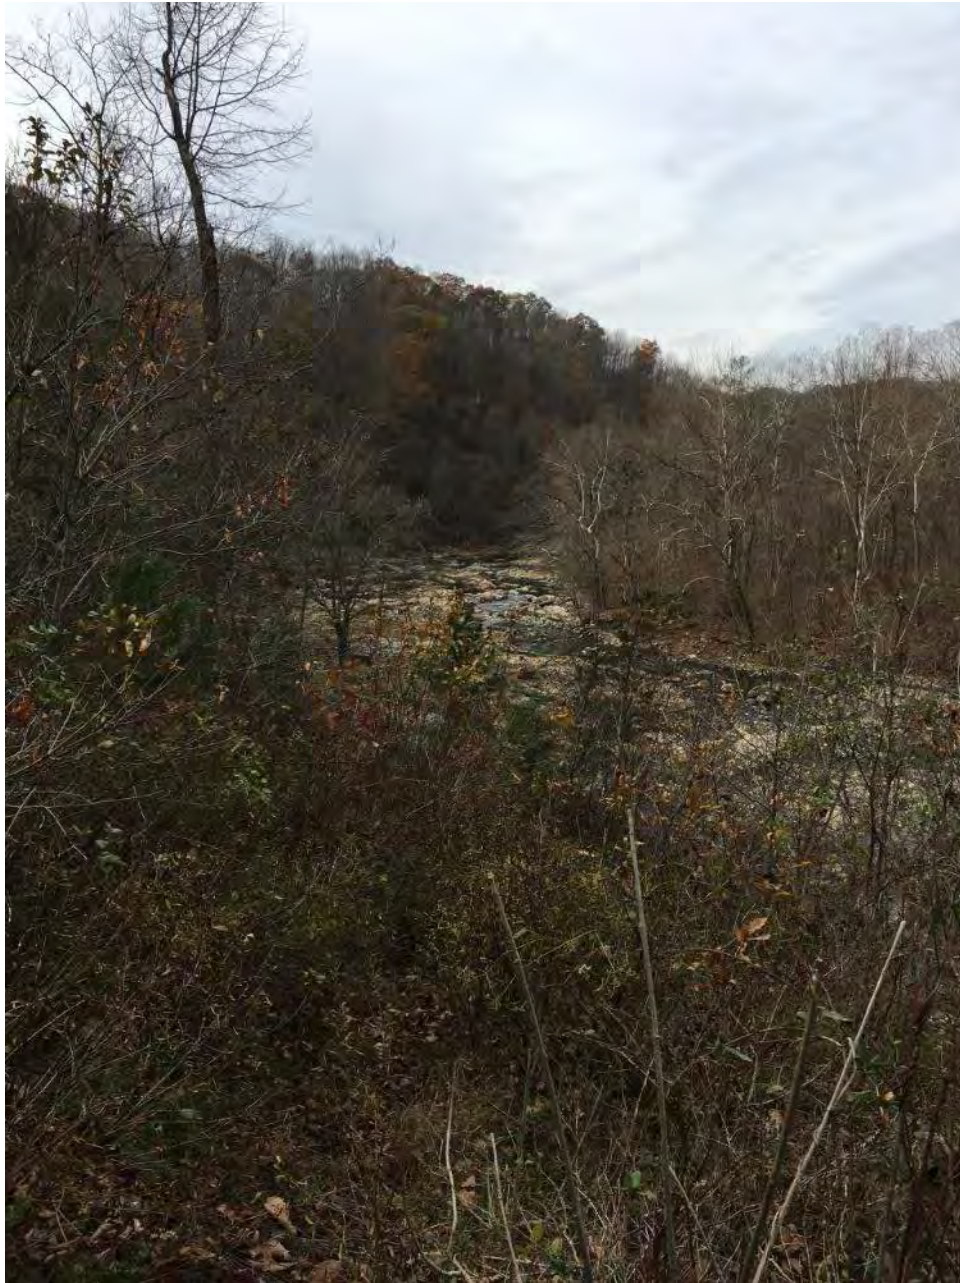
**November 15, 2019 – View of Spillway and Bypass from KOP-1
(Q=24 cfs)**

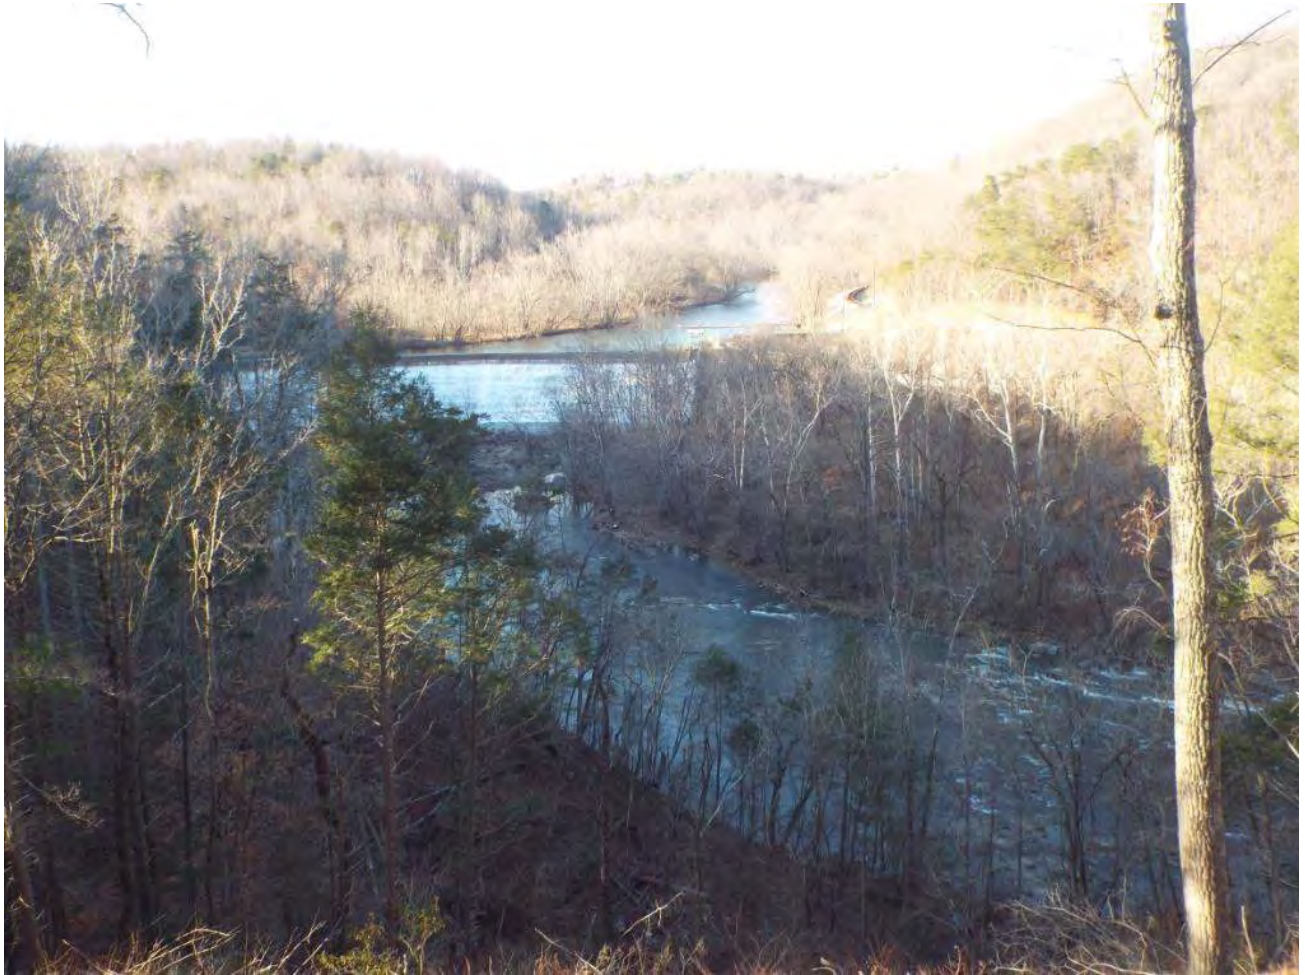
January 1, 2020 – View of Spillway and Bypass from KOP-1 (Q=332 cfs)

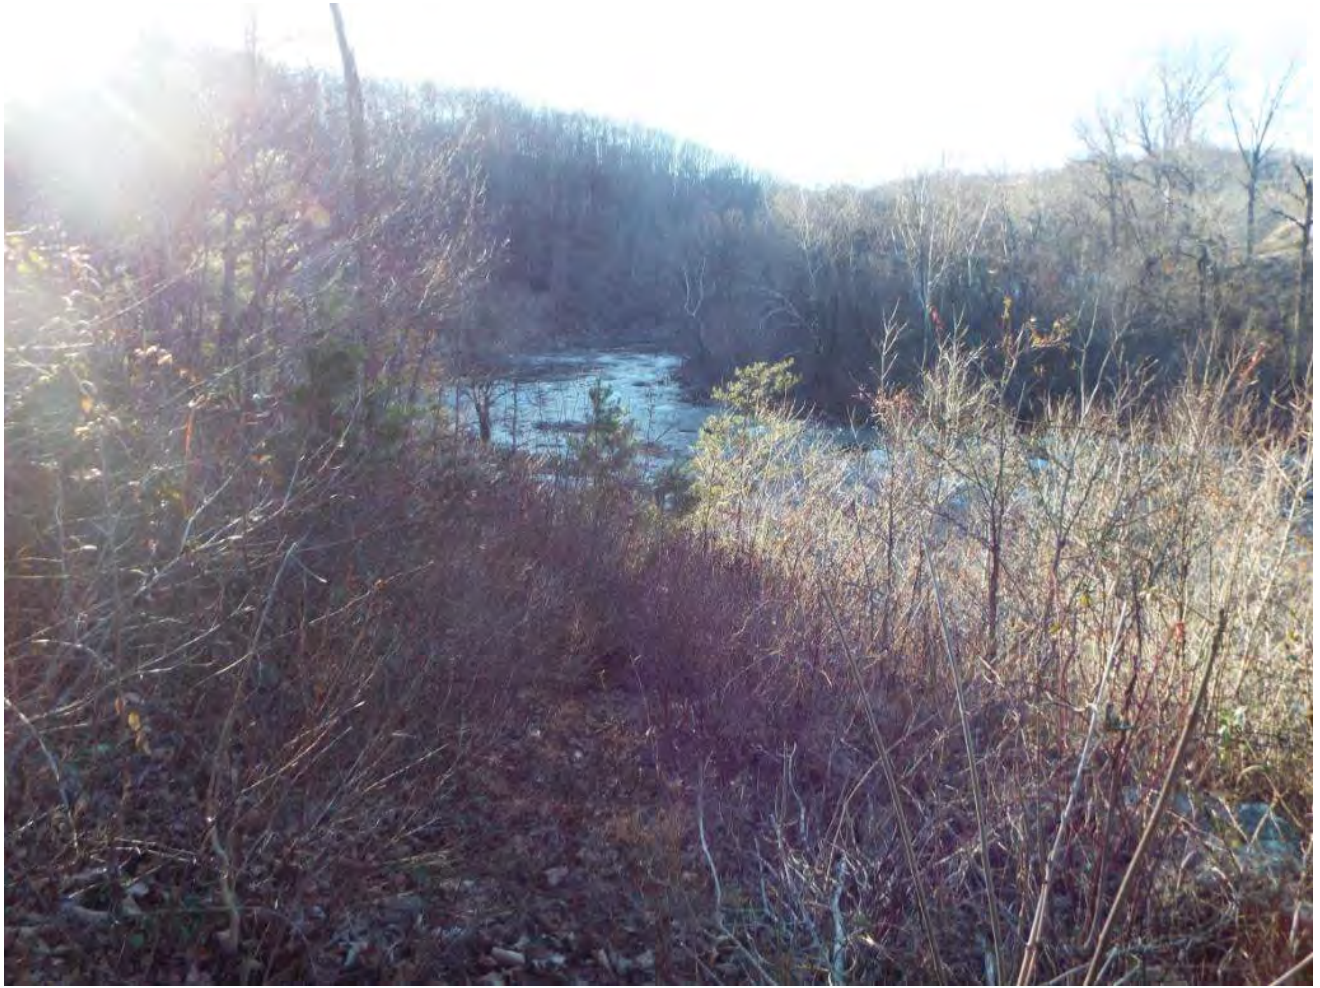
January 1, 2021 – View of Bypass from KOP-2 (Q=332 cfs)

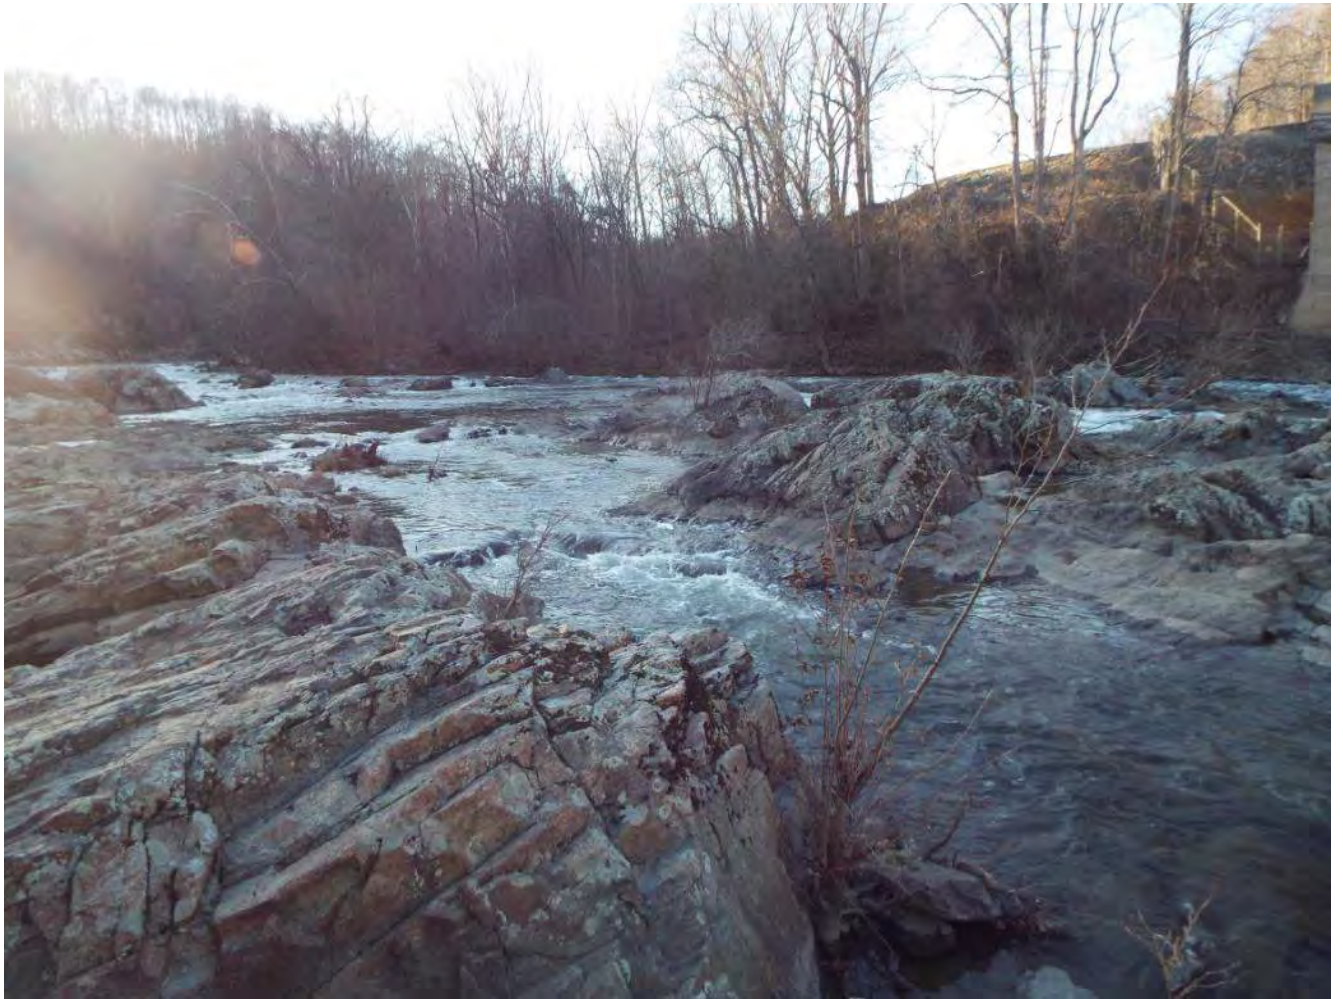
January 1, 2020 – View of Bypass from KOP-3 (Q=332 cfs)

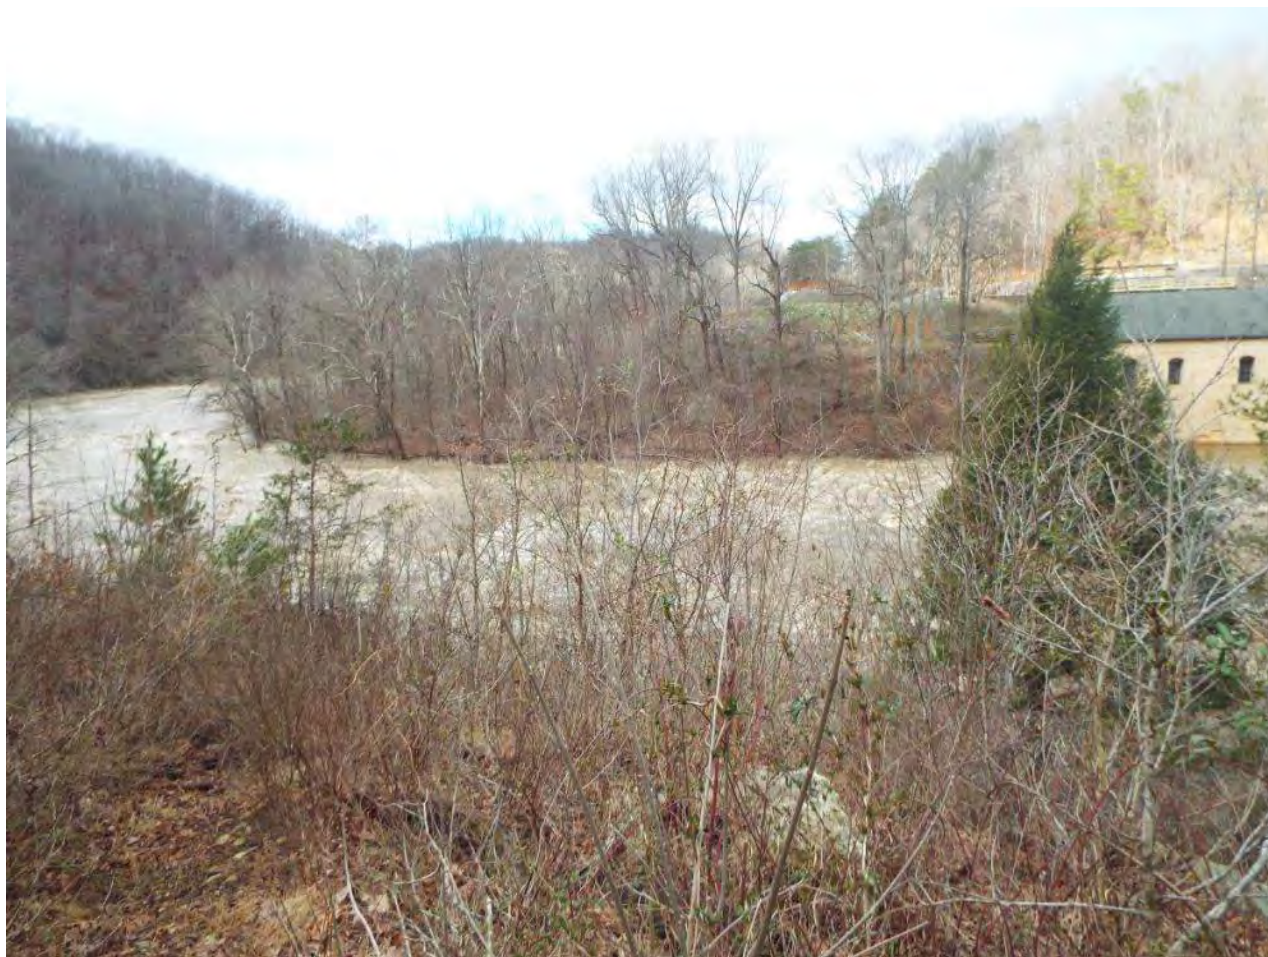
February 7, 2020 – View of Bypass from KOP-2 (Q=11,716 cfs)

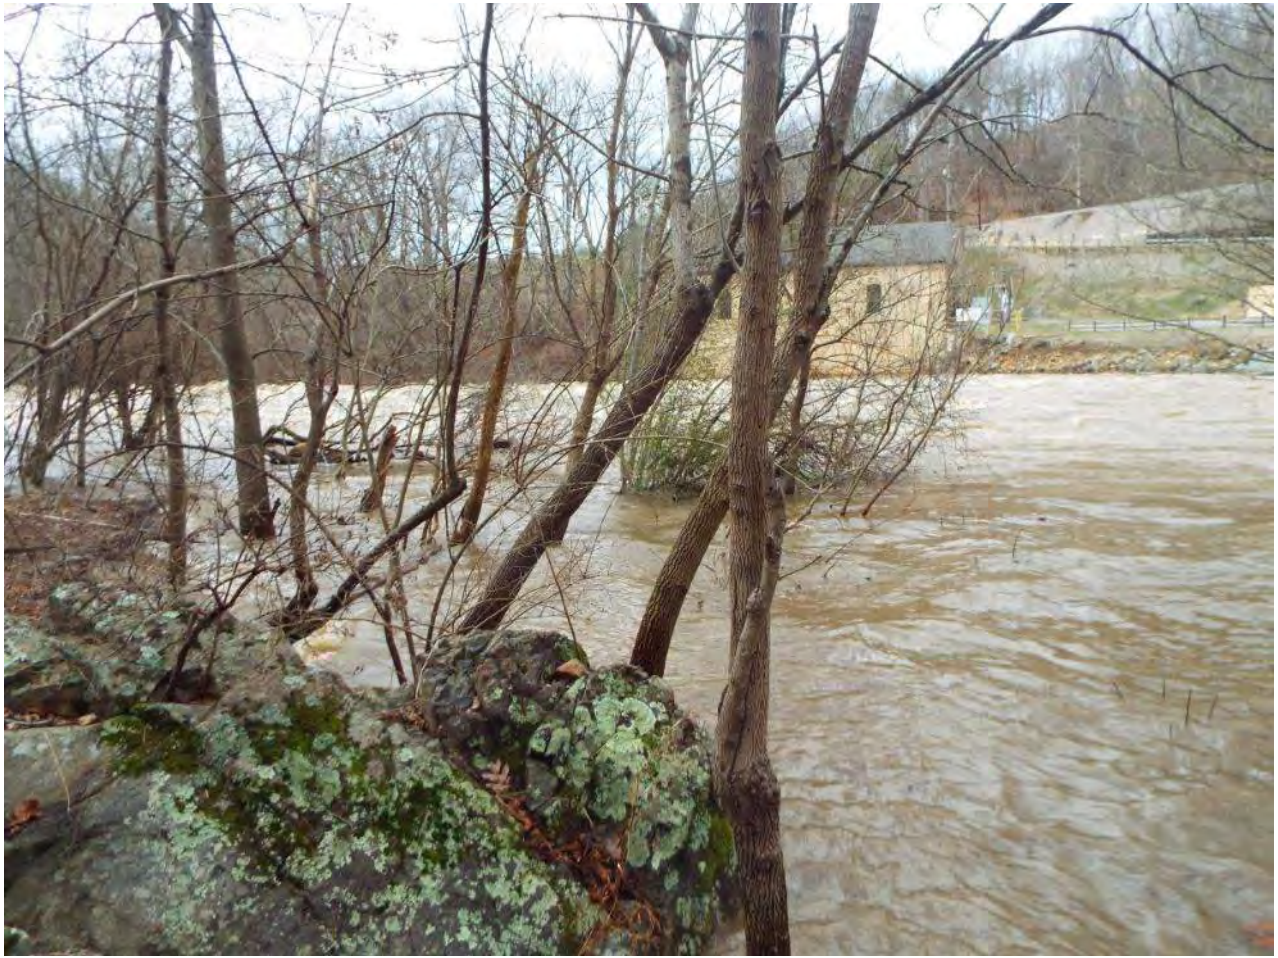
February 7, 2020 – View of Bypass from KOP-3 (Q=11,716 cfs)
