**SUBJECT: Constantine Hydroelectric Project (FERC No. 10661)
Response to Final License Application Additional Information
Requests**

7. Shoreline Survey Photographs - AEP Constantine Project Area 2019

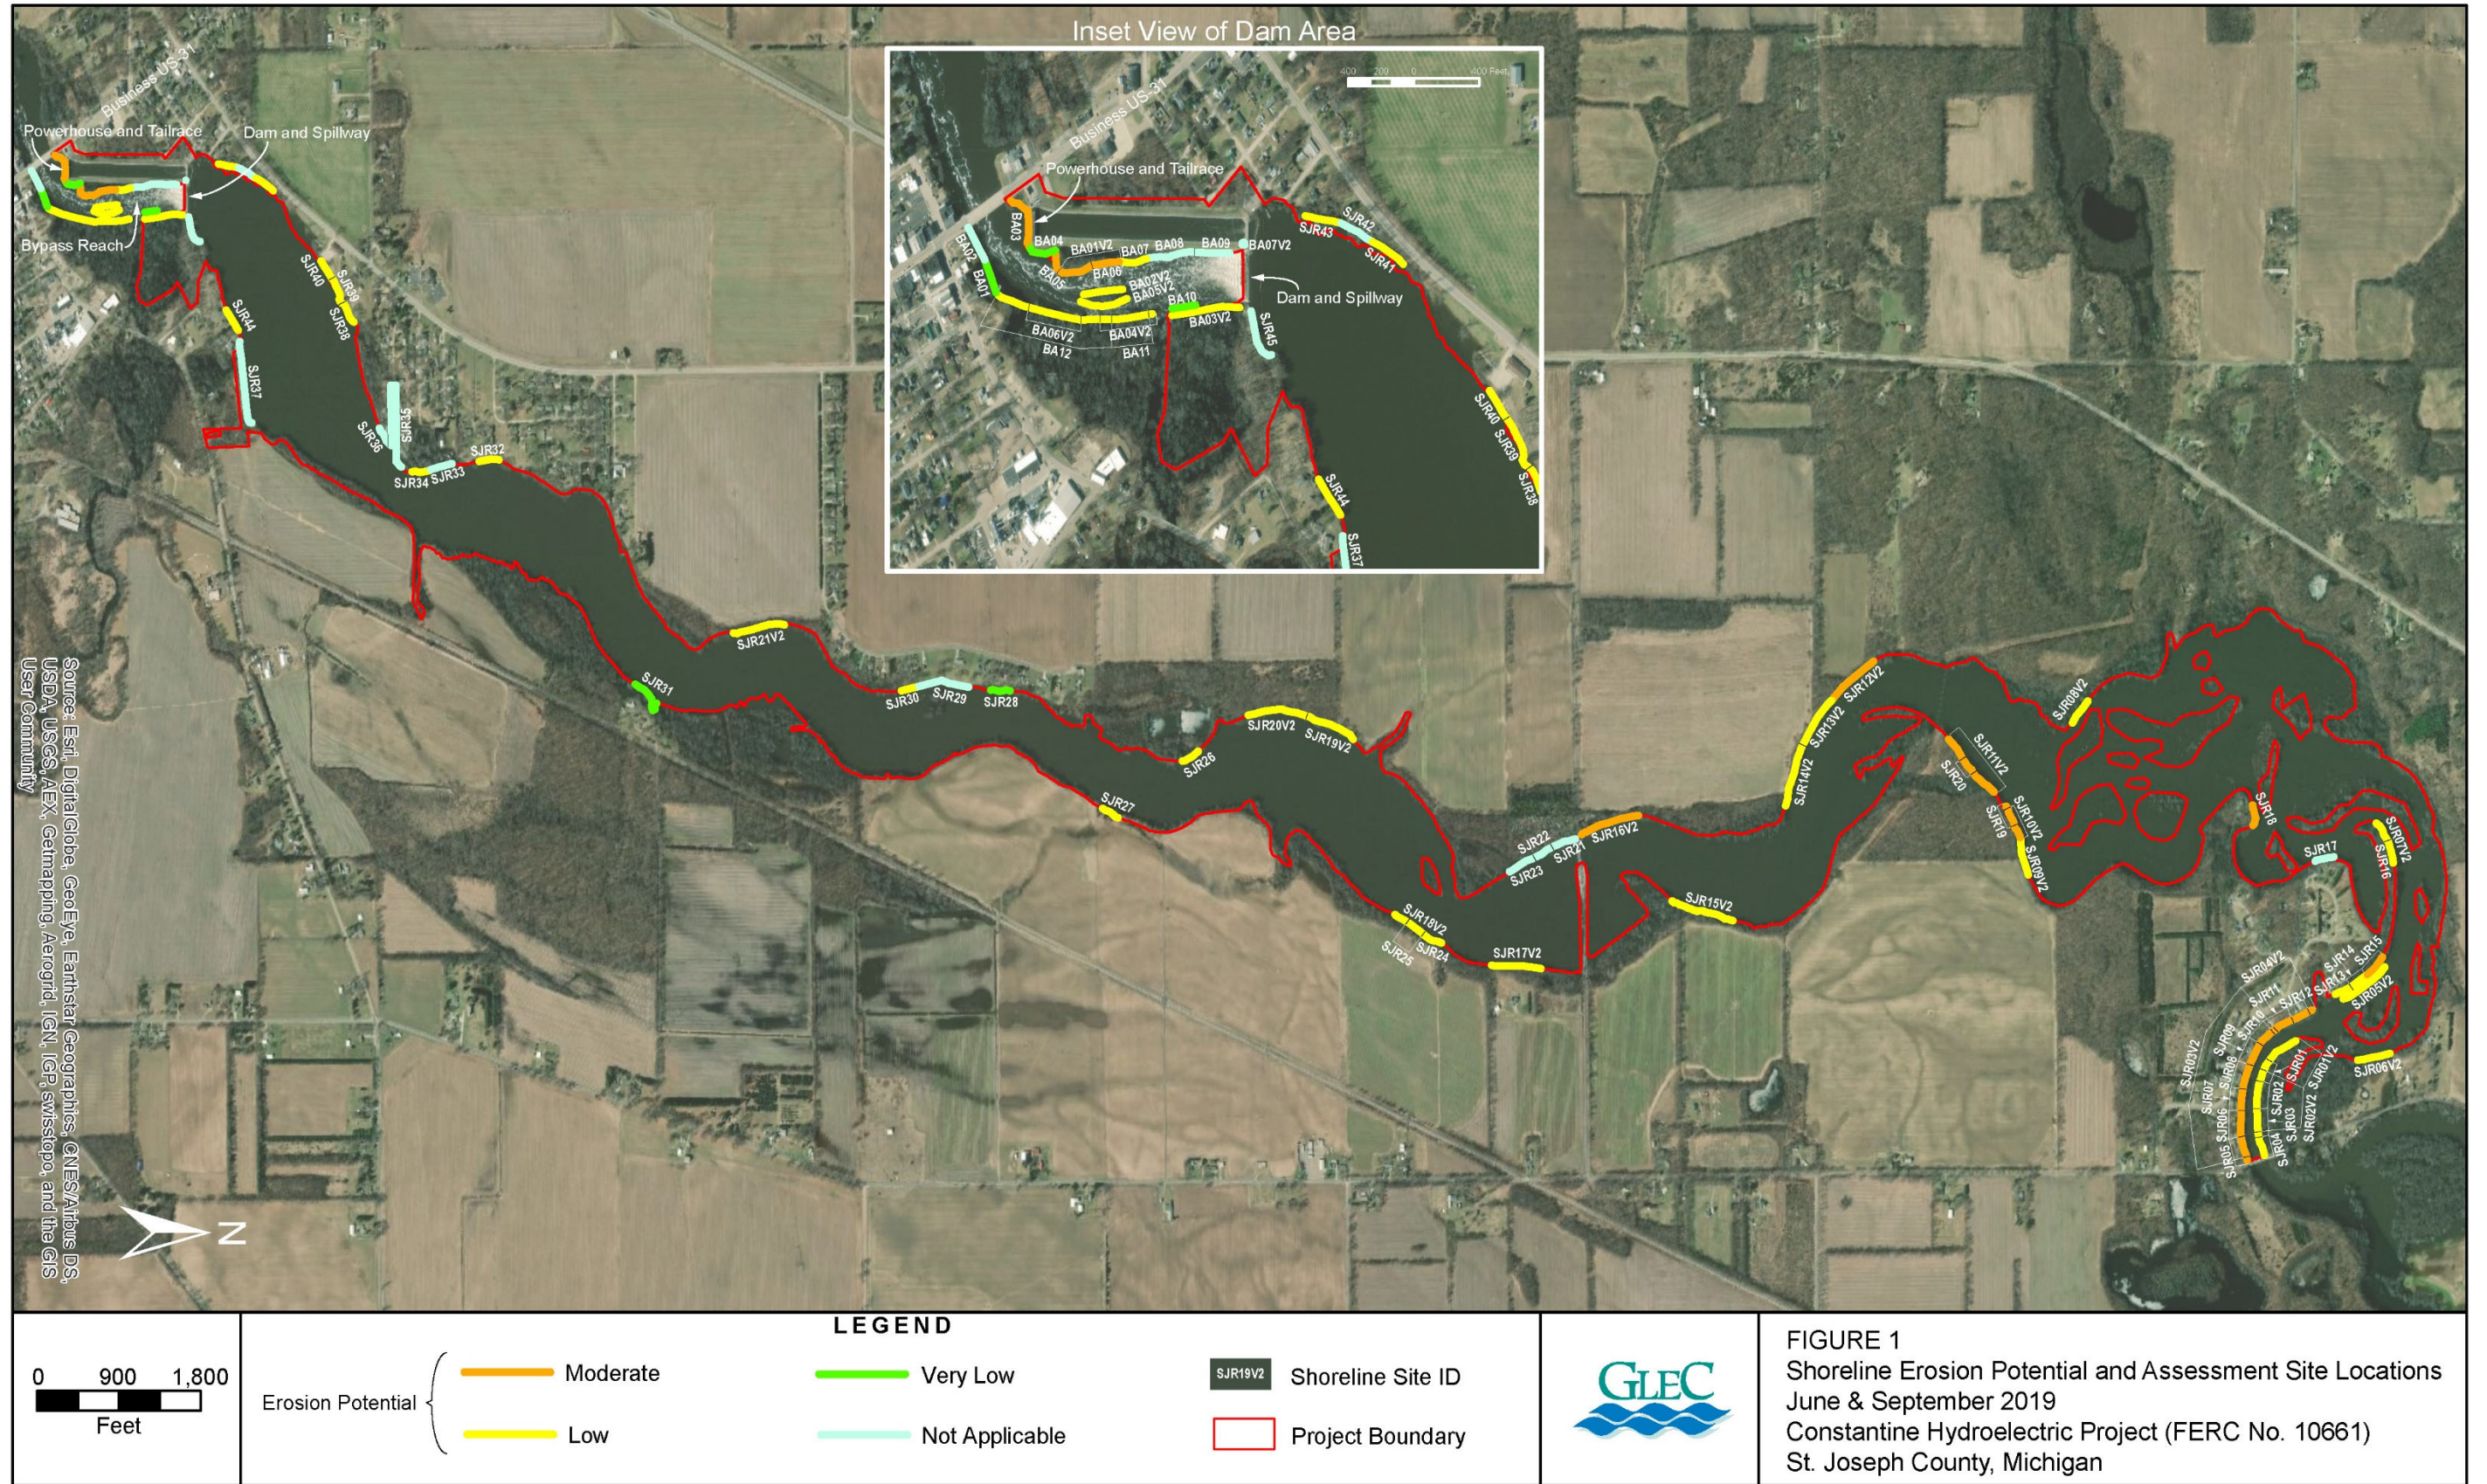
Figure 1. Shoreline Erosion Potential and Assessment Site Locations June & September 2019

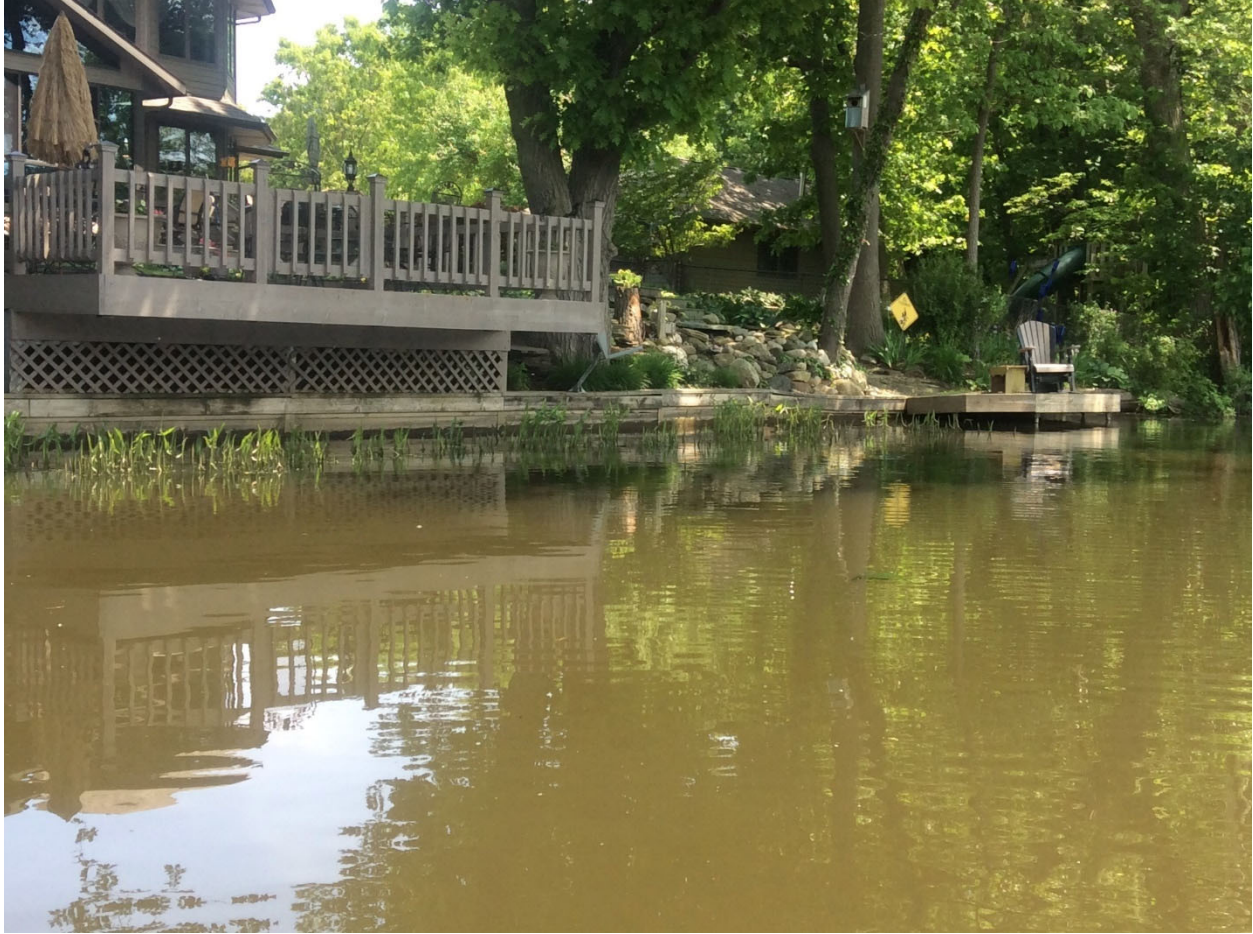
Figure 10. Site SJR17: An example of intensive landscaping along the shoreline within the reservoir area.

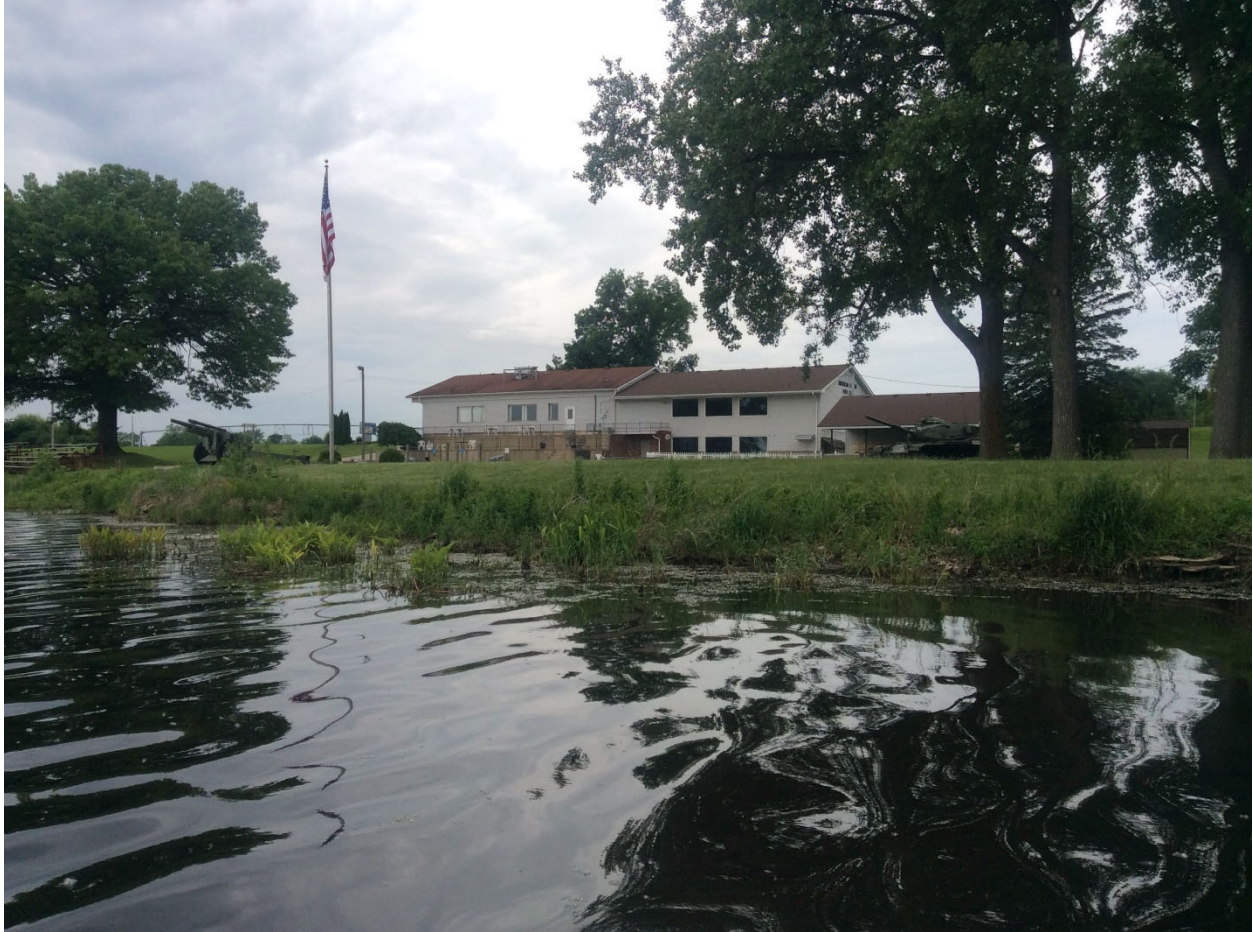
The remainder of the applicable reservoir sites assessed in June scored in the Low or Very Low category. The decrease in the bank angle and increase in root density and surface protection reduce the risk of erosion at these locations. Sites SJR27 (Figure 15) and SJR39 (Figure 16) are developed with buildings and lawns, but a decreased risk of erosion.

Figure 16. Site SJR39: Shoreline along VFW Hall.

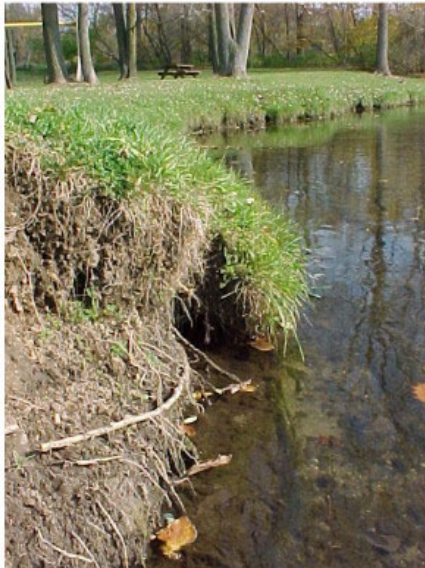
Figure B. Kalamazoo River

Note sod slumping into channel – a sure indication of an unstable bank, presumably because streamside vegetation = mowed grass, not woody vegetation. Otherwise the channel is in pretty good shape.

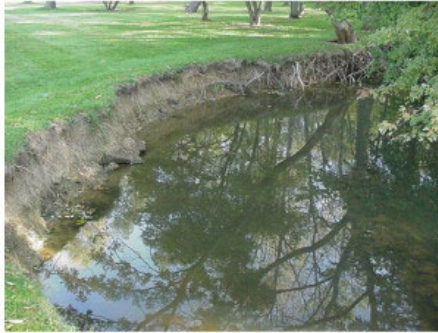
Figure C. Rouge River

Interesting site – roots extend to waterline, but are so few that they provide minimal bank protection. Also, this site is downstream from a dam, where erosion is usually atypically high due to “hungry water” created by the impoundment.
