# FINAL LICENSE APPLICATION

## Volume II of V Part 2 - Study Reports

Byllesby-Buck Hydroelectric Project  
(FERC No. 2514)

# Appendix B - Water Quality Study Report

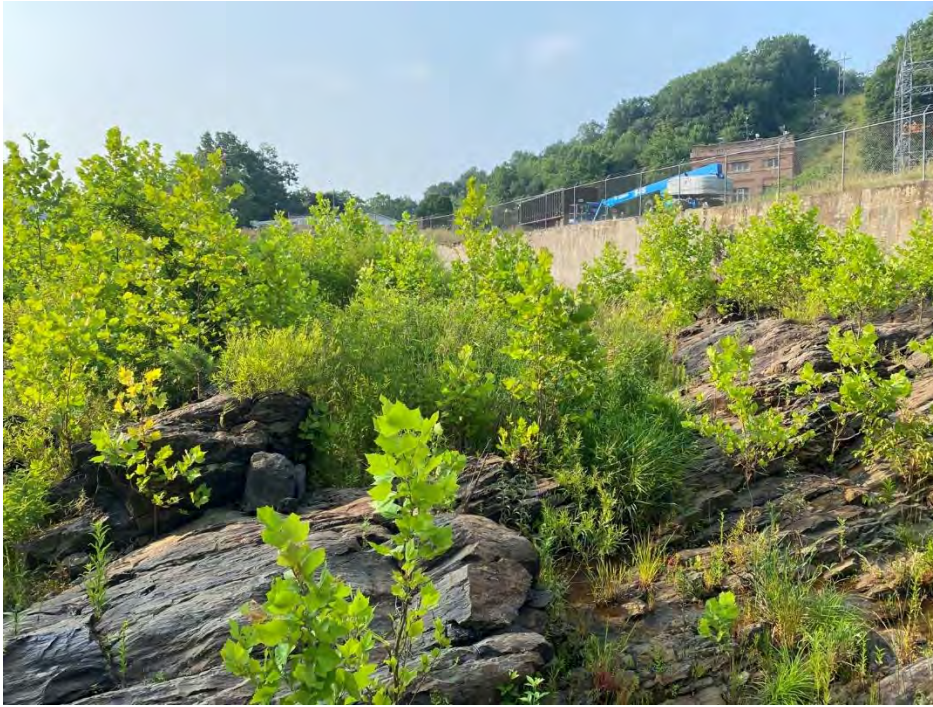
Photograph 5 – Representative Rocky Bottom Wetland near Byllesby Dam (dated July 21, 2021).

Rocky bottom wetlands were mainly observed in the bypass reaches. These wetlands are subject to flow based on release from the Byllesby-Buck developments. The stability of the bottom allows for more diverse plant species to develop and thrive. Typically these wetlands are high energy habitats with well-aerated waters.

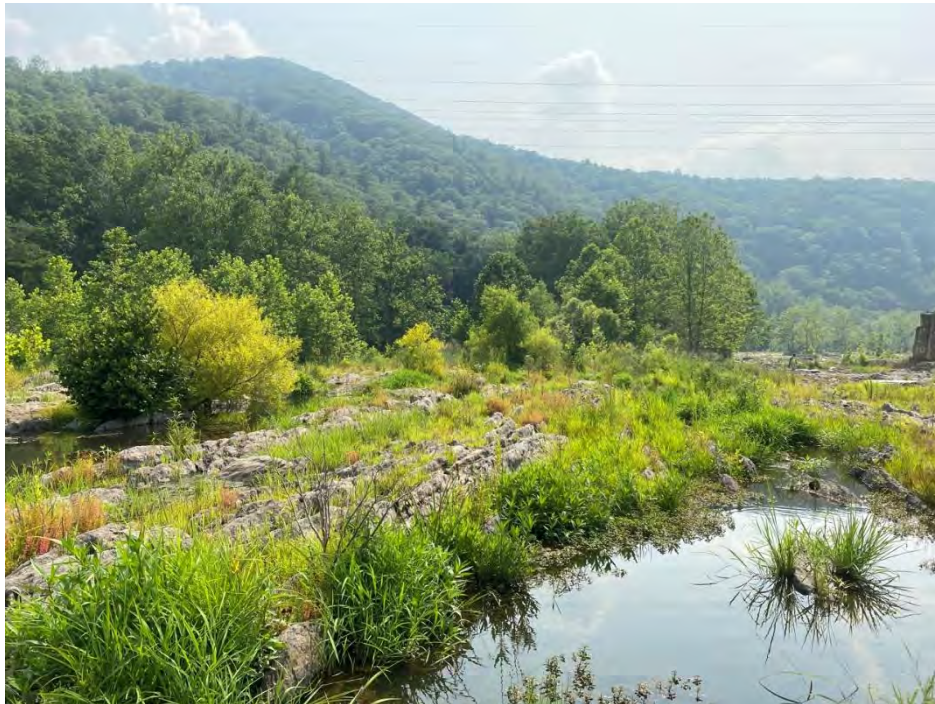
Photograph 9 – Rocky Bottom Wetland in Buck Bypass (dated July 21, 2021).

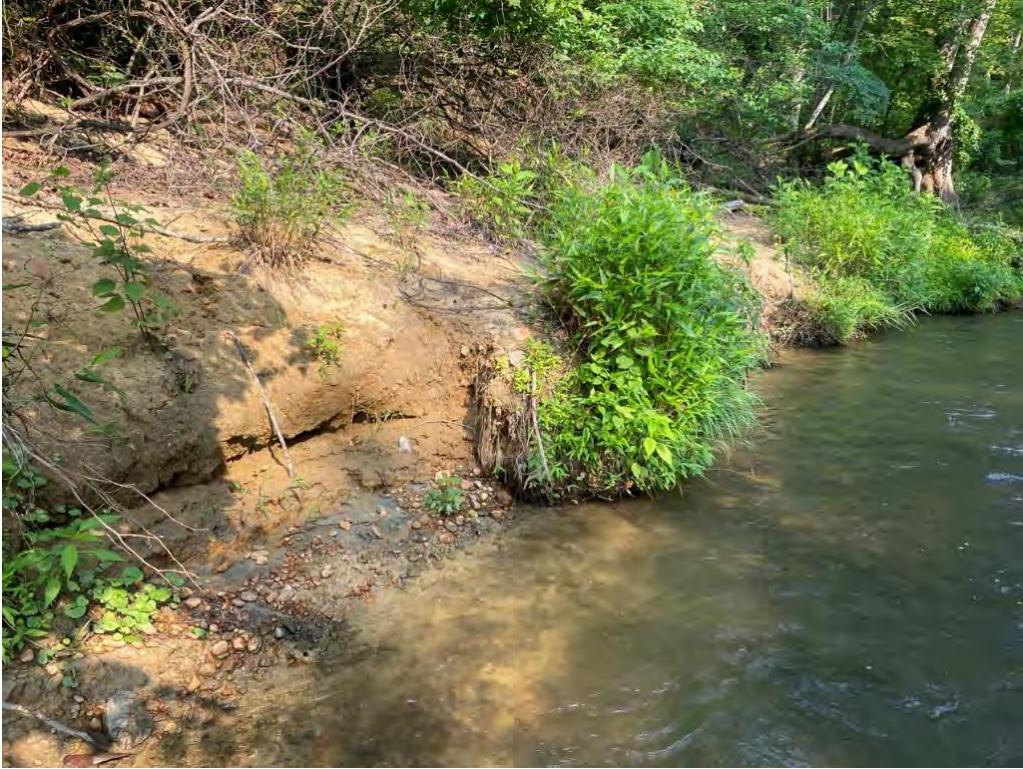
**Erosion Area 1; Category “High”**

Bank conditions were documented and representative photographs from each erosion area are provided in Attachment 1.

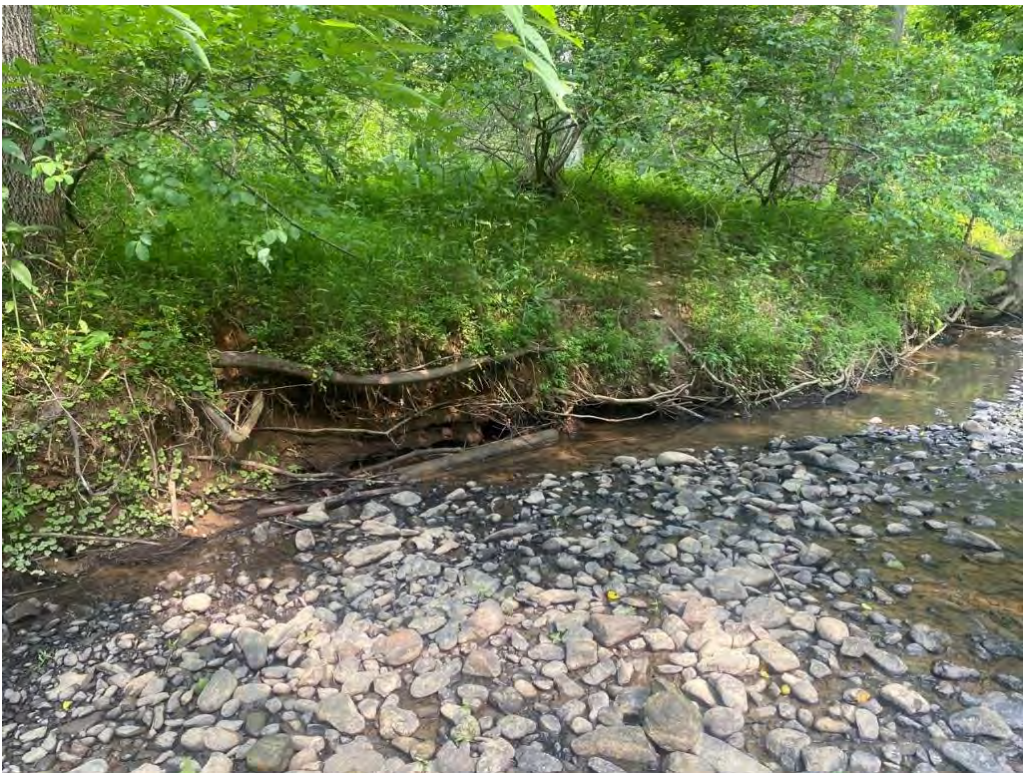
**Erosion Area 2; Category “High”**

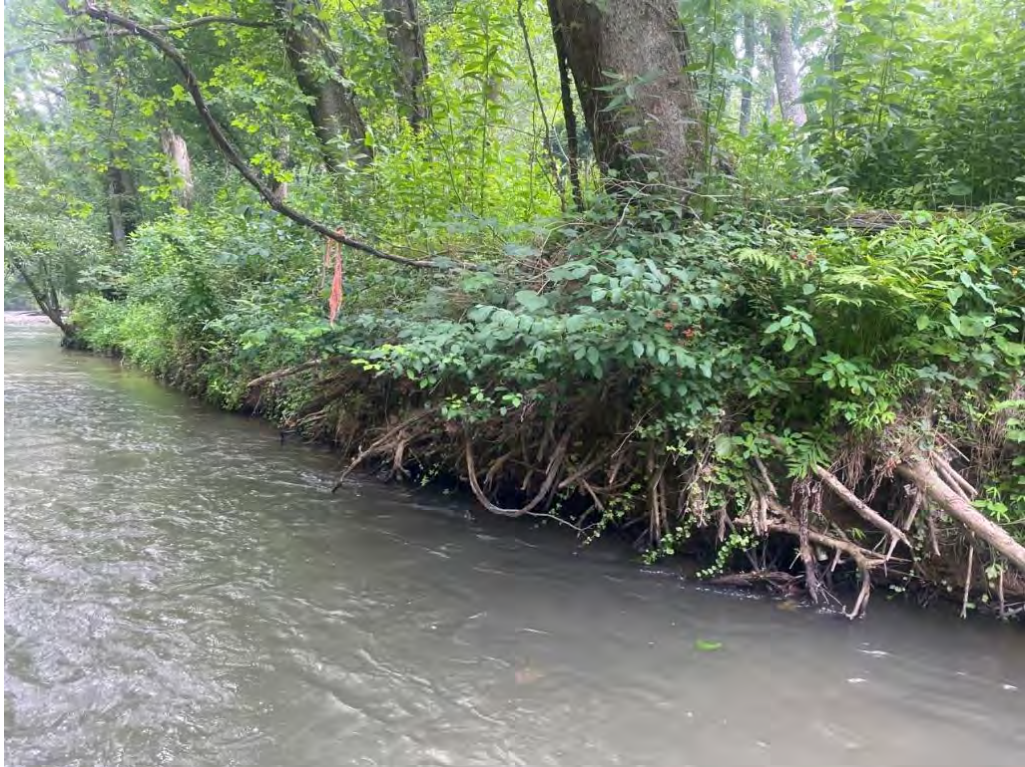
**Erosion Area 3; Category “Moderate”**

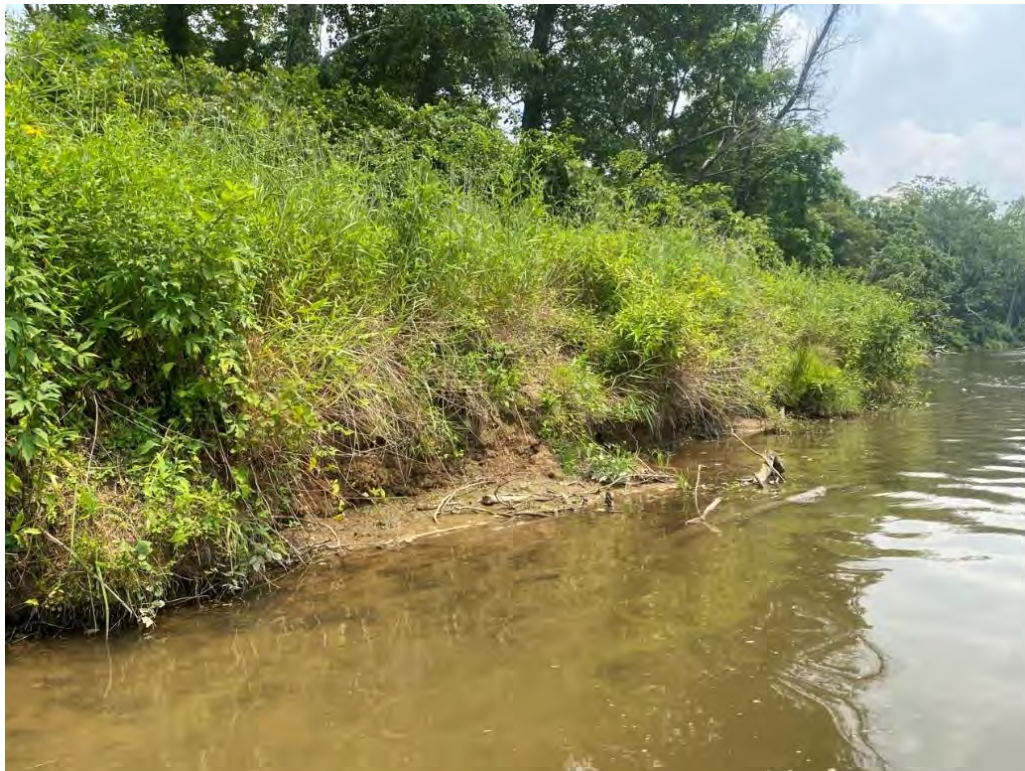
**Erosion Area 4; Category “High”**

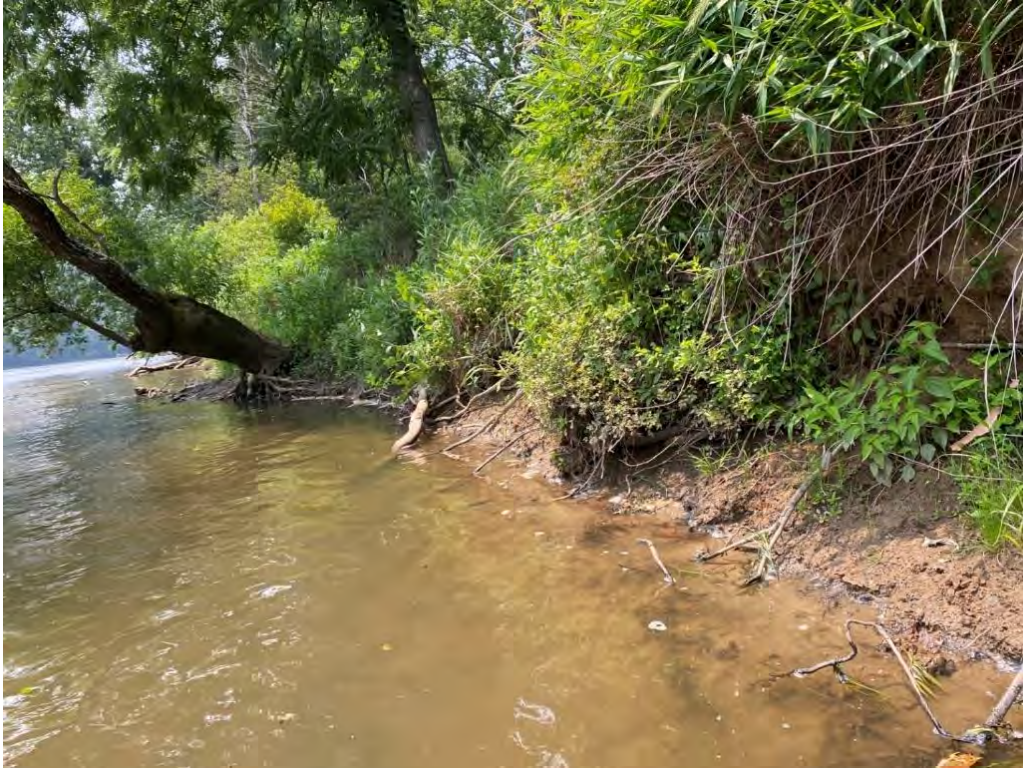
**Erosion Area 5; Category “High”**

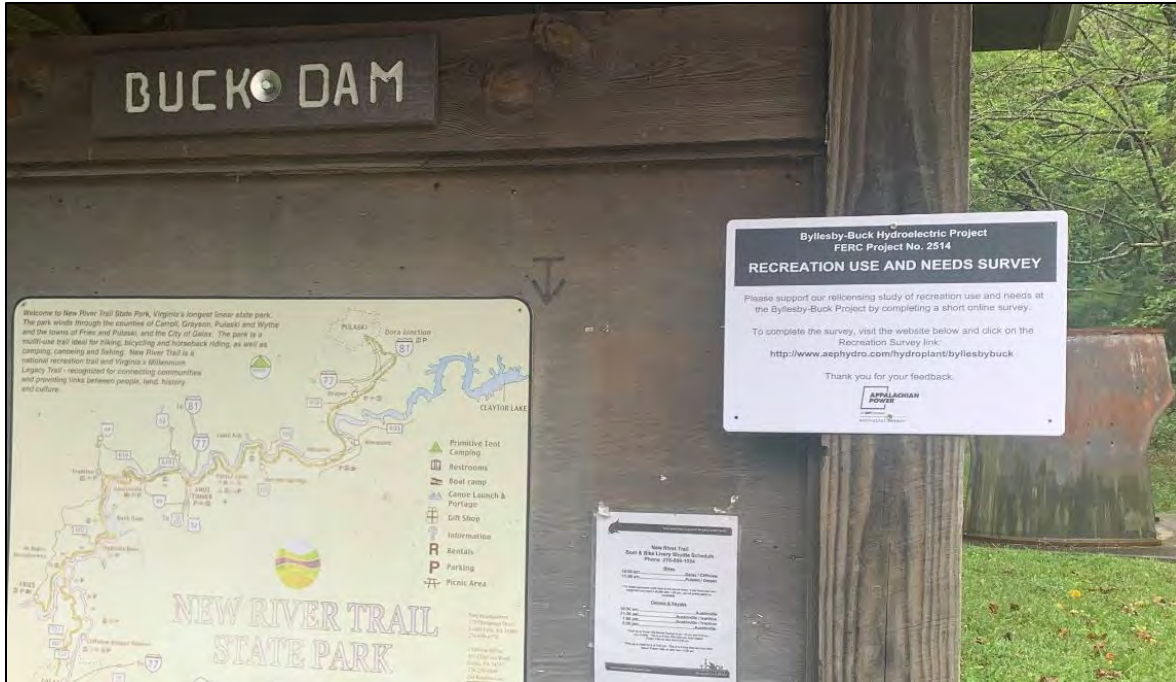
Figure 5-1. Recreation Use and Needs Survey Sign

Appalachian posted signs at the Project and Non-Project recreation facilities (except the Byllesby Boat Launch) providing a brief description of the purpose and intent of the survey and the website address (Figure 5-1). This allowed respondents to complete a survey onsite, or later upon returning home from their visit, or without visiting the Project if the link was identified through other (electronic) communications. Appalachian also contacted the U.S. Fish and Wildlife Service (USFWS), Virginia Department of Environmental Quality (VDEQ), VDCR, VDWR, New River Conservancy, and Carroll County stakeholders at the beginning and end of the survey window to support distribution of the survey. Additionally, Appalachian notified relicensing participants that the online survey was available through the quarterly ILP study progress report. Notice of the survey was also posted on the Project's relicensing website and on a relevant social media outlet (ex: Claytor Lake Facebook page) maintained by Appalachian.

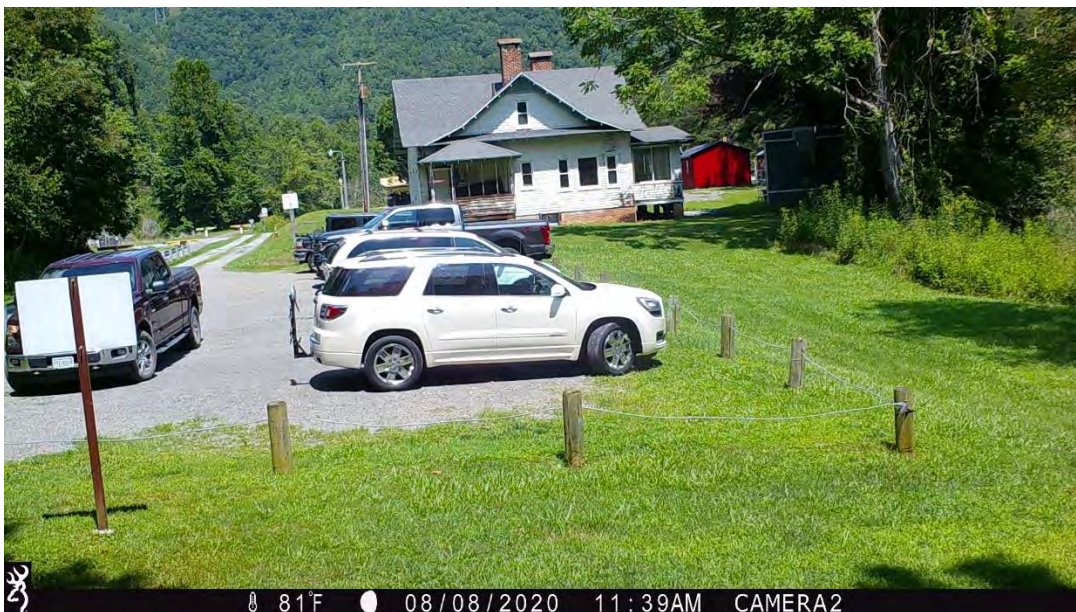
Figure 6-3. Optimal Weather Weekend – Parking Capacity at Byllesby Canoe Portage

The Byllesby Boat Launch and the parking lot at the Byllesby Canoe Portage had the highest overall usage of the recreation facilities during the trail camera analysis. As provided in the Assessment Report (Attachment 1) the Byllesby boat launch has 18 parking spaces and 7 spaces for boat trailers. The Byllesby Canoe Portage parking area has 12 spaces. At these two facilities, there were approximately ten to fifteen days during peak weekends (e.g., holidays) or when weekend weather was optimal where the parking lot appeared to reach capacity. An example of Byllesby Canoe Portage parking area reaching the parking lot capacity is shown in Figure 6-3.

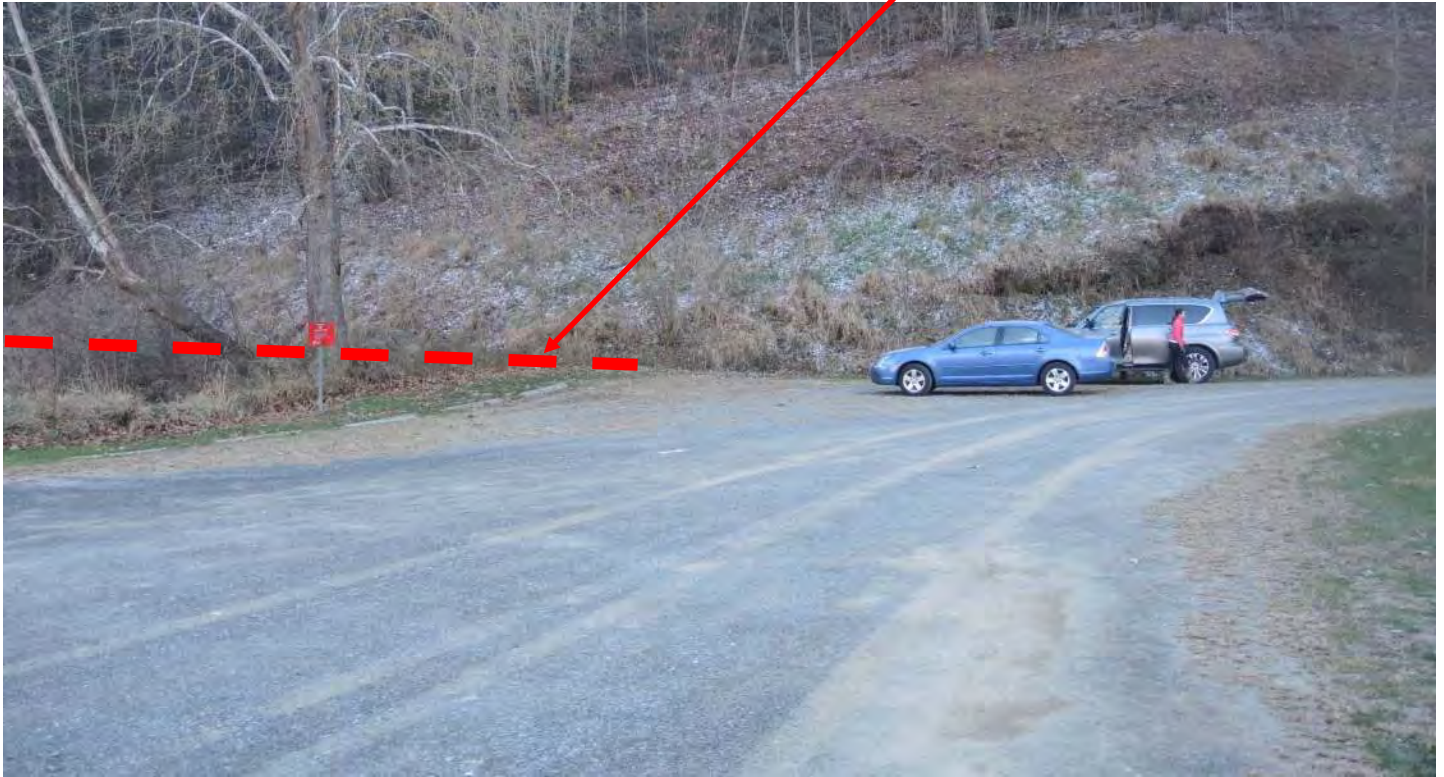
Photo 1-3: Parking along entrance into the site. There are currently five wheel stops; one more should be added. Possible trailhead access for interpretive trail.

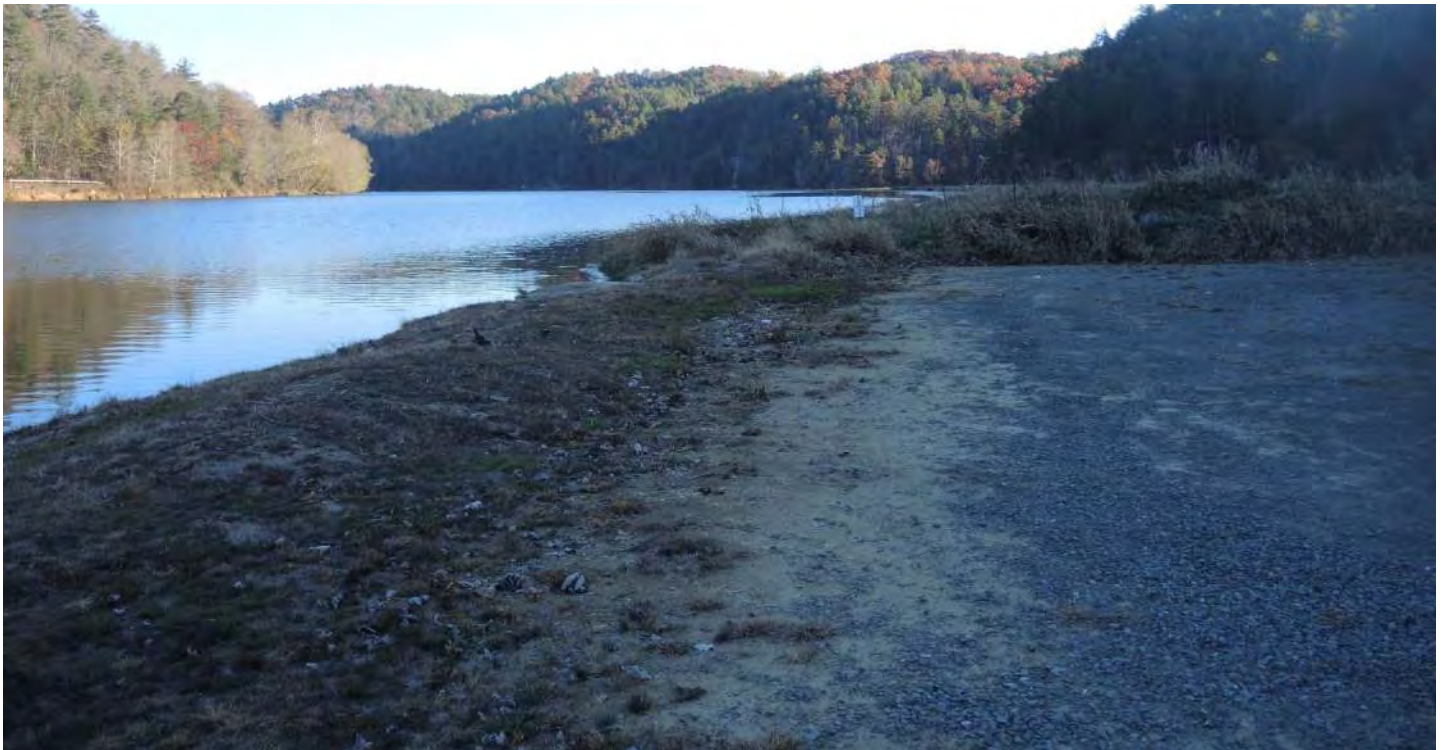
Photo 1-4: Soft dirt edge along parking lot

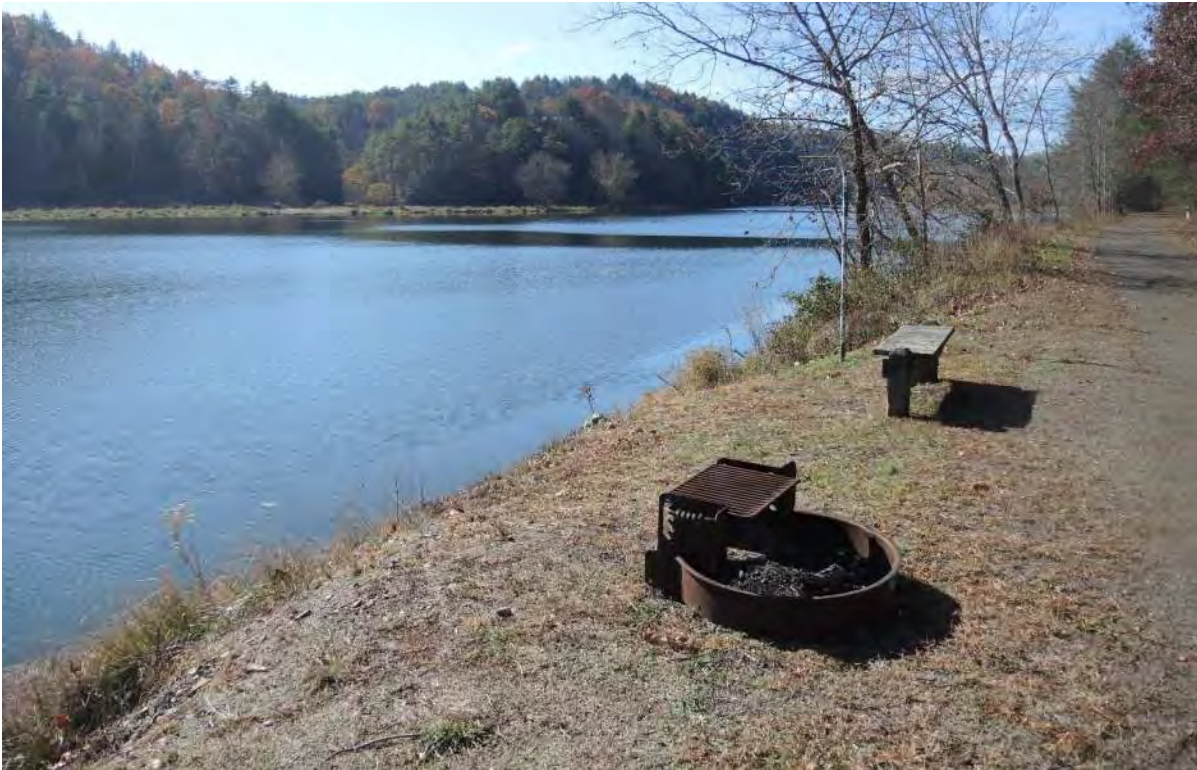
Photo 2-1: Fishing site with fire ring/grill, bench and lantern hook.

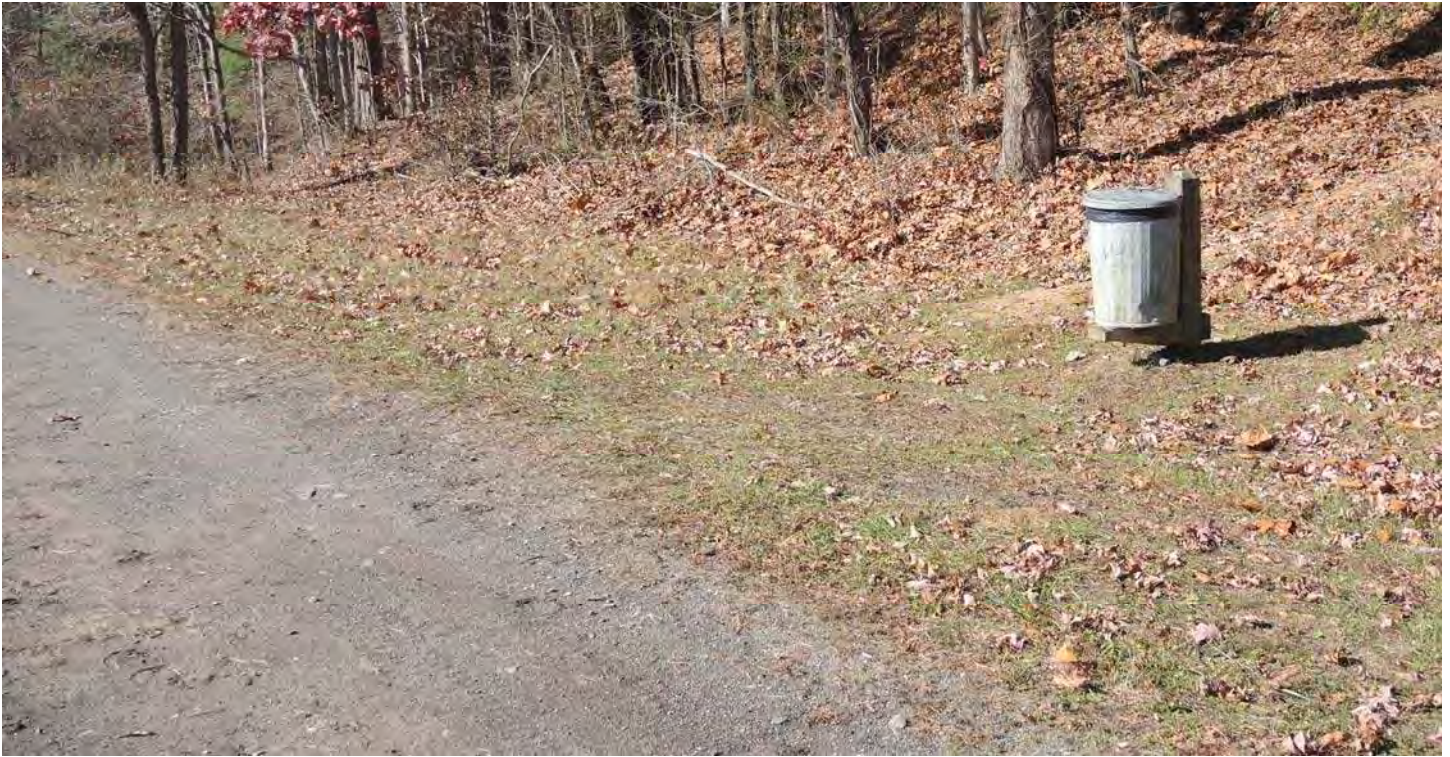
Photo 2-3: Trash can across the trail from the fishing site. Can has a dent at the bottom.

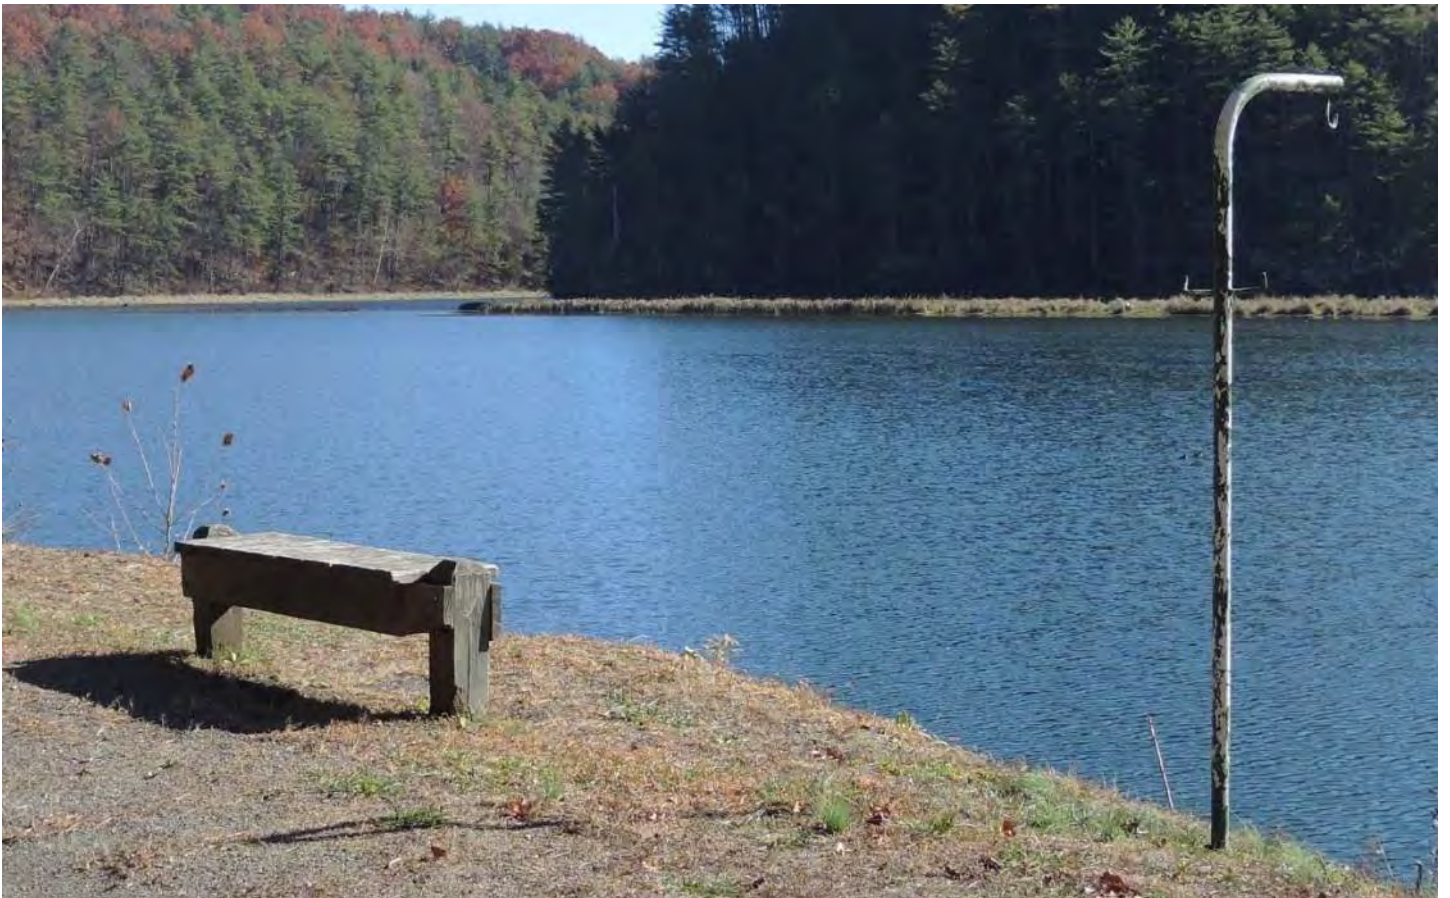
Photo 2-4: Rough wood bench and lantern hook with chipping paint.

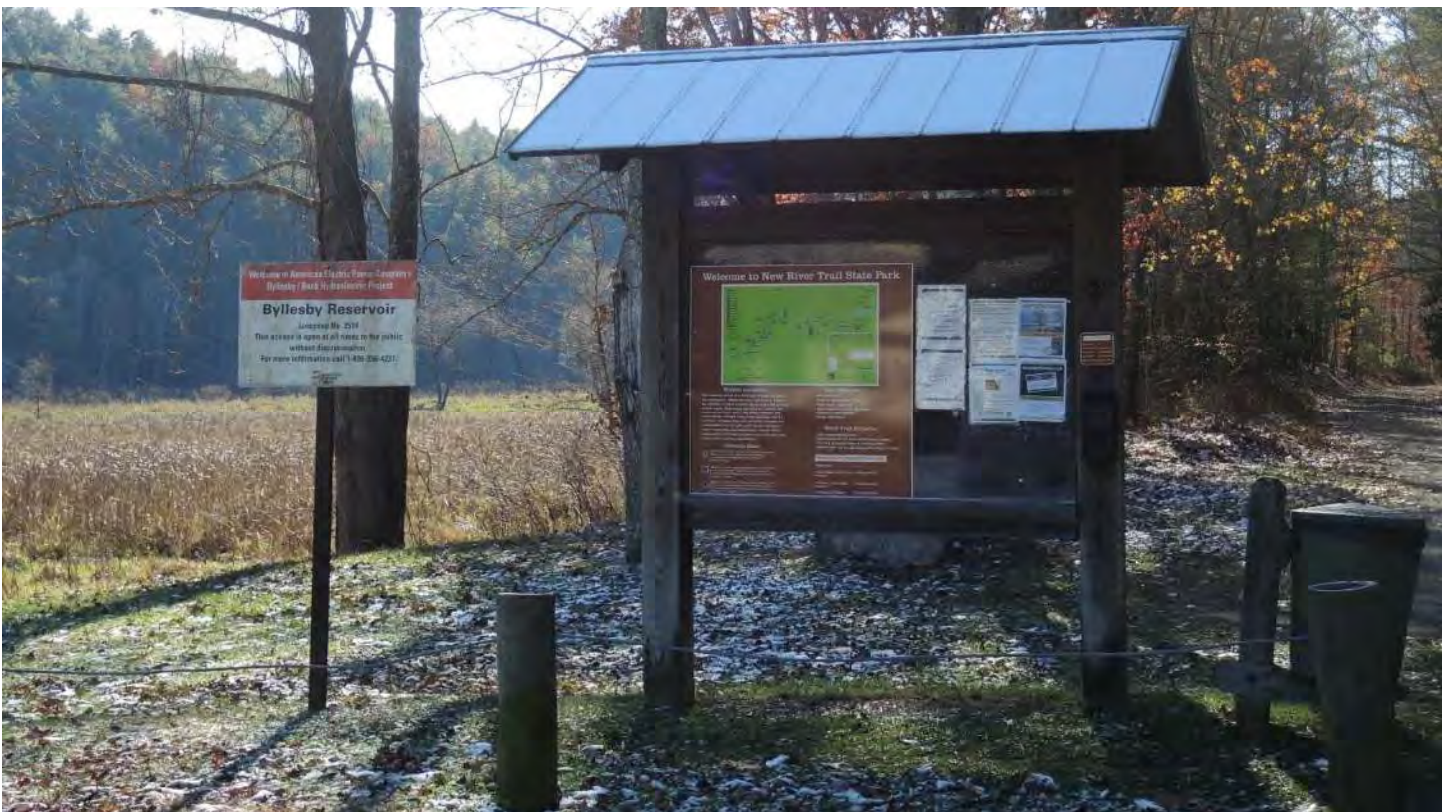
Photo 3-2: Kiosk with New River Trail State Park sign and informational posts. The Byllesby Reservoir sign is very dirty.

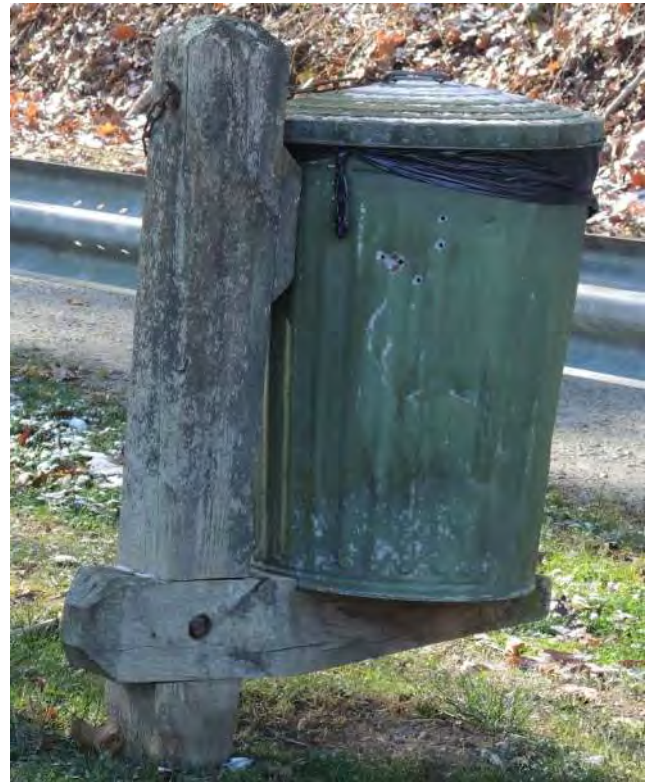
Photo 3-4: Trash can with holes and old wood post

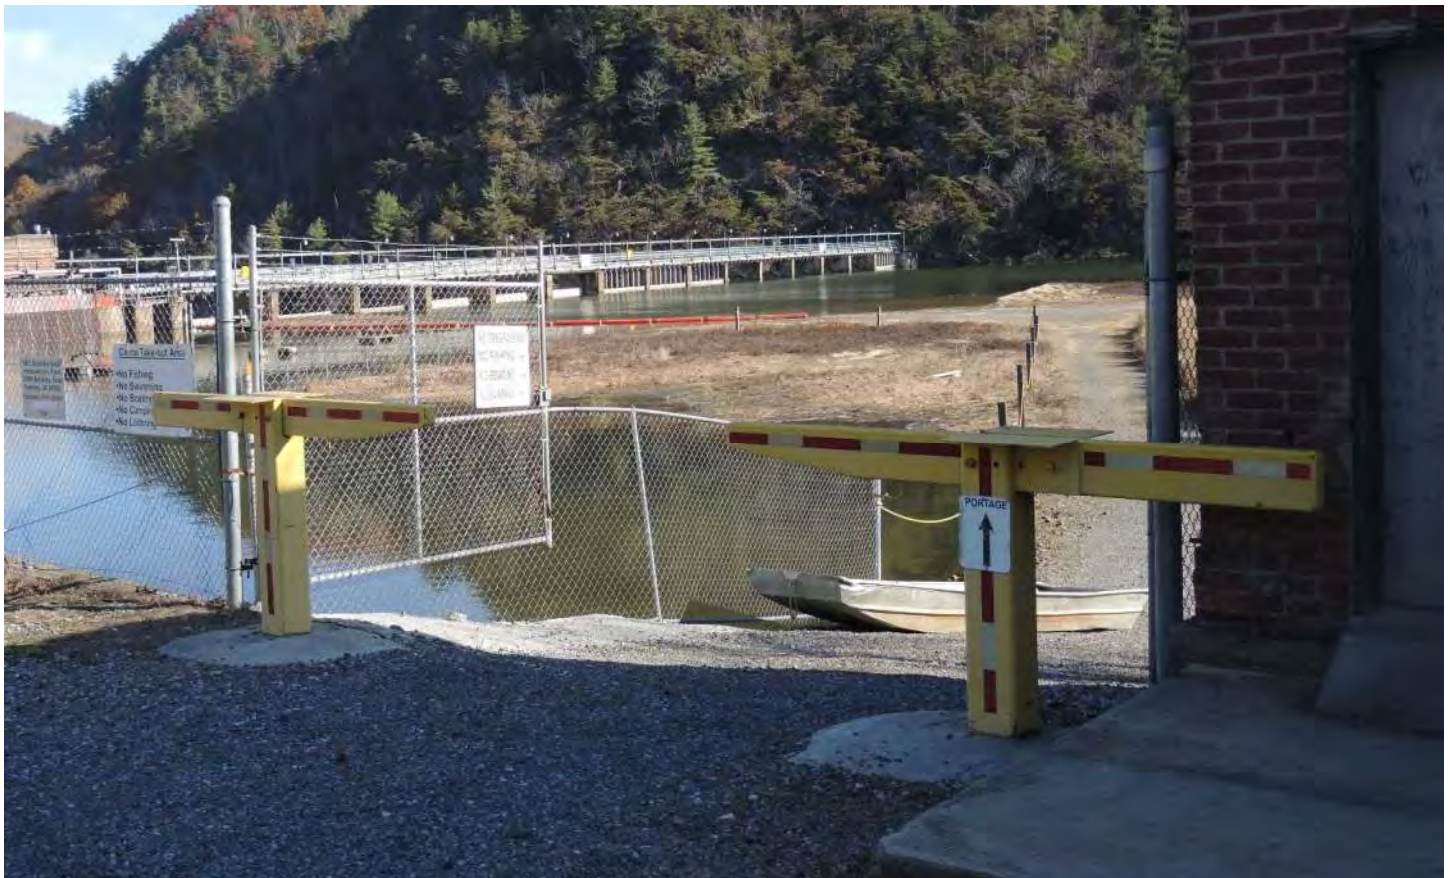
Photo 3-5: Gate to canoe portage with FERC, regulatory, and directional signage.

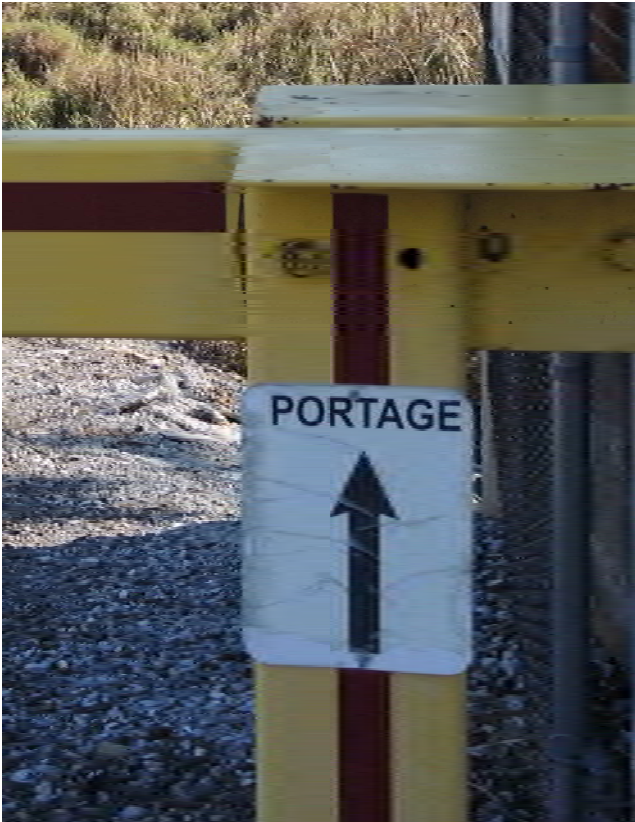
Photo 3-6: Portage sign on gate is very small and cracking/peeling

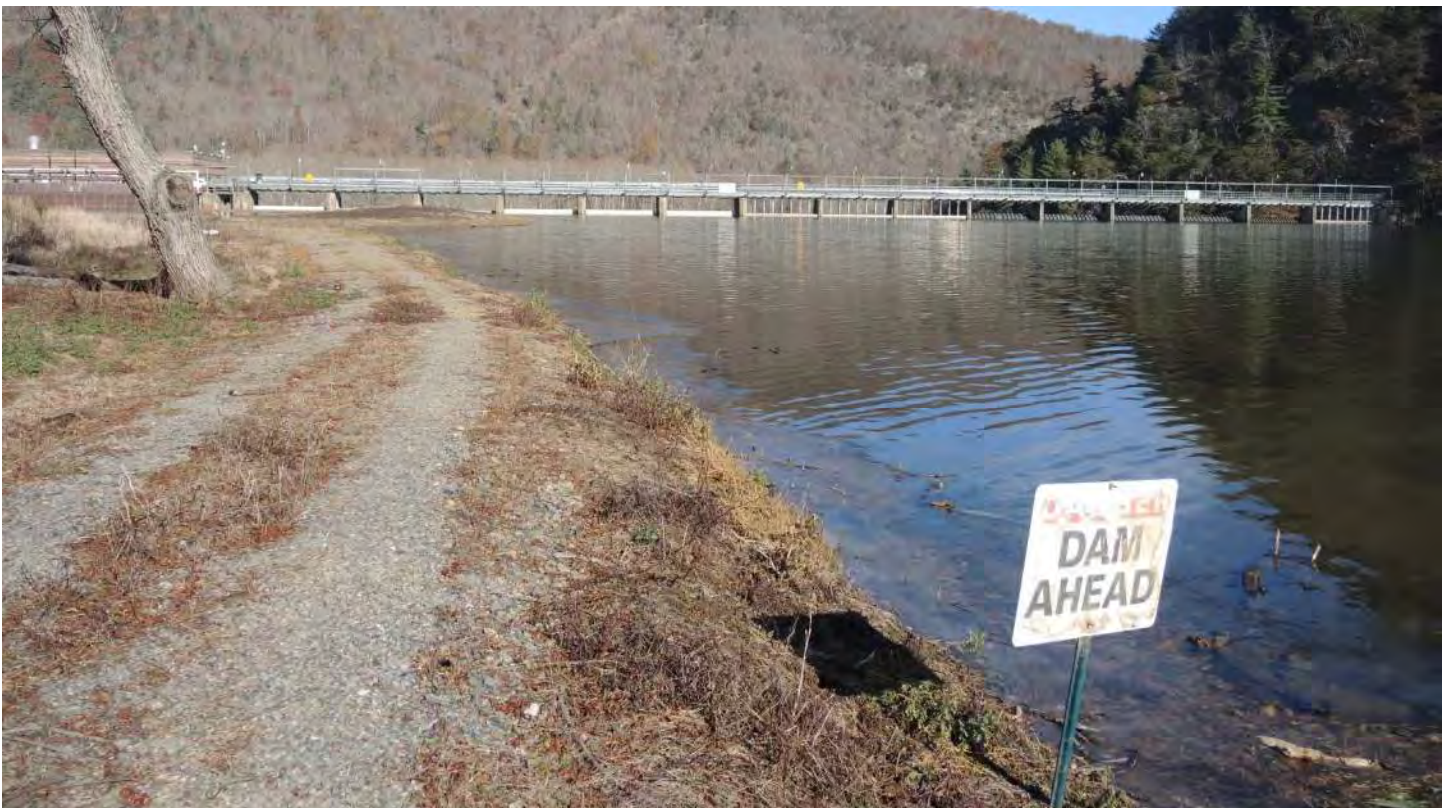
Photo 3-10: Looking back toward Byllesby Dam. The dam ahead warning sign is very faded and the trail has grass growing in the center.

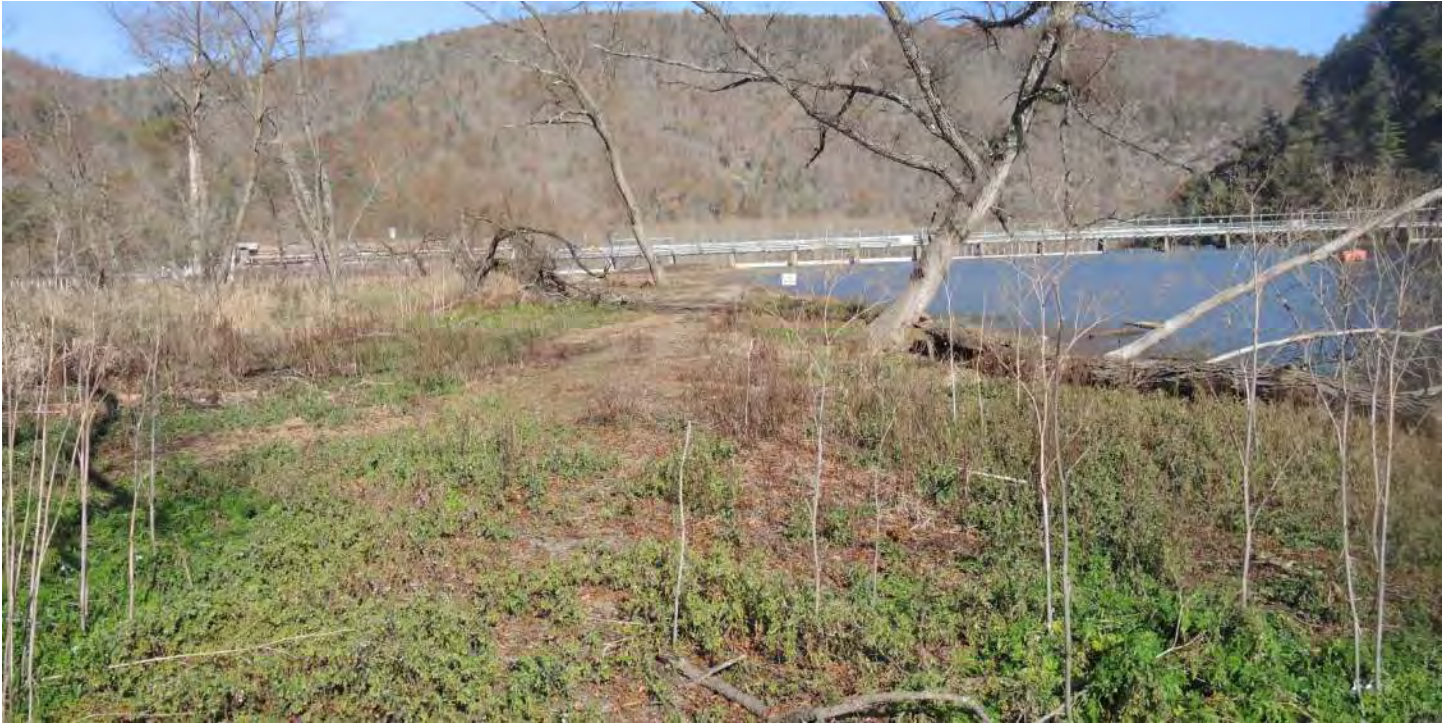
Photo 3-11: Section of trail near the portage take-out is grown over with vegetation and needs to be resurfaced to provide sufficient walking surface and to clarify trail route.

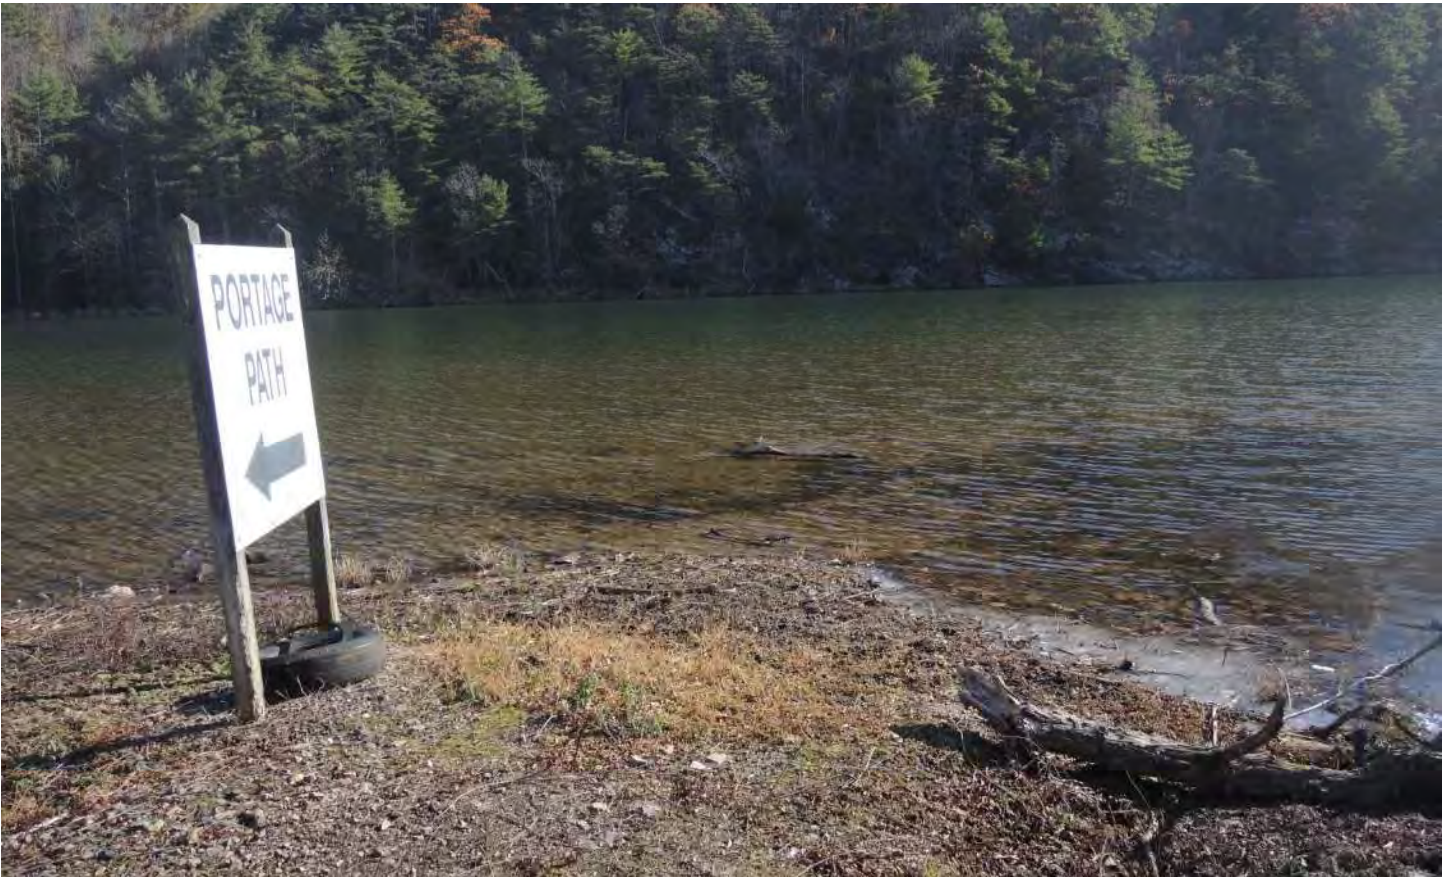
Photo 3-12: Canoe portage/river access and sign for the portage path. Portage take-out has no supporting infrastructure and the site is poorly maintained.

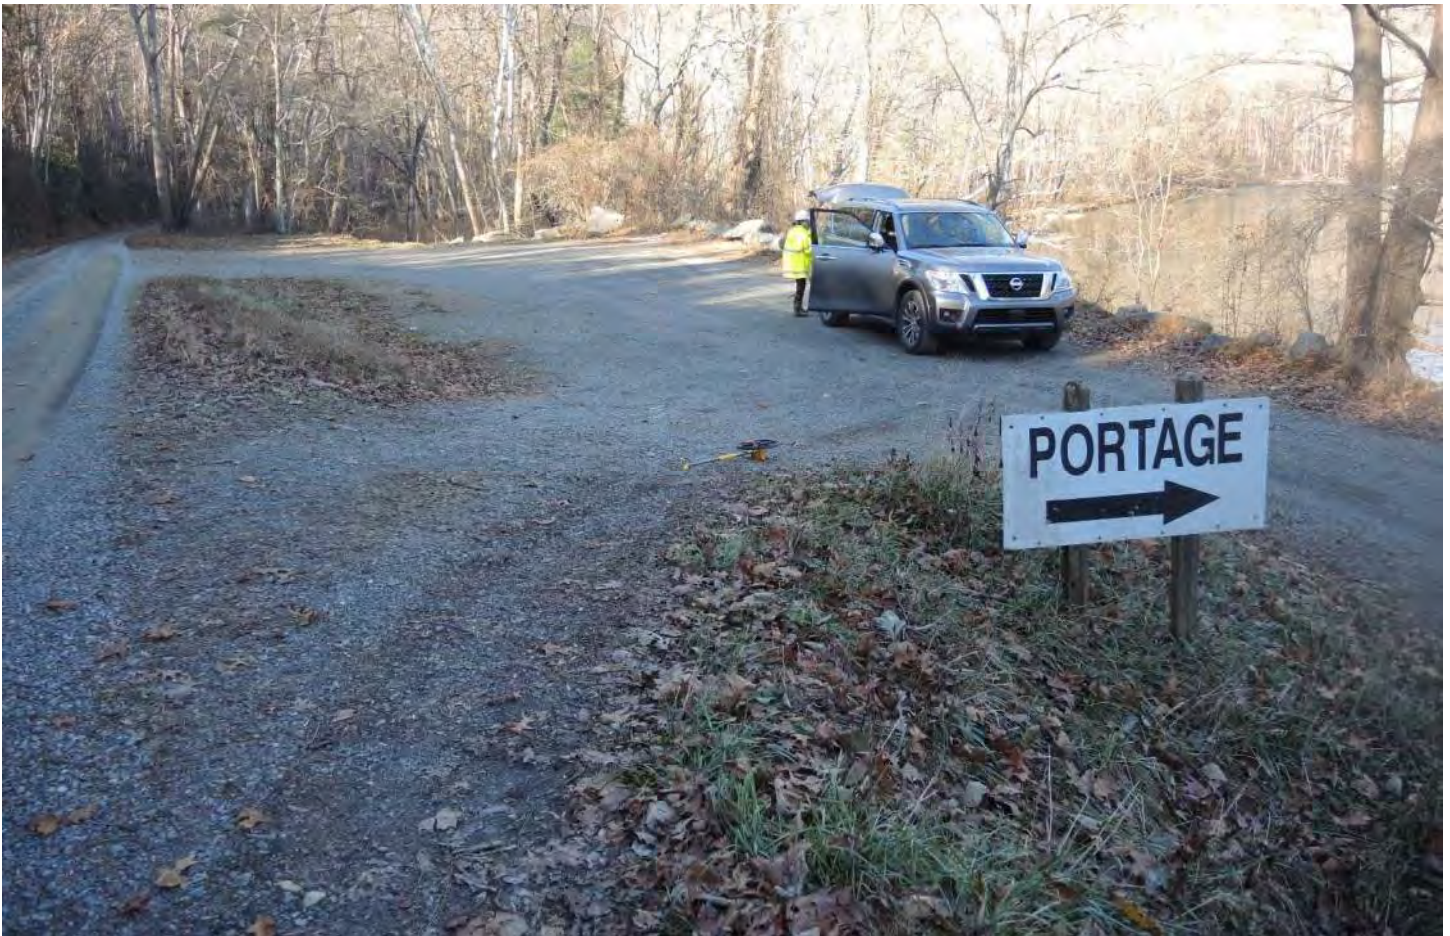
Photo 4-1: Parking lot and portage sign

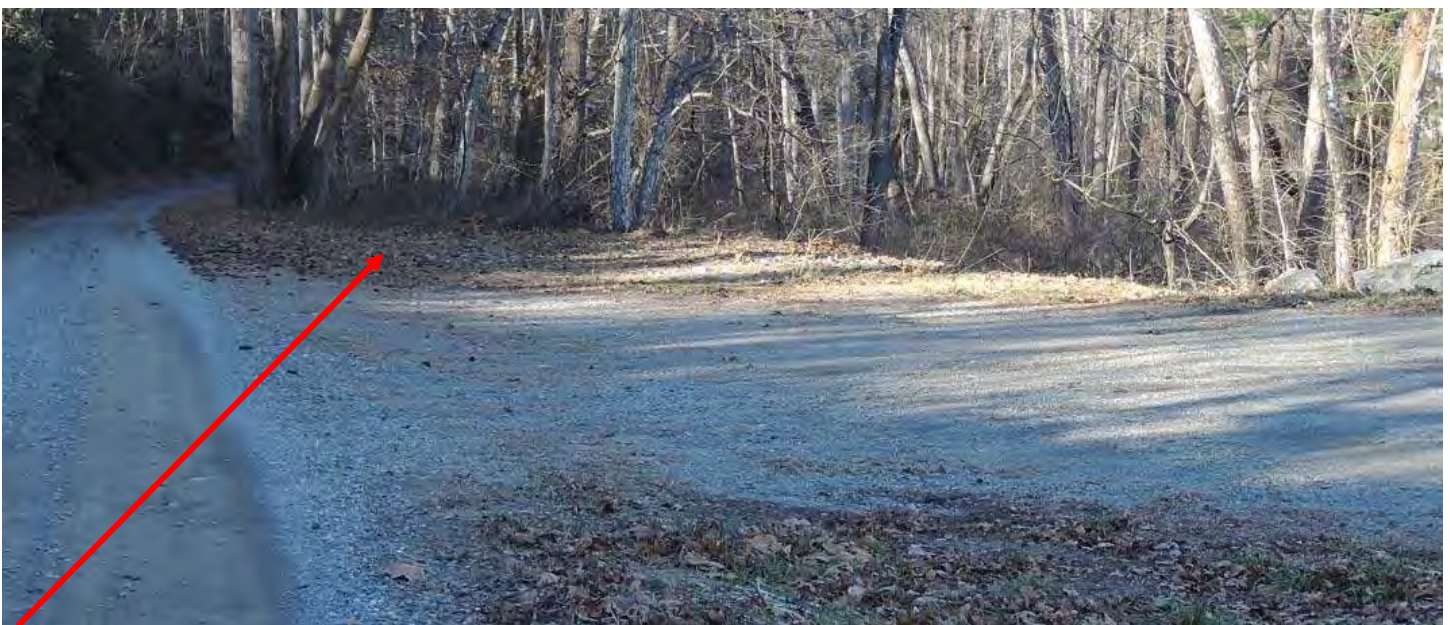
Photo 4-2: Flat area adjacent to road and parking lot that could potentially be graveled and used for additional parking

<b>PARKING</b>	Total Spaces: 10 Standard: 10 ADA: 0 Double (trailer): 0 Other: No marked parking spaces				<b>Condition</b>
	Surface Type: Asphalt Concrete (Gravel) Other: There is a flat area adjoining the parking area along the road that could potentially be surfaced and used for additional parking.				N / R / (M) / G
