# FINAL LICENSE APPLICATION

## Volume II of V Part 2 - Study Reports

Byllesby-Buck Hydroelectric Project  
(FERC No. 2514)

# Appendix B - Water Quality Study Report

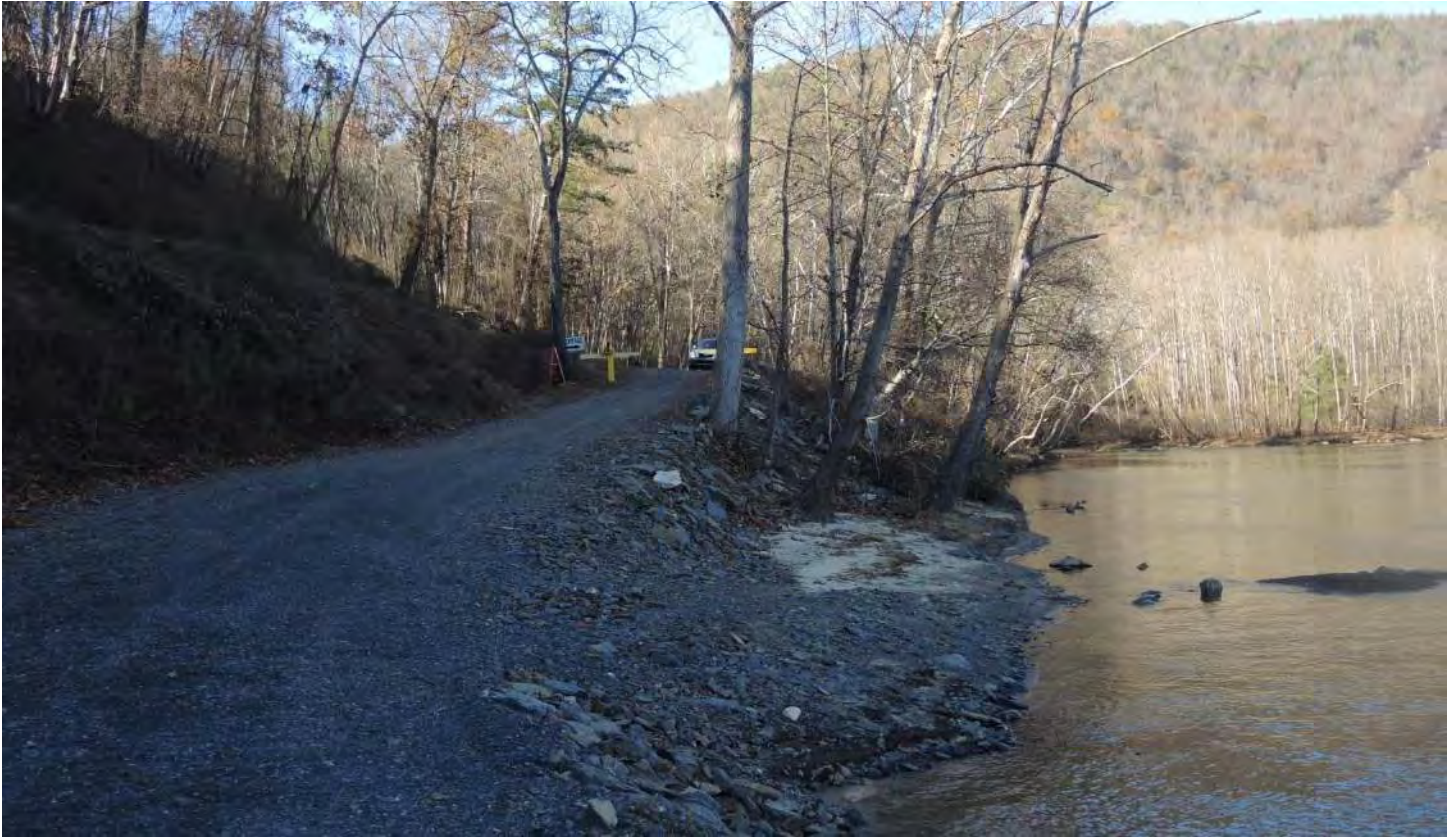
Photo 4-3: Canoe portage put-in and maintenance road accessing it from the parking area

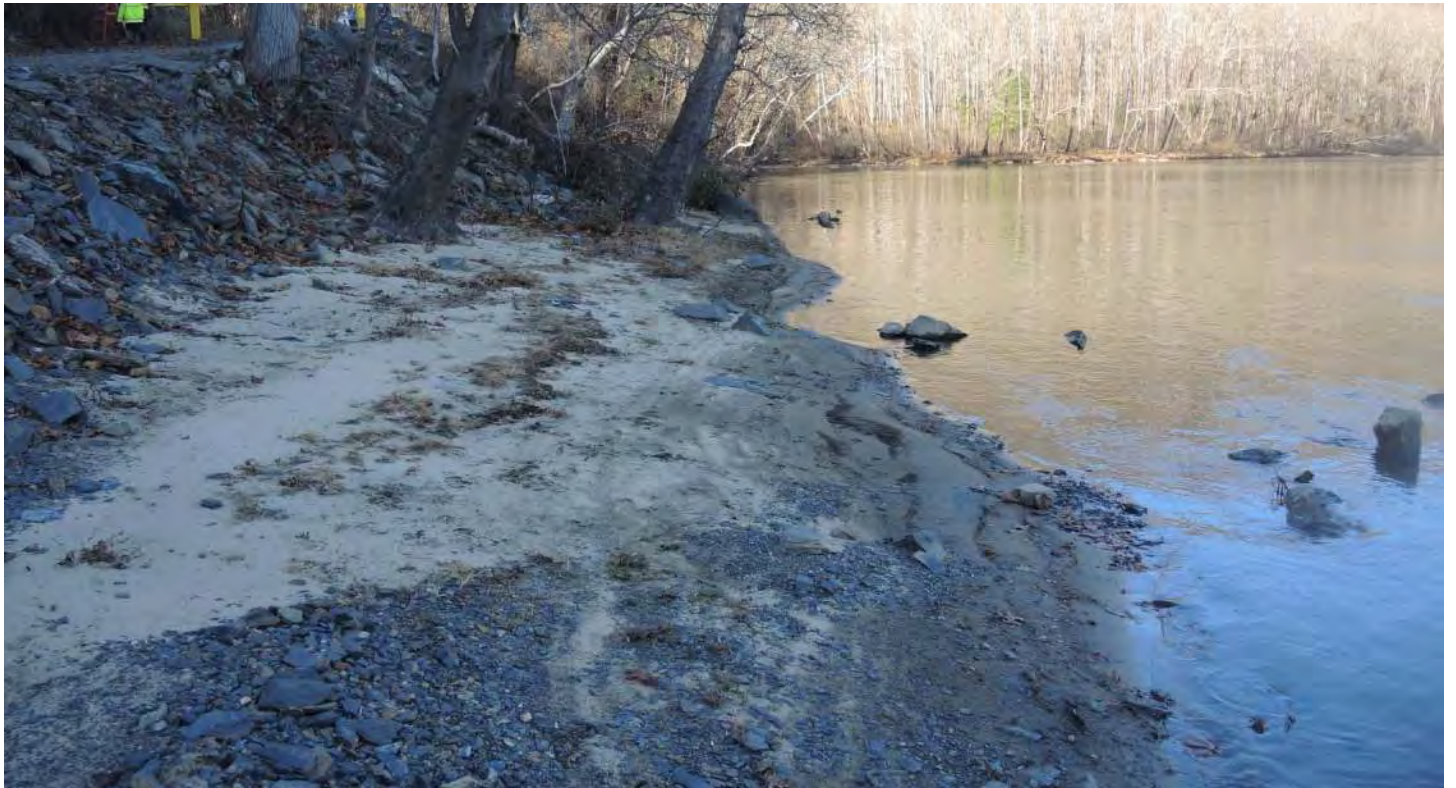
Photo 4-4: Canoe portage put-in

**ADDITIONAL COMMENTS/NOTES:** Note the age of the facilities (if known) as well as any signs of overuse.  
Portage put-in is informal, but functional. Proximity of parking to the put-in and arrangement of put-in site makes this portage site comfortable to use.

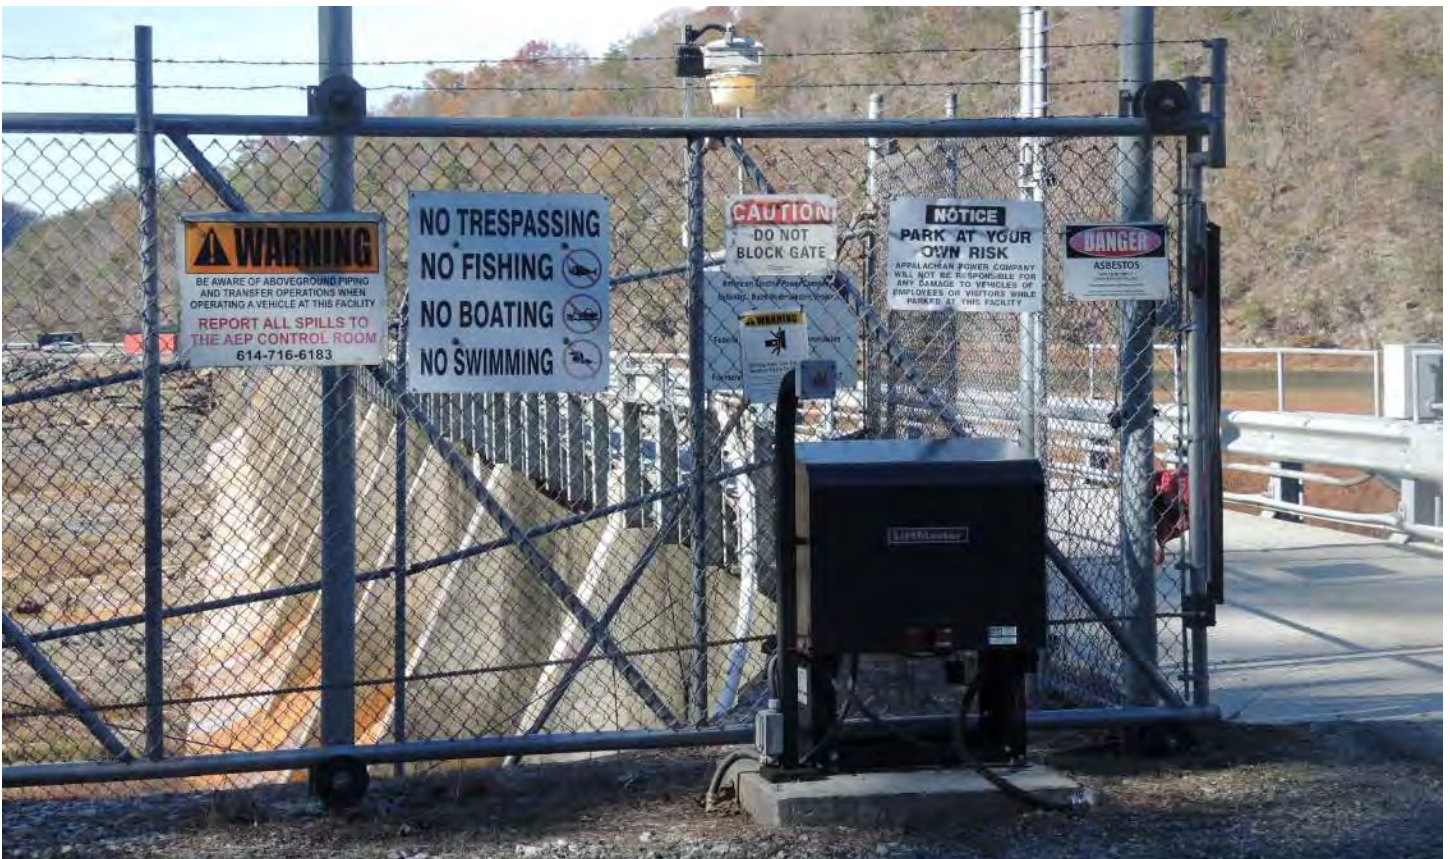
Photo 6-2: Dam gate with regulatory signs

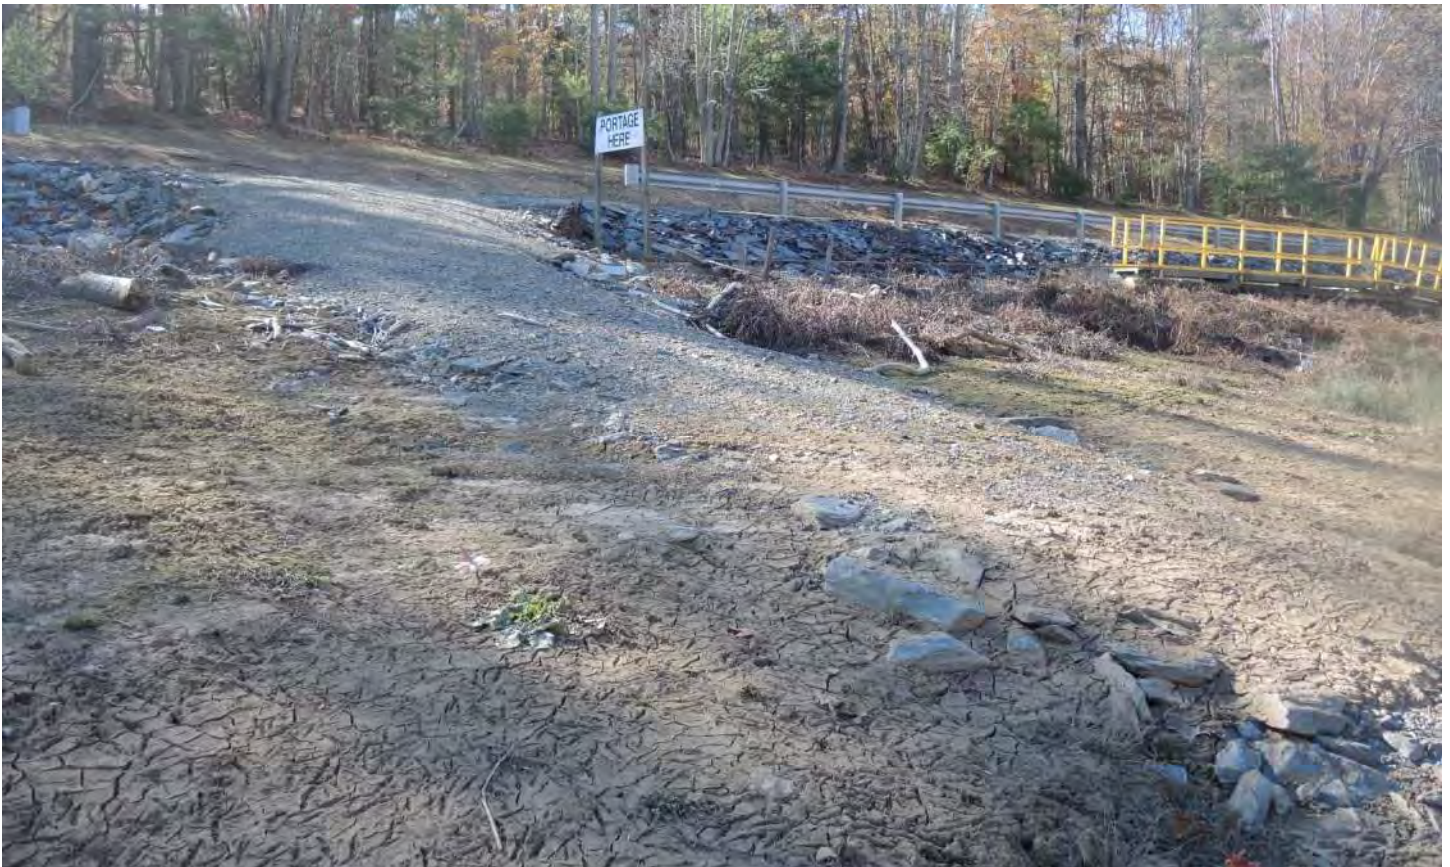
Photo 7-1: Upper canoe portage take-out. Note that water elevation was low when picture was taken, so the put-out length is not usually this long.

**ADDITIONAL COMMENTS/NOTES:** *Note the age of the facilities (if known) as well as any signs of overuse.*  
Portage is open to the public by water access only. No public parking is available, which limits the usability of the facility. Note that water elevation was low during site visit.

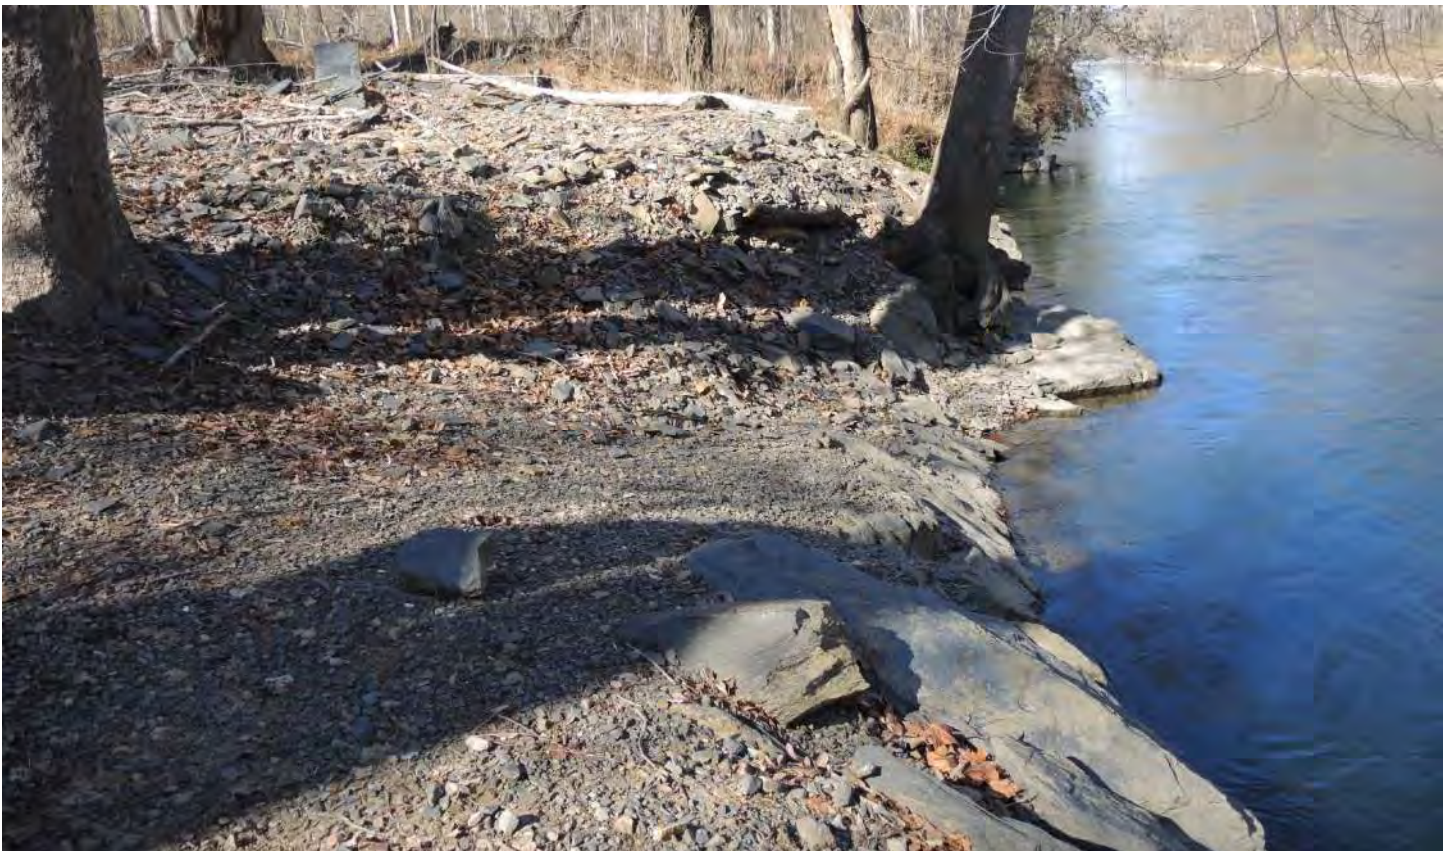
Photo 7-9: Water access at put-in location facing downstream. Note the steep access, deep water, and narrow land strip.

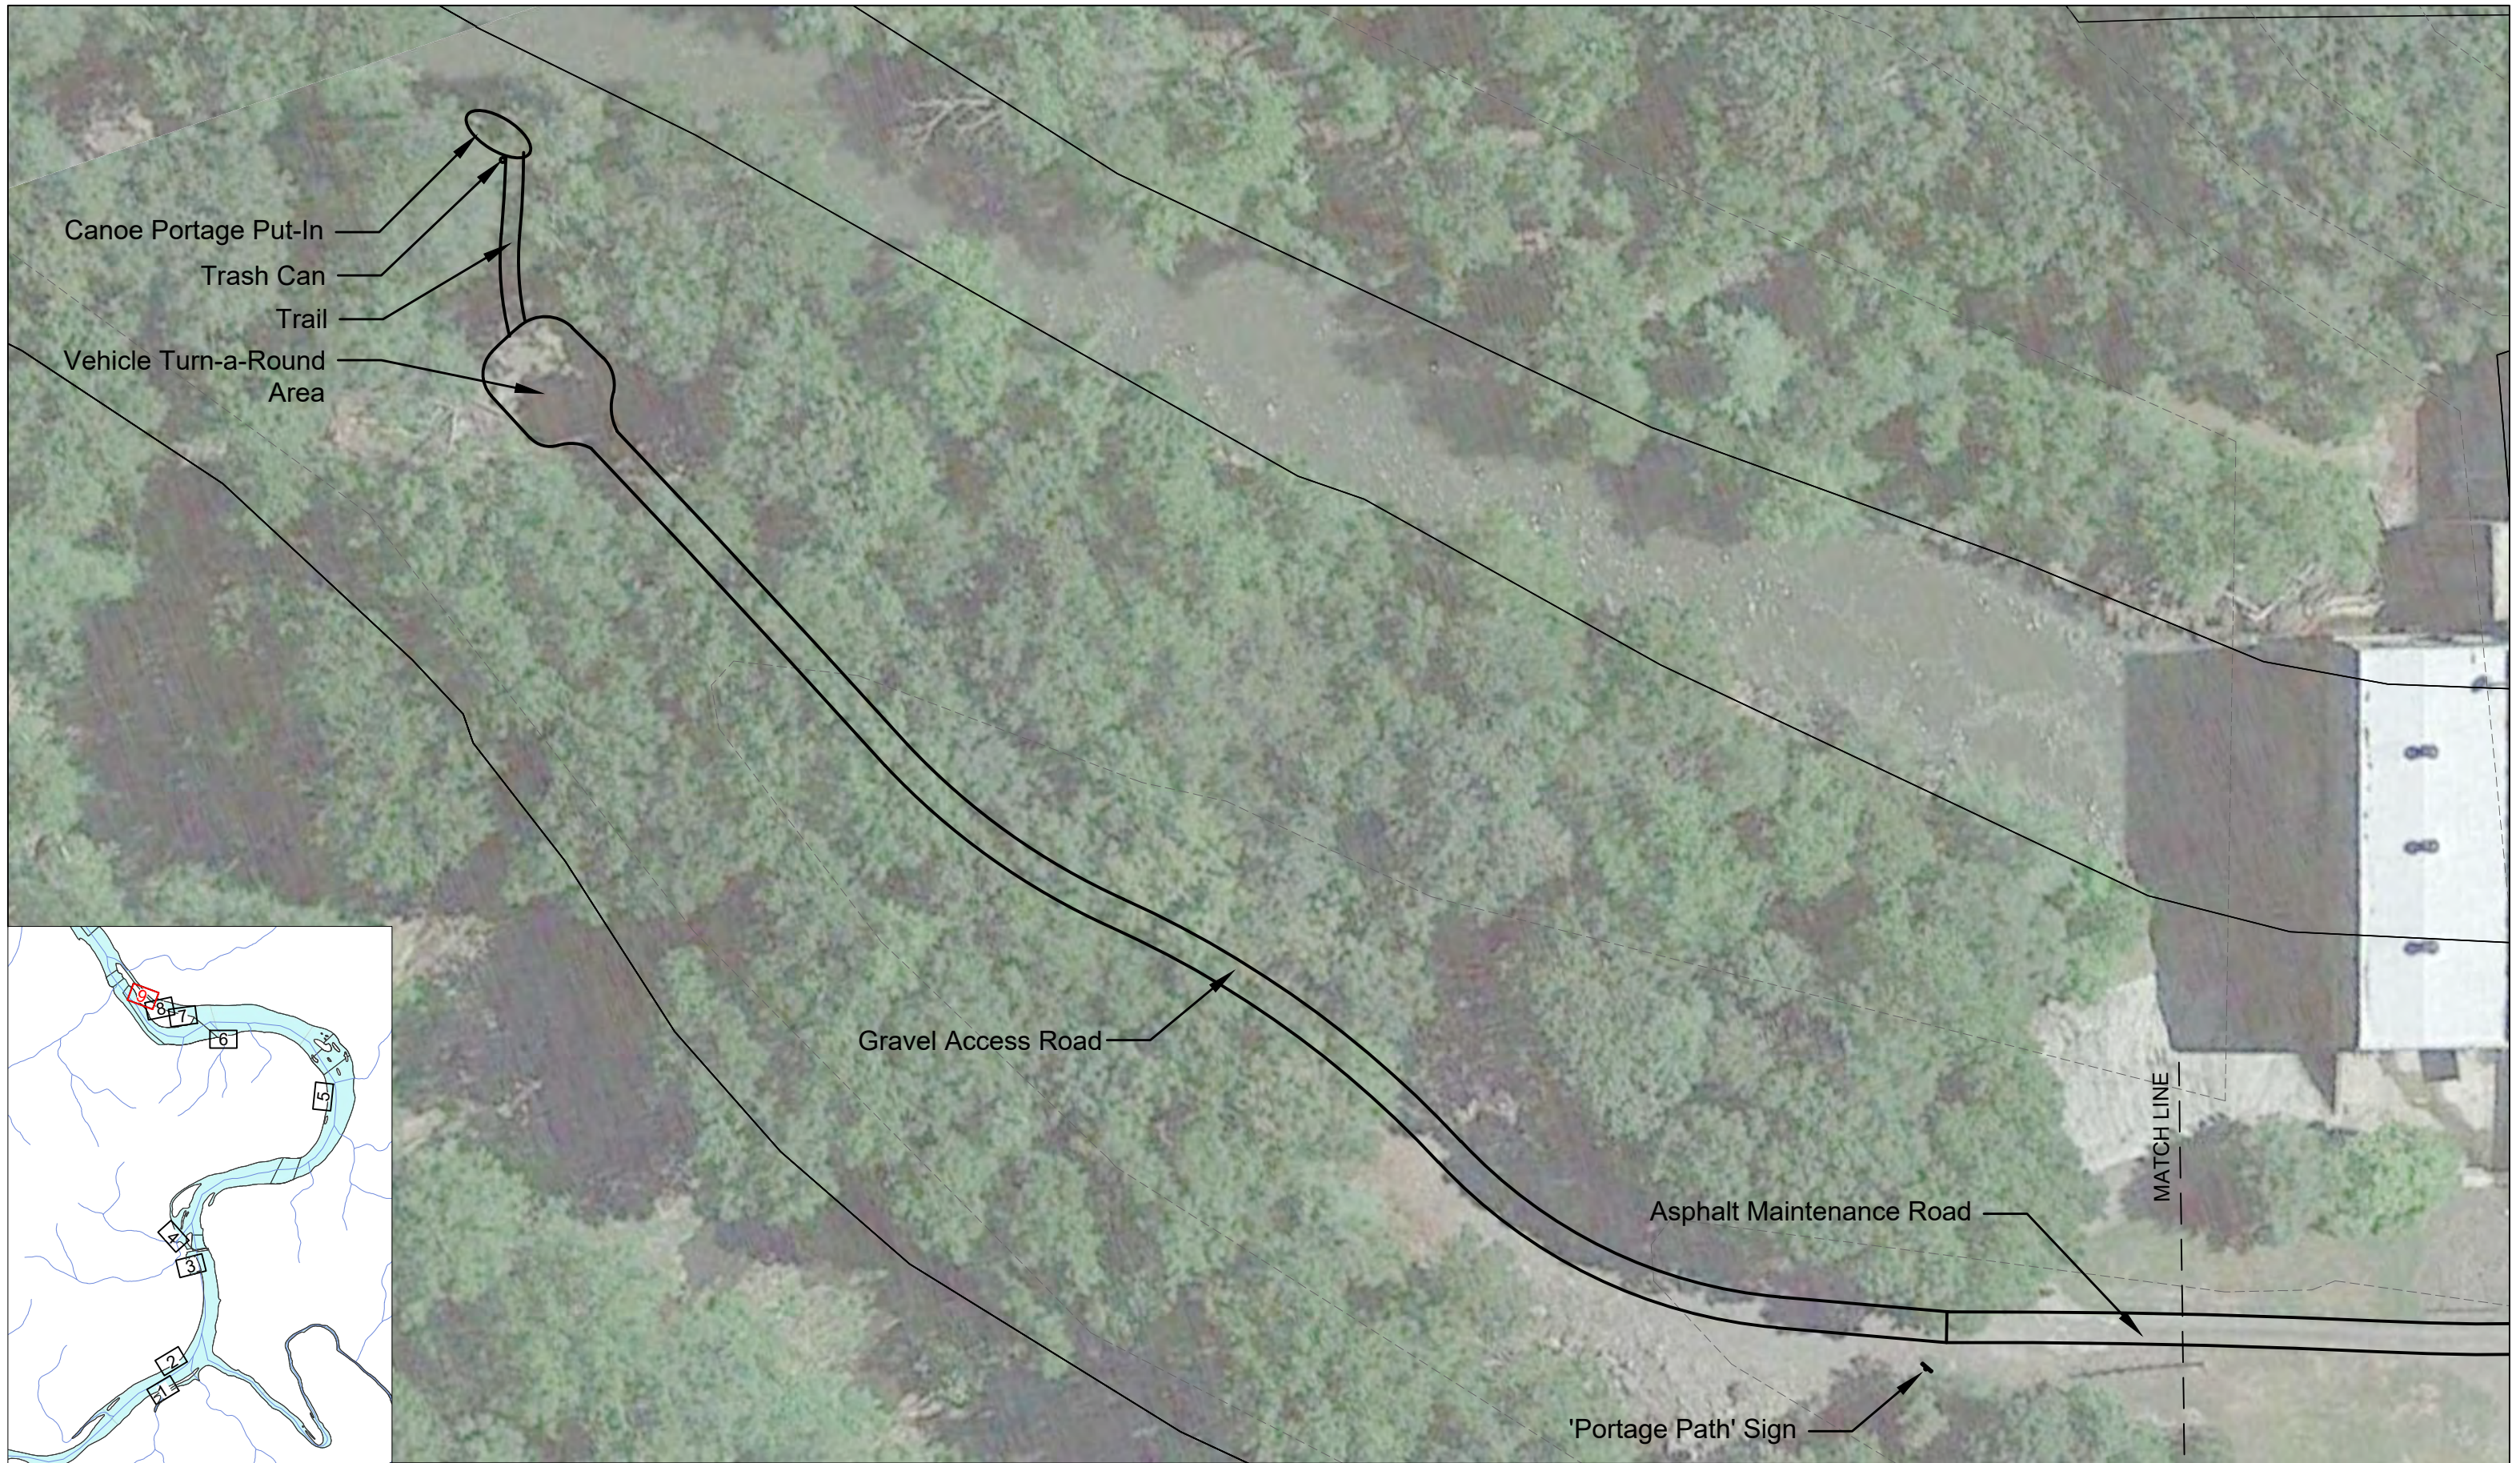
Canoe Portage  
Take Out

'Portage Here' Sign

Canoe Portage Put-In  
 Trash Can  
 Trail  
 Vehicle Turn-a-Round Area

Gravel Access Road

'Portage Path' Sign

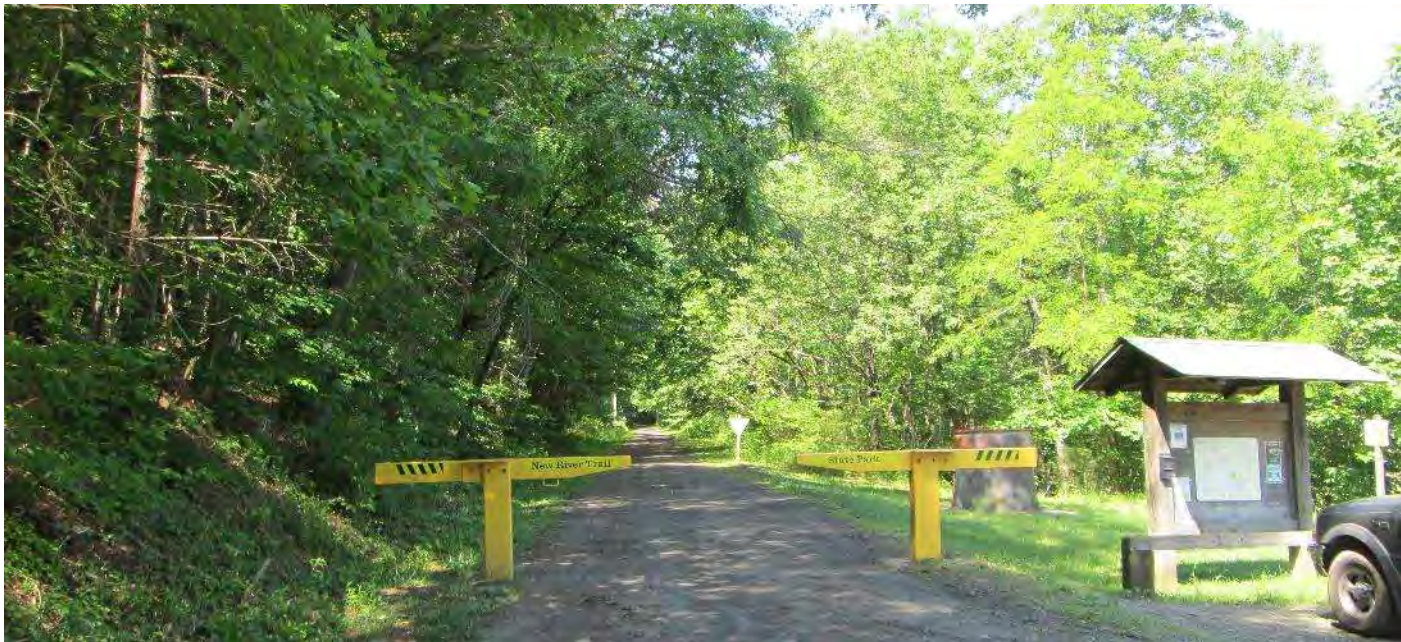
# Byllesby VDWR Boat Launch

- Leased and Operated by VDGIF (now VDWR) and located within the Project Boundary
- Provides single-lane concrete boat launch with gravel parking area.

- **Byllesby Boat Launch** – VDWR noted that the only approved use of this facility is for boating and fishing. The site is also used for duck hunting access in the winter months. All other use is technically considered trespass. Site is open at all hours for these recreation activities only.

- VDWR performs site maintenance once a month at a minimum. VDWR contracts with a vendor for regular mowing and trash pickup.
  - The access road to the site is on the list (i.e., Carroll County 6-year plan) to be paved by Virginia Department of Transportation. VDWR noted that they do not control the fabrication or placement of the “trailblazer” signs on public roads.

- The boat ramp is not usable when the reservoir is drawn down (e.g., for dam maintenance). Appalachian pointed out that the frequency of drawdowns has and is expected to continue to decrease due to operation of the inflatable crest gates preventing flashboard failure.

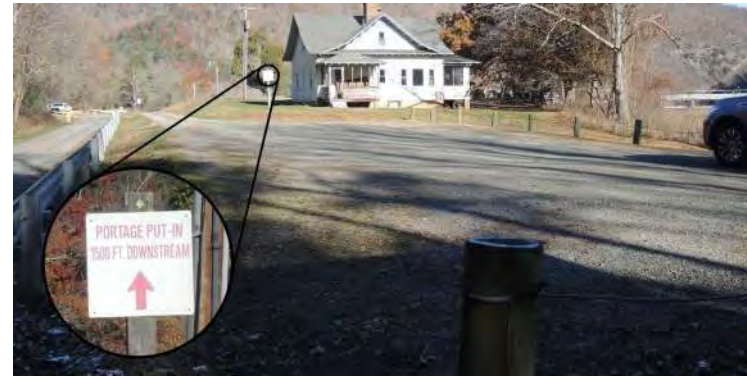
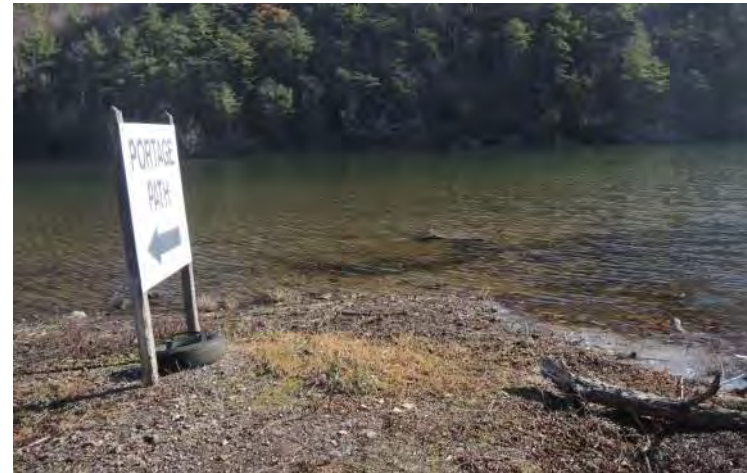
# Byllesby Canoe Portage: Inventory Conditions Assessment

- Rustic portage take-out; large and level for easy transfer
- Portage is 775 ft from parking lot
- Trashcan at parking lot is aged but functional and is regularly serviced
- Varying site and directional signage
- No ADA amenities

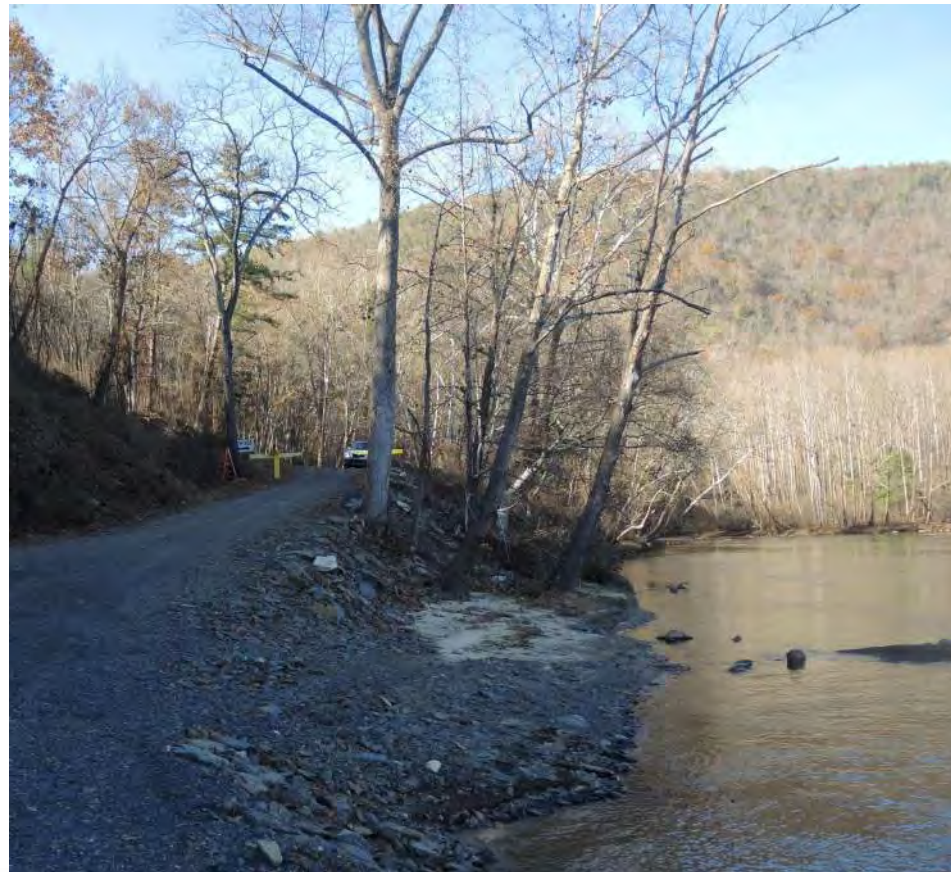
# New River Canoe Launch: Inventory Conditions Assessment

- Rustic portage put-in is functional
- Large level sandy surface at portage makes transfer easy
- Gravel parking area for approximately 10 cars
- Canoe put-in is 125 ft from parking area and 1,175 ft (0.22 miles) from take-out
- Clear directional signage
- No site furnishings
- No ADA amenities

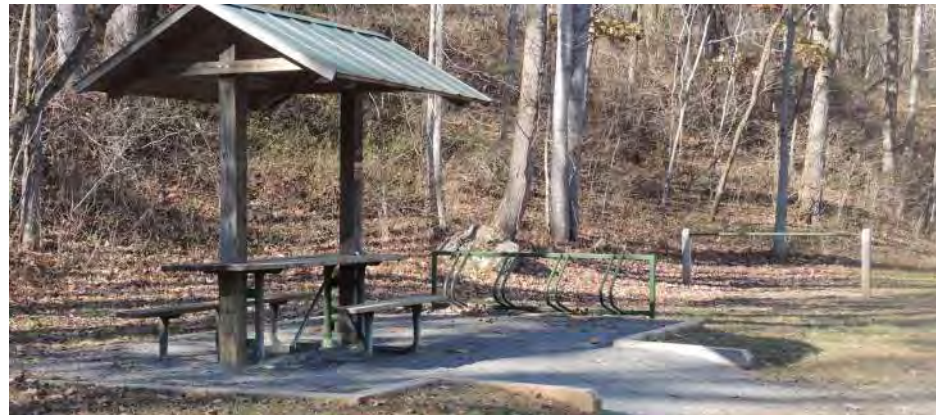
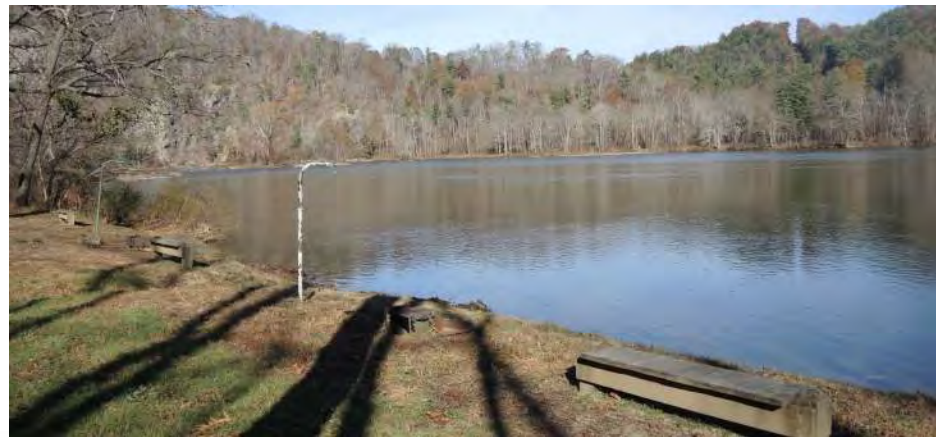
# New River Trail Picnic Area: Inventory Conditions Assessment

- Informal parking on shoulder off of road.
- Informal unsigned path leads down hill to upper picnic area off New River trail.
- Upper picnic area amenities are in good/serviceable condition. Picnic table is ADA accessible.
- Lower picnic area furnishings (bench, trash can) require maintenance. Grill is older and could be replaced.
- Some degree of site and directional signage.

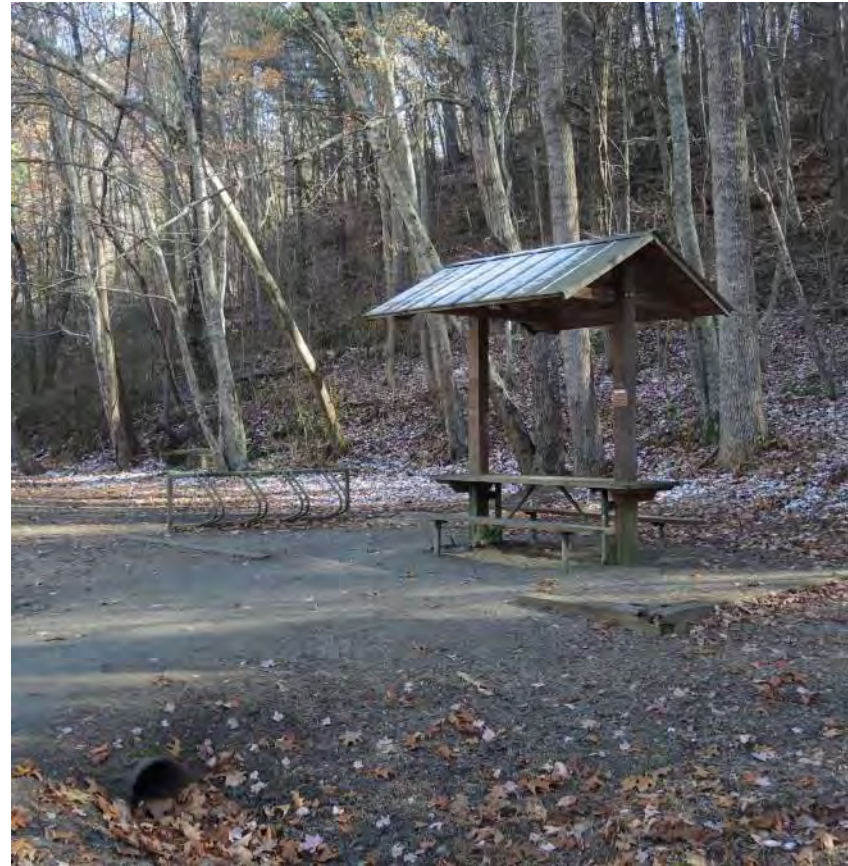
## Buck Dam Picnic Area: Inventory Conditions Assessment

- Picnic site along the New River Trail, approx. 650 ft from parking area.
- Gravel parking for approx. 5 cars, needs light maintenance.
- Portable restroom is ADA accessible.
- An industrial artifact is located by parking area.
- Some degree of site and directional signage, in varying conditions.
